WASTEWATER DISPOSAL REPORT

SMH Consultants
Owl Ridge Subdivision

EPC Parcel #: 5100000447

February 2022 (revised August 2022) (Second revision April 2023)

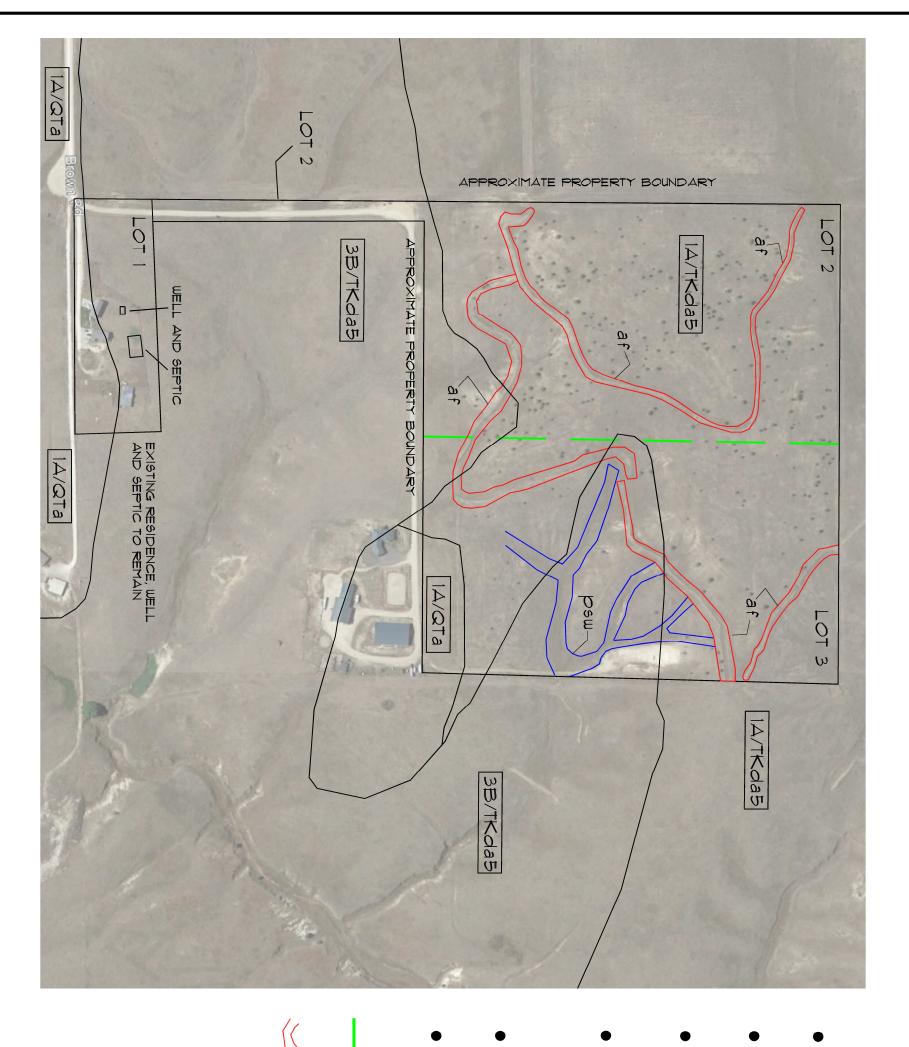
ENGINEERING AND GEOLOGY MAP

Based on our field observations and review of relevant geologic maps, a geologic map was prepared which identifies the geologic conditions affecting the development. The geologic conditions affecting the development are presented in the Engineering and Geology Map, Figure 6.

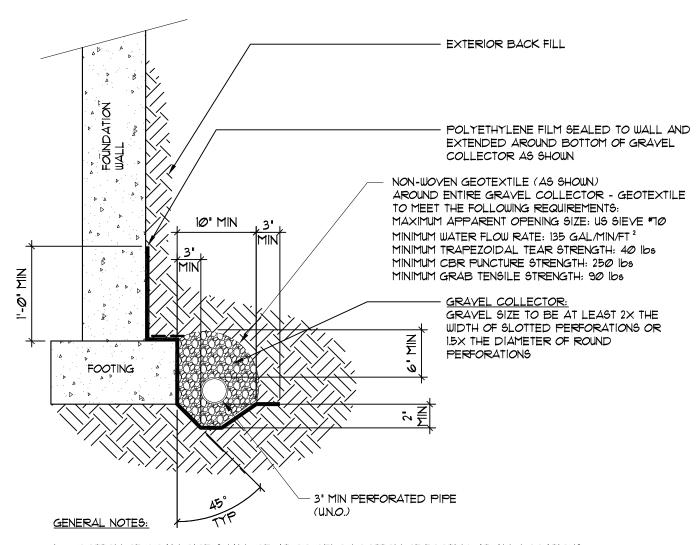
- 1. BOTTOM OF DRAIN PIPE SHALL BE AT OR BELOW BOTTOM OF FOOTING AT ALL LOCATIONS
- 2. ALL DRAIN PIPE SHALL BE PERFORATED PLASTIC, WITH THE EXCEPTION OF THE DISCHARGE PORTION WHICH SHALL BE SOLID, NON-PERFORATED PIPE.

- 3. DRAIN PIPE SHALL HAVE POSITIVE FALL THROUGHOUT.
- 4. DRAIN PIPE SHALL BE PROVIDED WITH A FREE GRAVITY OUTFALL, IF POSSIBLE. IF A GRAVITY OUTFALL CANNOT BE ACHIEVED, THEN A SUMP PIT AND PUMP SHALL BE USED. THE OUTFALL SHOULD EXTEND PAST BACKFILL ZONES AND DISCHARGE TO A LOCATION THAT IS GRADED TO DIRECT WATER OFF-SITE.

- 5. ALL DRAIN COMPONENTS SHALL BE RATED/APPROVED BY THE MANUFACTURER FOR THE INSTALLED DEPTH AND APPLICATION
- 6. DRAIN SYSTEM, INCLUDING THE OUTFALL OF THE DRAIN, SHALL BE OBSERVED BY QUALIFIED PERSONNEL PRIOR TO BACKFILLING TO VERIFY INSTALLATION.

In addition to the previously identified mitigation alternatives, surface and subsurface drainage systems should be considered. Exterior, perimeter foundation drains should be installed around below-grade habitable or storage spaces. A typical perimeter drain detail is presented in Figure 10. Surface water should be efficiently removed from the building area to prevent ponding and infiltration into the subsurface soil.
