Extended Detention Basin (EDB)

PRESIDENT'S RIDGE
PHASE 1

EXTENDED DETENTION BASIN OPERATION
AND MAINTENANCE PLAN (PLAN AND PROFILE)

Standard Operation Procedures (SOP)
For
Extended Detention Basin (EDB)
Inspection and Maintenance

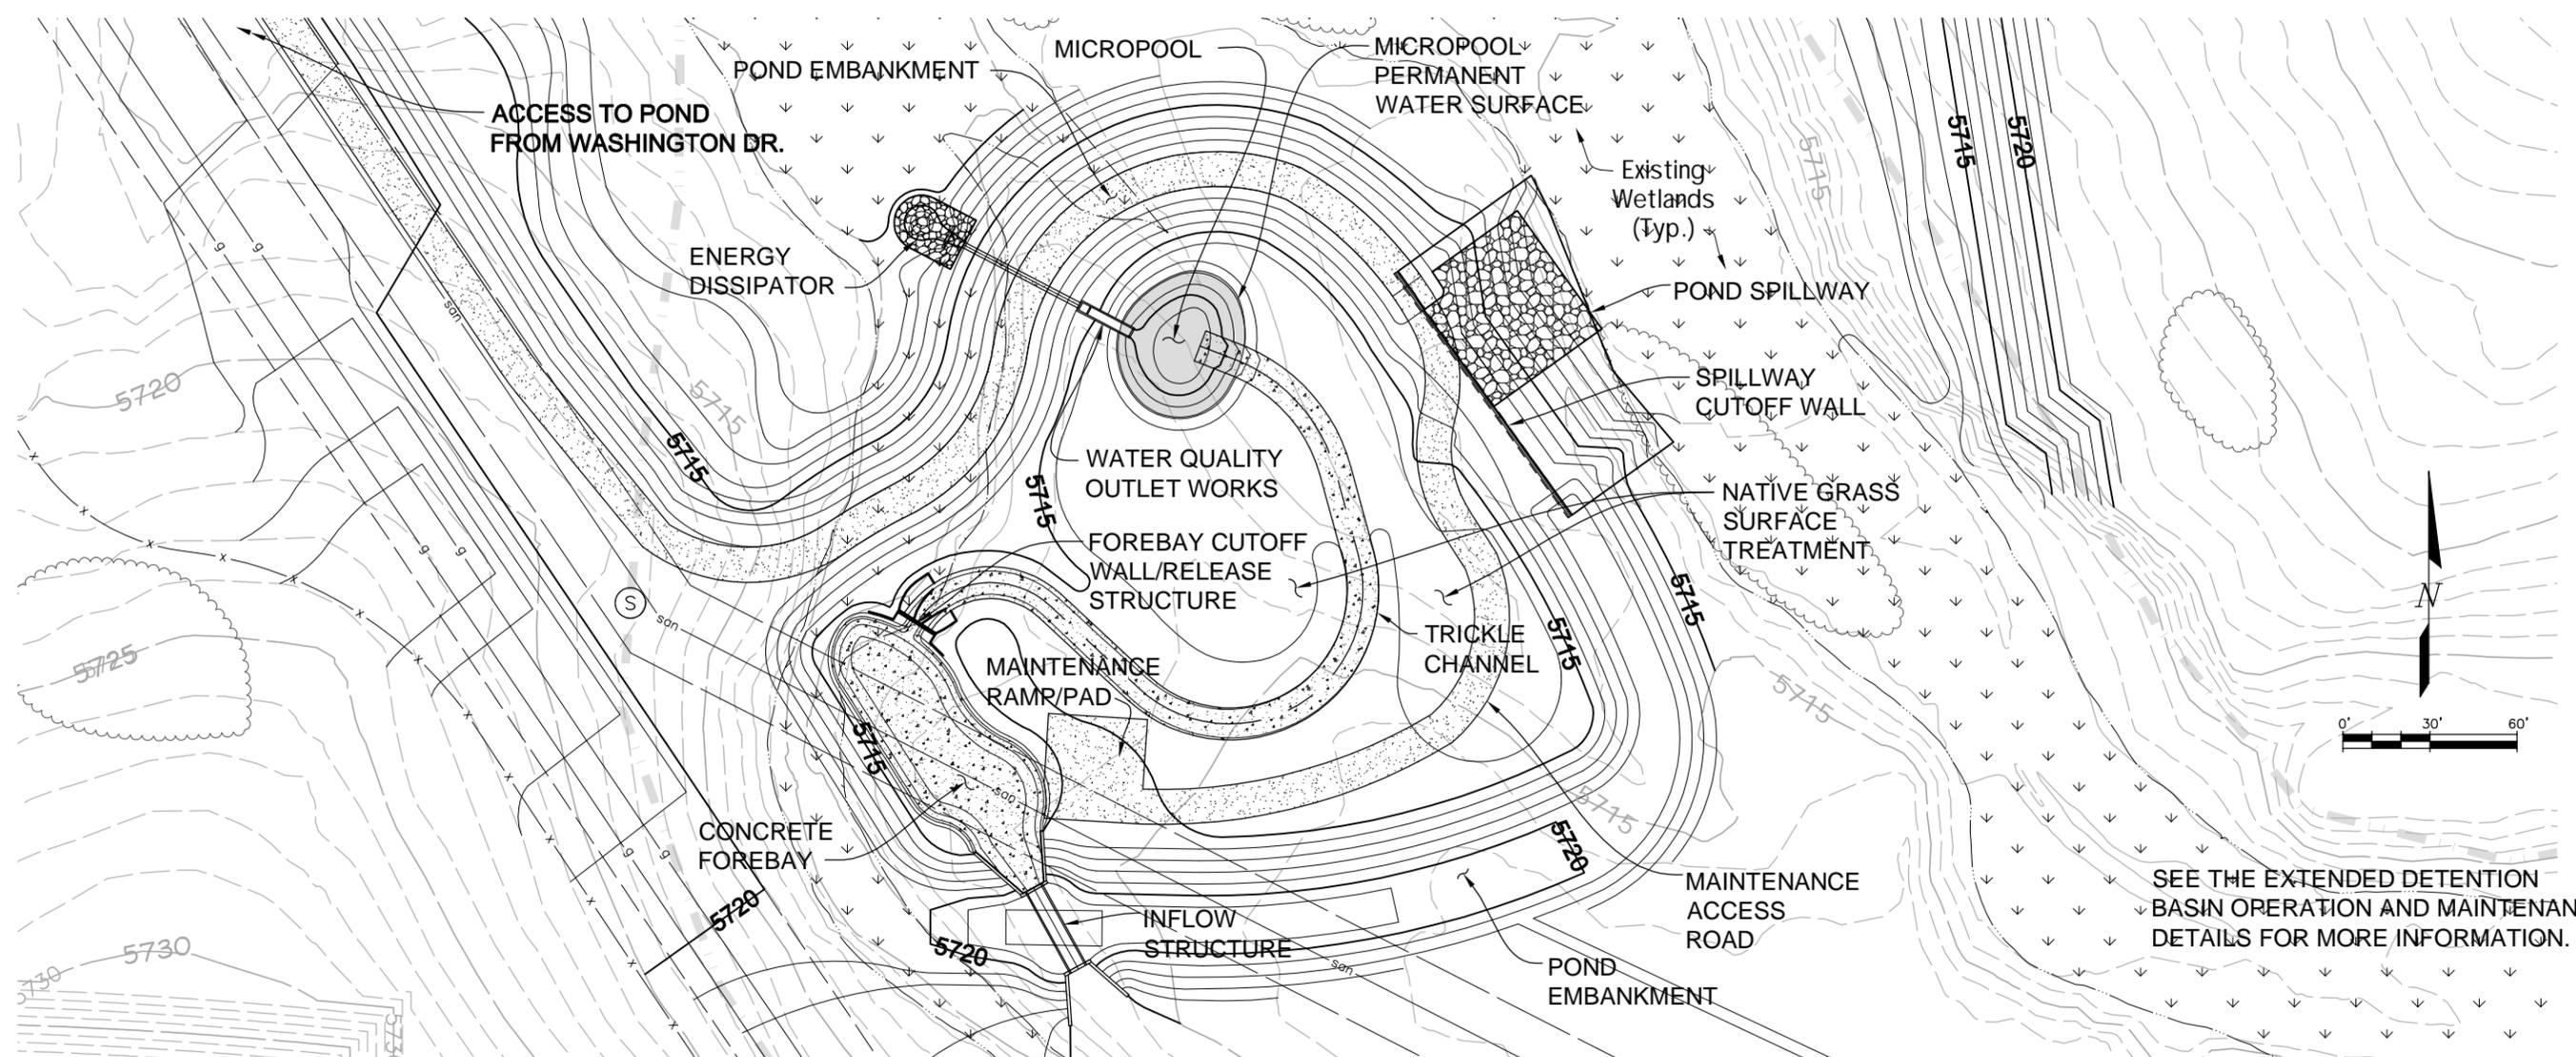
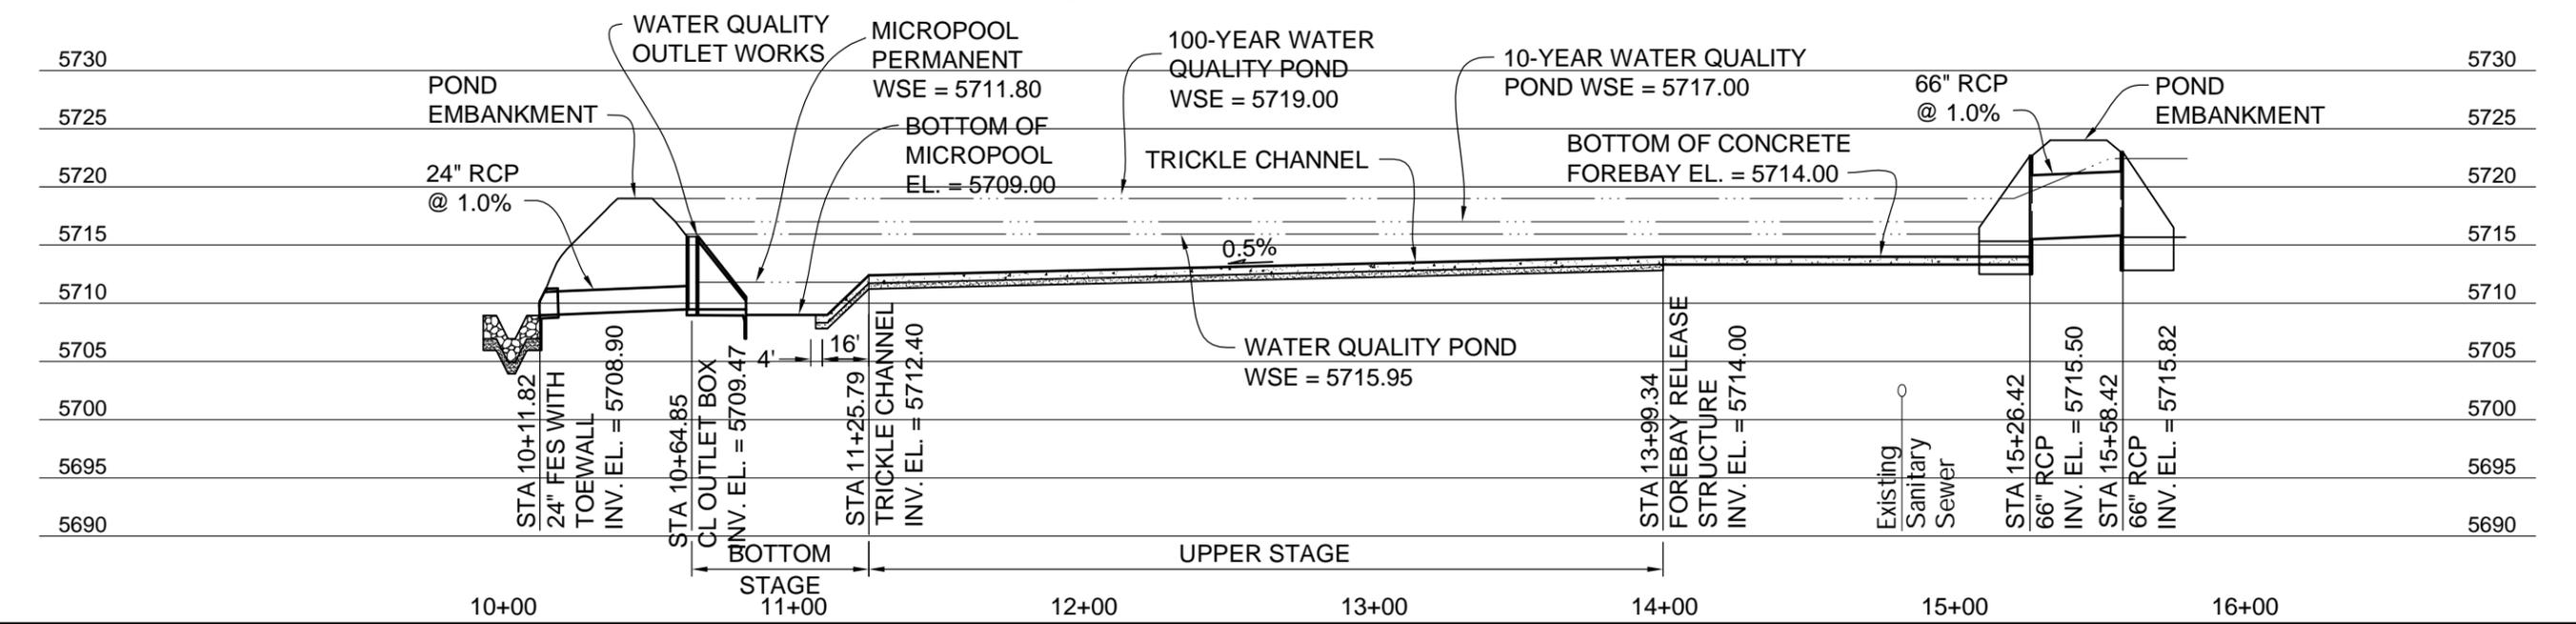
SEE THE EXTENDED DETENTION BASIN OPERATION AND MAINTENANCE DETAILS FOR MORE INFORMATION.
