**PRIVATE DETENTION BASIN /
STORMWATER QUALITY BEST MANAGEMENT PRACTICE
MAINTENANCE AGREEMENT AND EASEMENT**

POND NE CORNER OF WHEATLAND AND BRIARGATE

Legal Description: Tract F, Homestead North at Sterling Ranch Filing No. 1

Stormwater Management Facility Operation and Maintenance (O&M) Plan Template

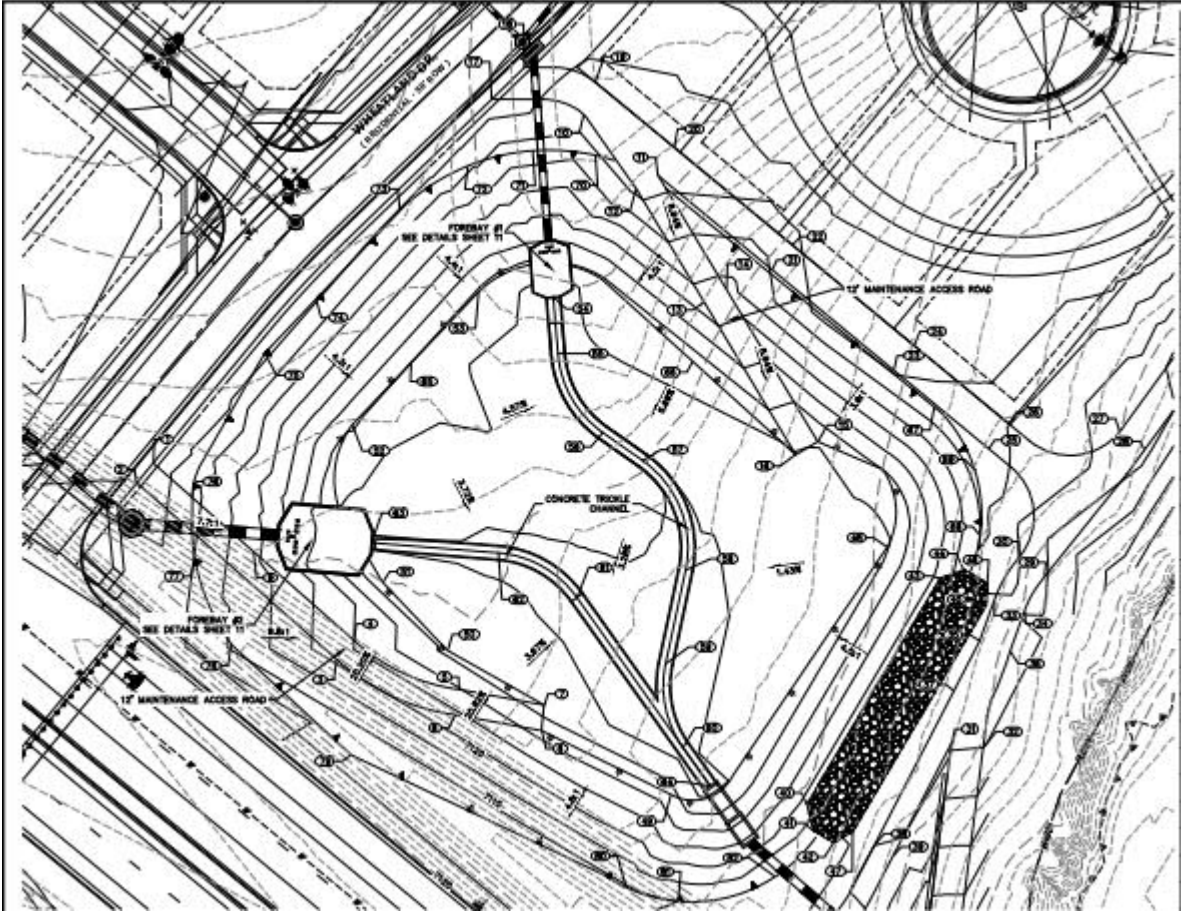
POND NE CORNER OF WHEATLAND AND BRIARGATE

EDB Checklist
