**PRIVATE DETENTION BASIN /  
STORMWATER QUALITY BEST MANAGEMENT PRACTICE  
MAINTENANCE AGREEMENT AND EASEMENT**

**EXHIBIT C**  
**PCM O&M MANUAL**

Standard Operation Procedures  
for  
Inspection and Maintenance  
of  
Extended Detention Basin(s)

Honor Charter School

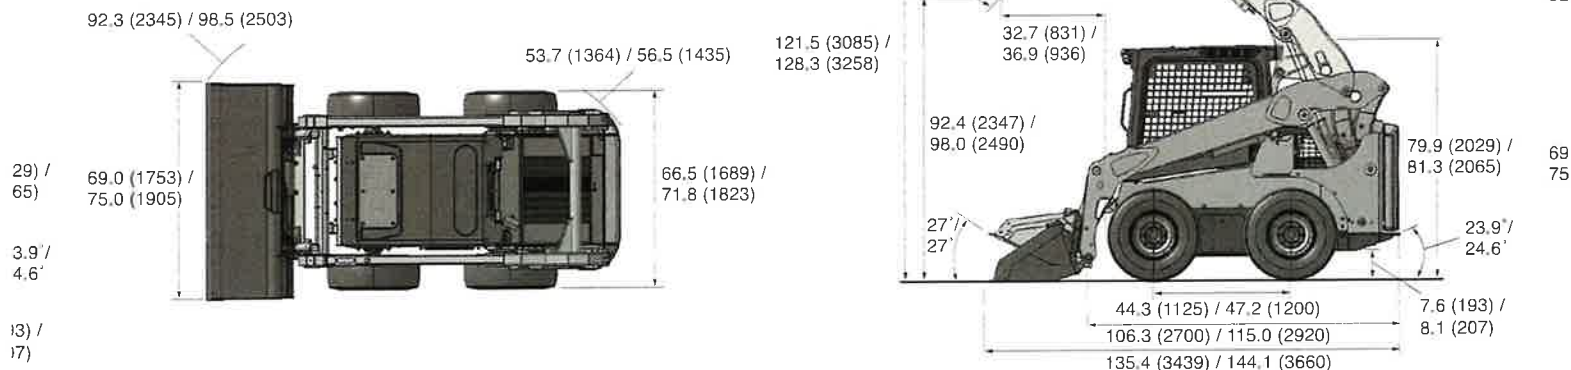
### SSV65 / SSV75

## DIMENSIONS
