Soils and Geology
&
Wastewater Treatment
System
Evaluations
For
Wyoming Estates
3050 N. Curtis Road
June 6, 2019

PROJECT DESCRIPTION

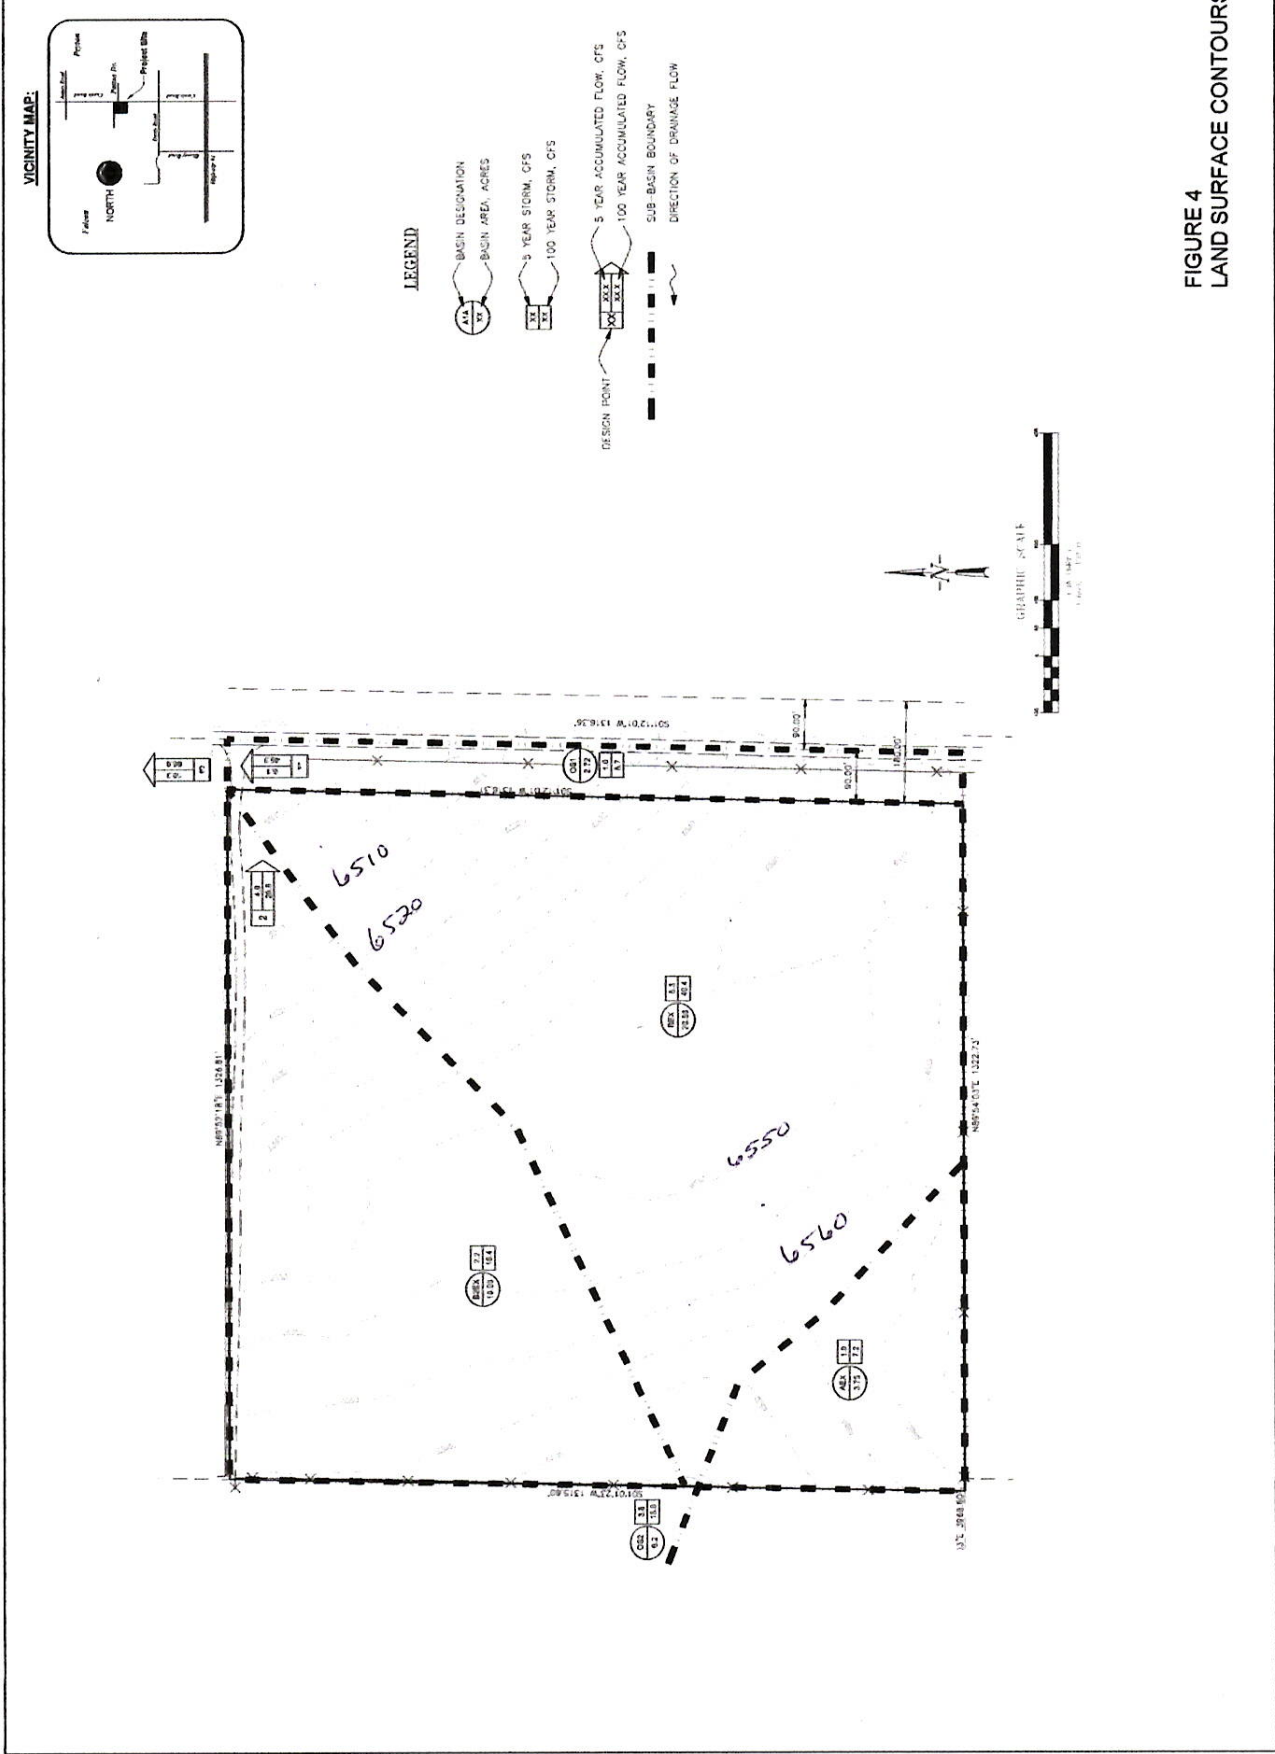
Home Run Restorations, Inc. 5990 WILEY RD PEYTON, CO 80831	WYOMING ESTATES SUBDIVISION EL PASO COUNTY, CO	DRAINAGE PLAN EXISTING CONDITIONS	DRAWING NUMBER: C	SHEET: 1
---	---	--	--------------------------------------	-----------------------------	----------

The Project Site generally slopes to the northeast ranging from 1% to 9%. In the southwest corner, drainage is to the southeast. Figure 4 provides the Project Site Surface Contours.

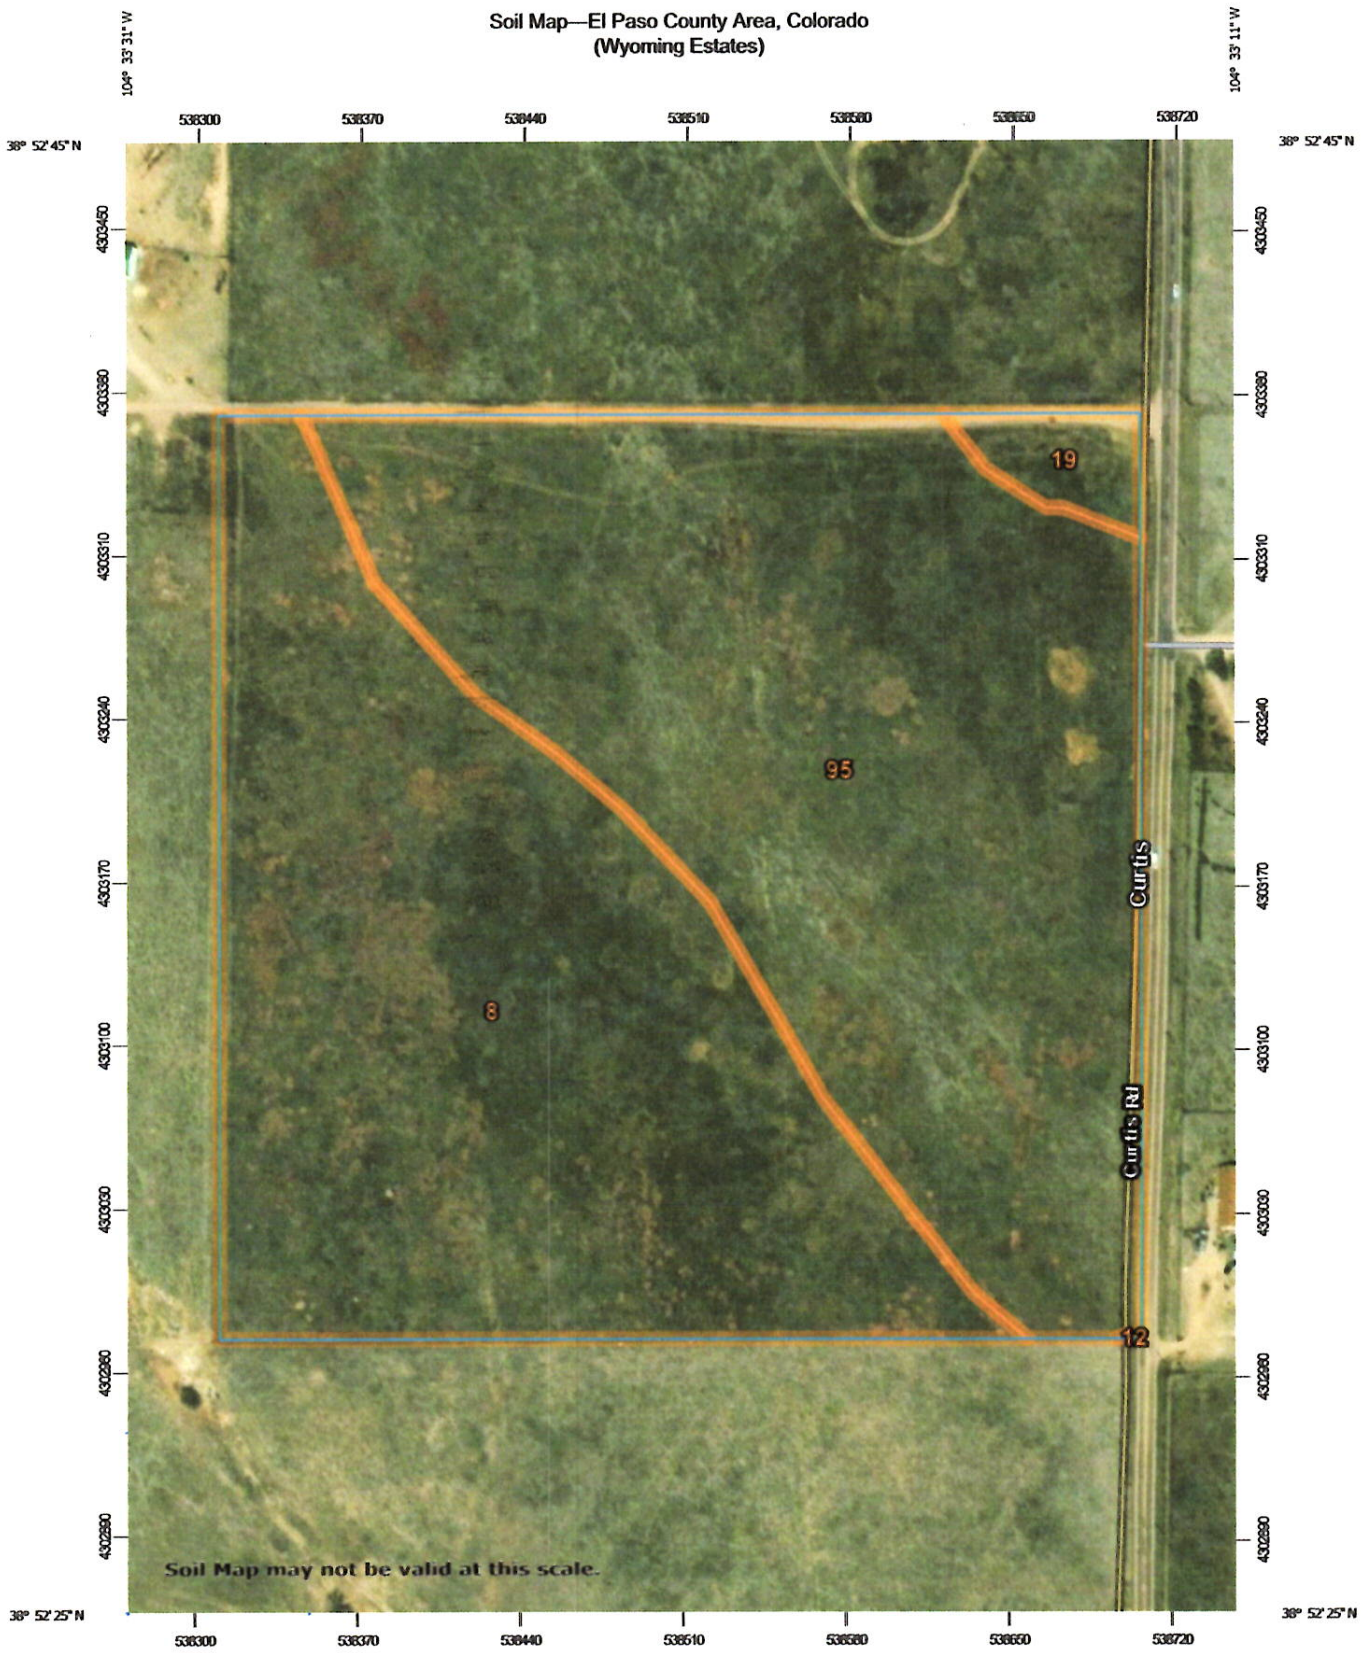
FIGURE 5
 Soil Map—El Paso County Area, Colorado
 (Wyoming Estates)

The National Resource Conservation Service (NRCS) has identified three soil types with a northeast trend on the Property (Figure 5).

Type	Description	Percent Coverage
8	Blakeland Loamy Sand, 1 to 9 percent Slope	46.8
19	Columbine gravelly sandy loam sand, 0 to 3 % slopes	1.8
95	Truckton Sandy Loams, 1 to 9 percent Slope	51.4

Attachment 1 provides a complete description of the soils. The soil is classified as “well” to “excessively well” drained. Runoff potential is low with no ponding or flooding which is consistent with historical aerial photos.

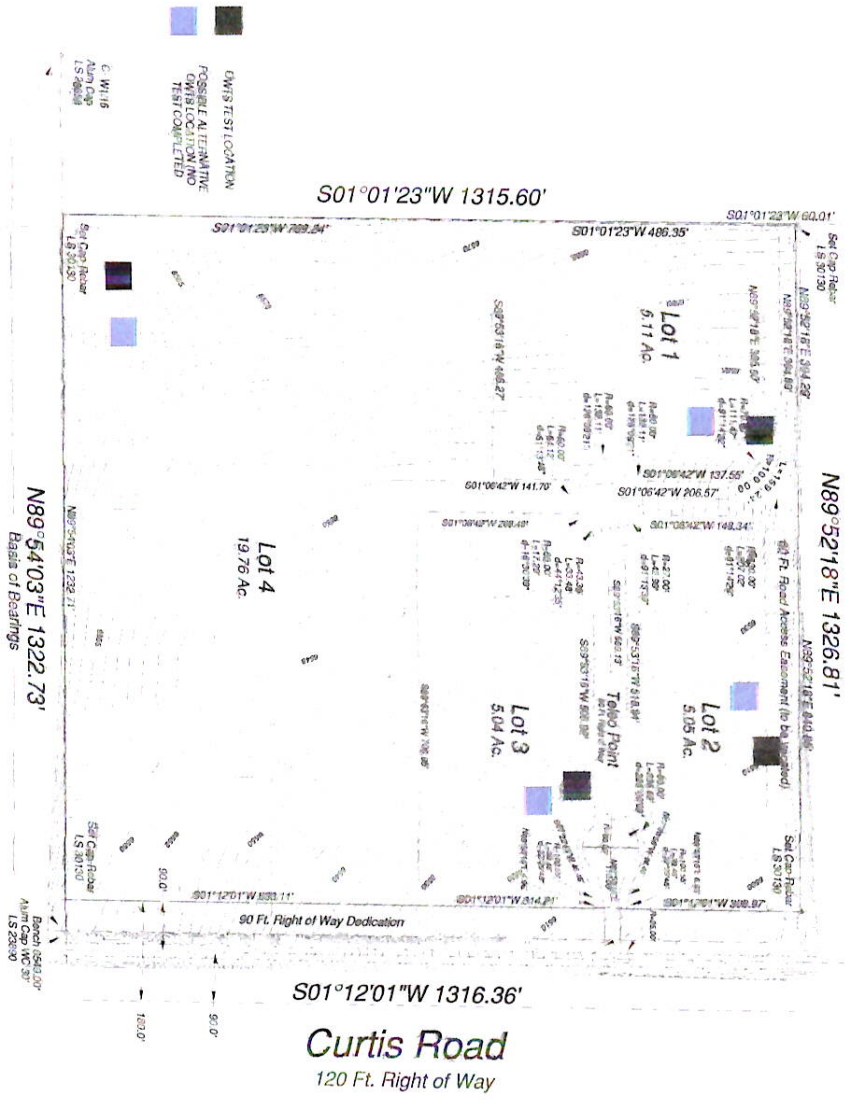
FIGURE 6

Field investigations at the Project Site consisted of excavating two profile pits at each proposed lot (8 total) to identify onsite wastewater treatment system (OWTS) locations (PARR 2018, Figure 6). The OWTS profile pits were excavated to a maximum depth of 8.5 feet below ground surface. Samples were collected from select intervals and evaluated for soil properties. At locations tested on Lots 1, 2 and 4, a conventional, non-engineered onsite wastewater treatment system was determined to be acceptable. At the location tested at Lot 2, results indicate that an engineered onsite wastewater treatment system is needed. Table 1 summarizes the field investigations results. Attachment 3 provides the detailed engineering reports.

OWTS SITE MAP

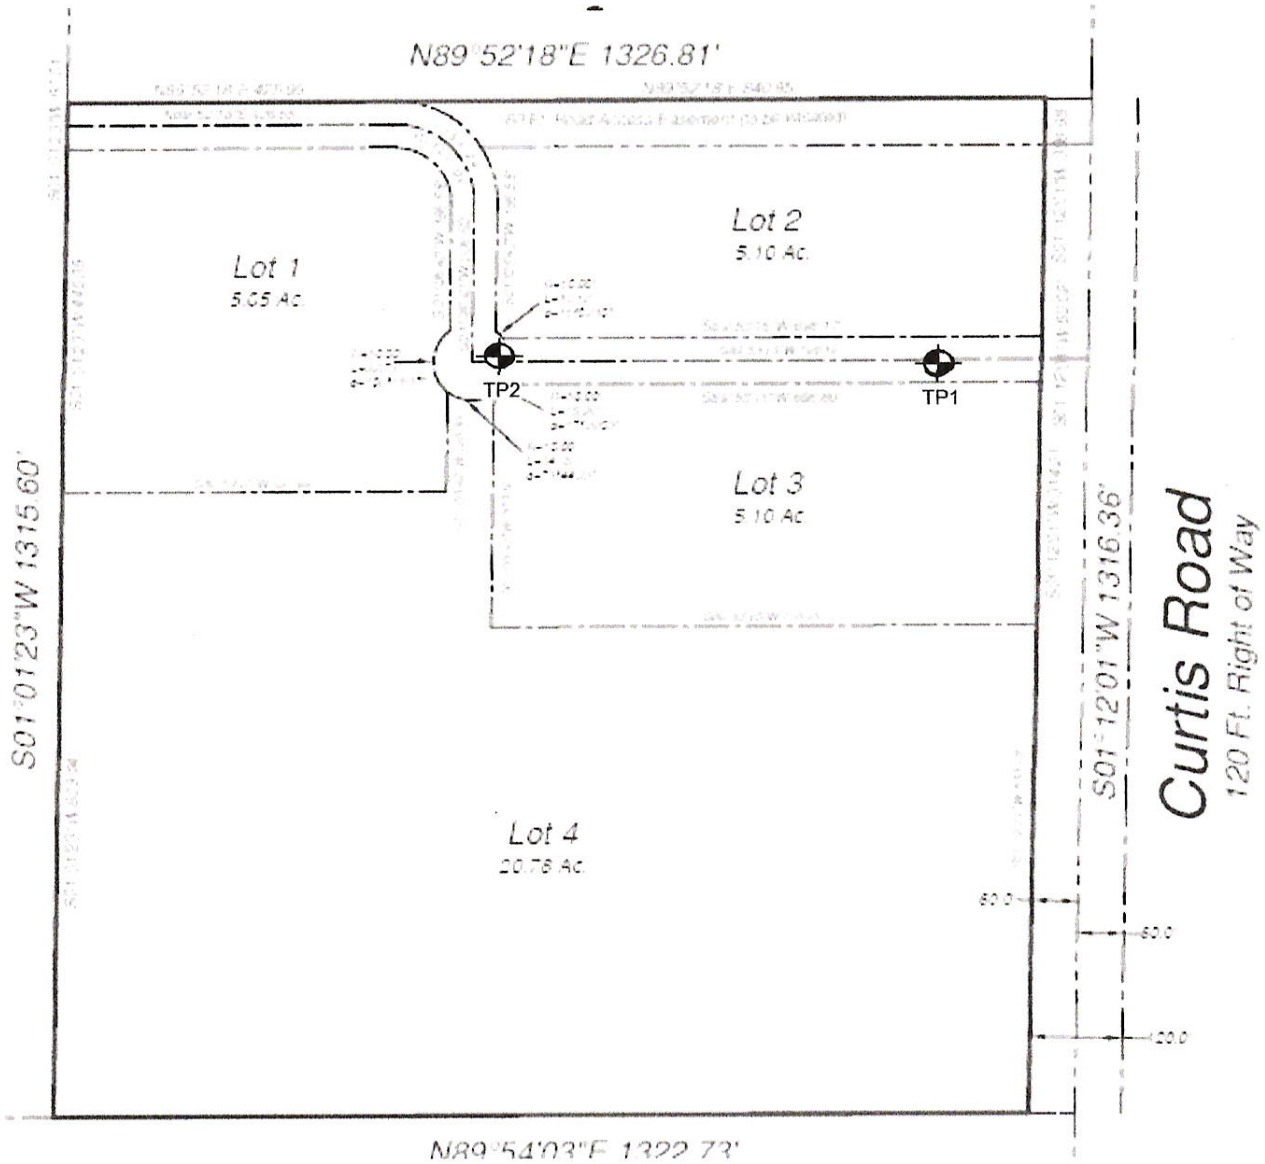
FIGURE 7
Pavement Design Test Pit Locations

Two test holes were evaluated for a proposed gravel roadway for pavement design (Raiper, 2019, Figure 7). Soil samples were collected with testing included sieve analysis and Atterberg limits in addition to determining resistance values (R-Values). The results are summarized in Table 2.

Approximate Backhoe Test Pit Excavation

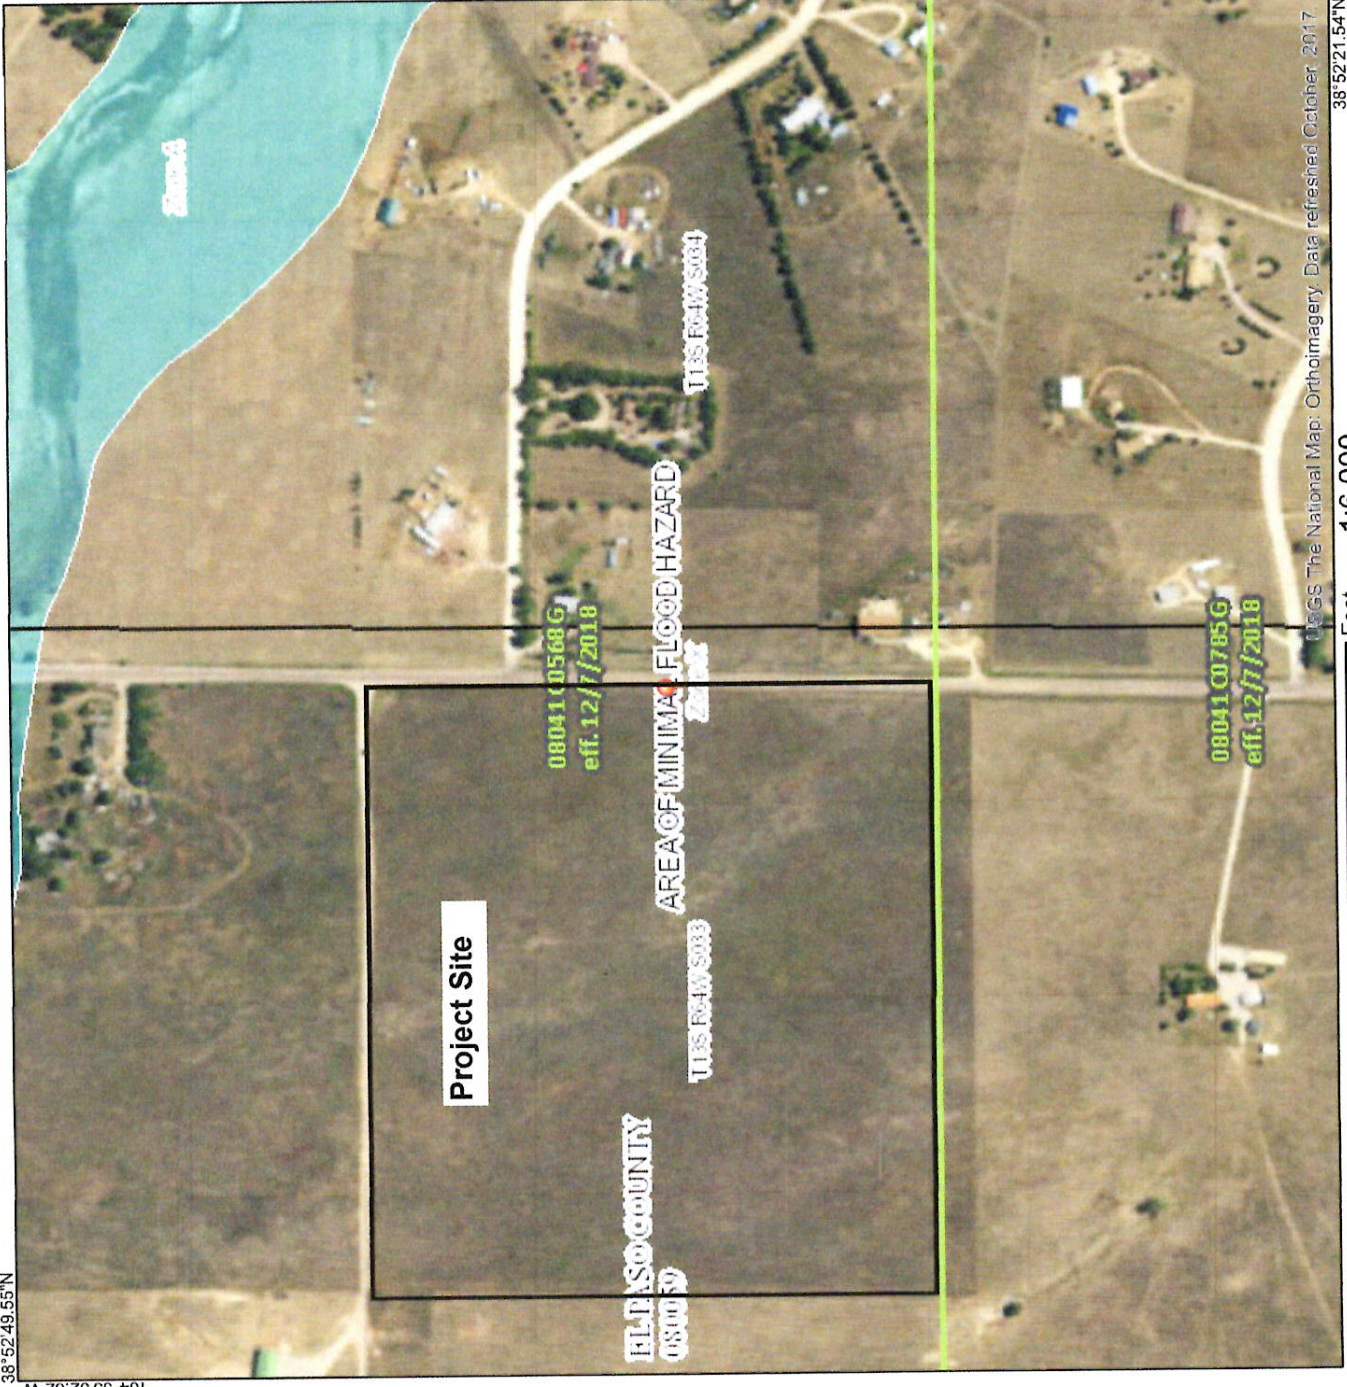
FIGURE 8

The Project Site was evaluated for geologic hazards that may impact development. Hazards identified in the El Paso County Land Development Code including: Mining, wildfire, highwater table or polluted water, landfills, fill areas, contamination; airports and major utility facilities, and landslides were not identified on the Project Site. The National Flood Hazard map delineated the Property and surrounding area an “area of Minimal Flood Hazard” (FEMA 2018). The Project Site is not located in a flood plain (Figure 8).

AREA OF MINIMAL FLOOD HAZARD

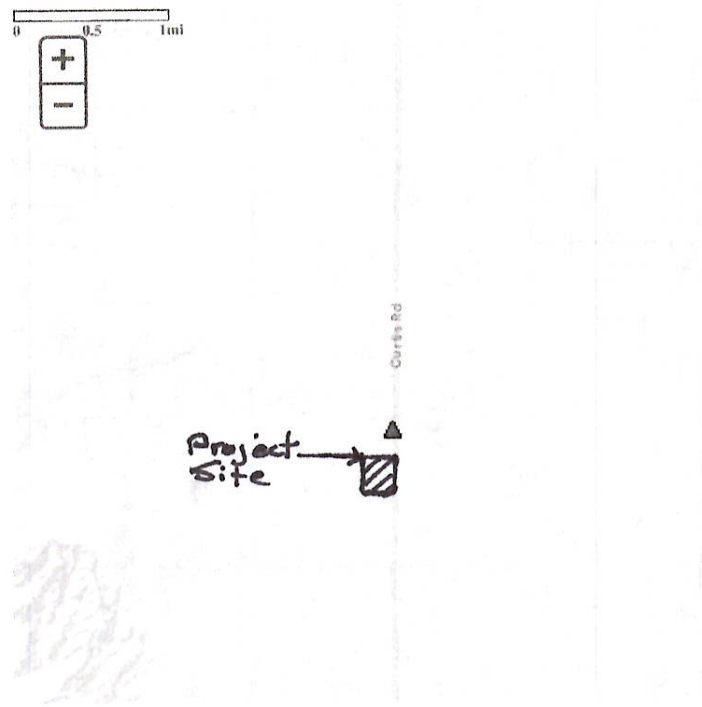
Site Number: 385250104331301 - 5C01306433AAA1

Latitude 38°52'49.7", Longitude 104°33'14.5" NAD83
 El Paso County, Colorado, Hydrologic Unit 11020004
 Well depth: 75.1 feet
 Hole depth: 75.1 feet
 Land surface altitude: 6,485.00feet above NGVD29.
