Stormwater Management Facility Operation and Maintenance (O&M) Plan Template

Saddlehorn Ranch - Filing 3 and 4

Standard Operation Procedures
for
Inspection and Maintenance
of
Extended Detention Basin(s)

SADDLEHORN RANCH - FILING 3
 POND C GRADING PLAN
 SHEET 50 OF 60
 JOB NO. 21542.05

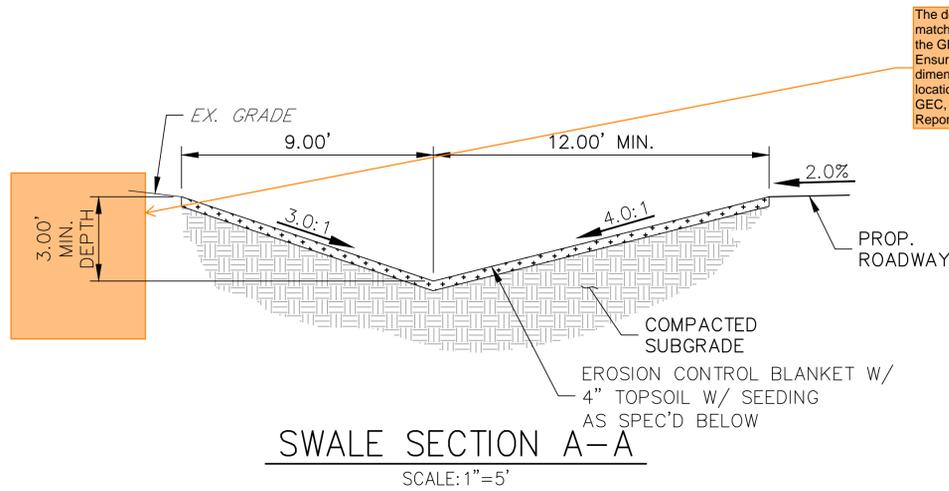
SWALE SECTION A-A
SCALE: 1"=5'

SWALE SEED MIX:
EROSION CONTROL BLANKET WITH PAWNEE BUTTES SEED INC. – "LOW GROW NATIVE MIX"
-IDAHO FESCUE
-SANDBERG BLUEGRASS
-ROCKY MOUNTAIN FESCUE
-BIG BLUEGRASS

The depth does not match what is shown on the GEC Plan or CD's. Ensure swale dimensions match in all locations applicable: GEC, CD's, Drainage Report, SWMP, etc.

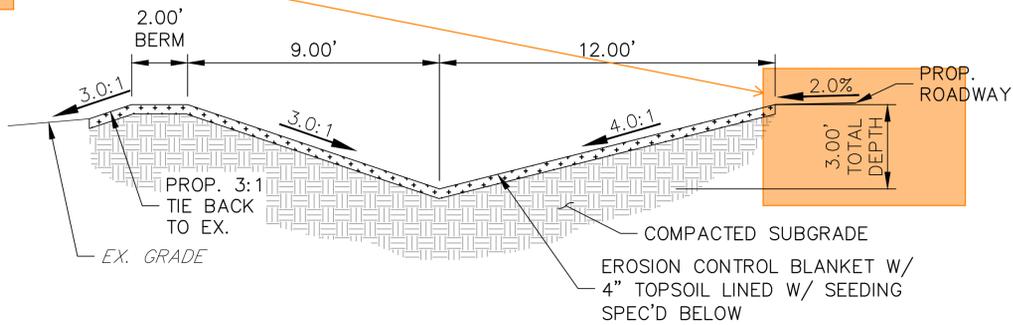
SWALE SECTION B-B
SCALE: 1"=5'

SWALE SEED MIX:
EROSION CONTROL BLANKET WITH PAWNEE BUTTES SEED INC. – "LOW GROW NATIVE MIX"
-IDAHO FESCUE
-SANDBERG BLUEGRASS
-ROCKY MOUNTAIN FESCUE
-BIG BLUEGRASS

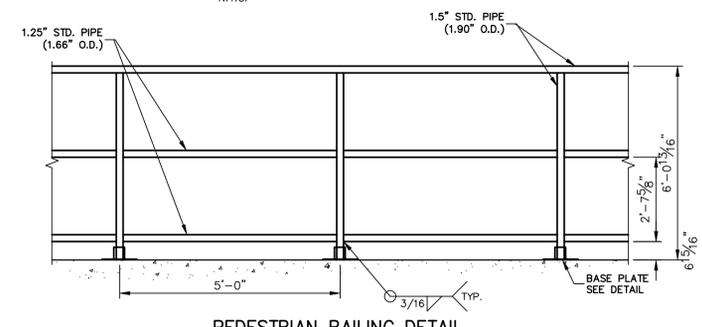
PEDESTRIAN RAILING DETAIL
SCALE: N.T.S.
RAILING TO BE HOT-DIPPED GALVANIZED
