**PRIVATE STORMWATER FACILITY  
MAINTENANCE AGREEMENT AND EASEMENT**

C. WHEREAS, Developer desires to plat and develop on the Subject Property a Subdivision to be known as SADDLEHORN RANCH FILING NO. 3 (the Development); and

## PERMANENT BMP APPLICABILITY MAP

SADDLEHORN RANCH -  
FILING 3  
GRASS SWALE PLAN  
FACILITIES PLAN

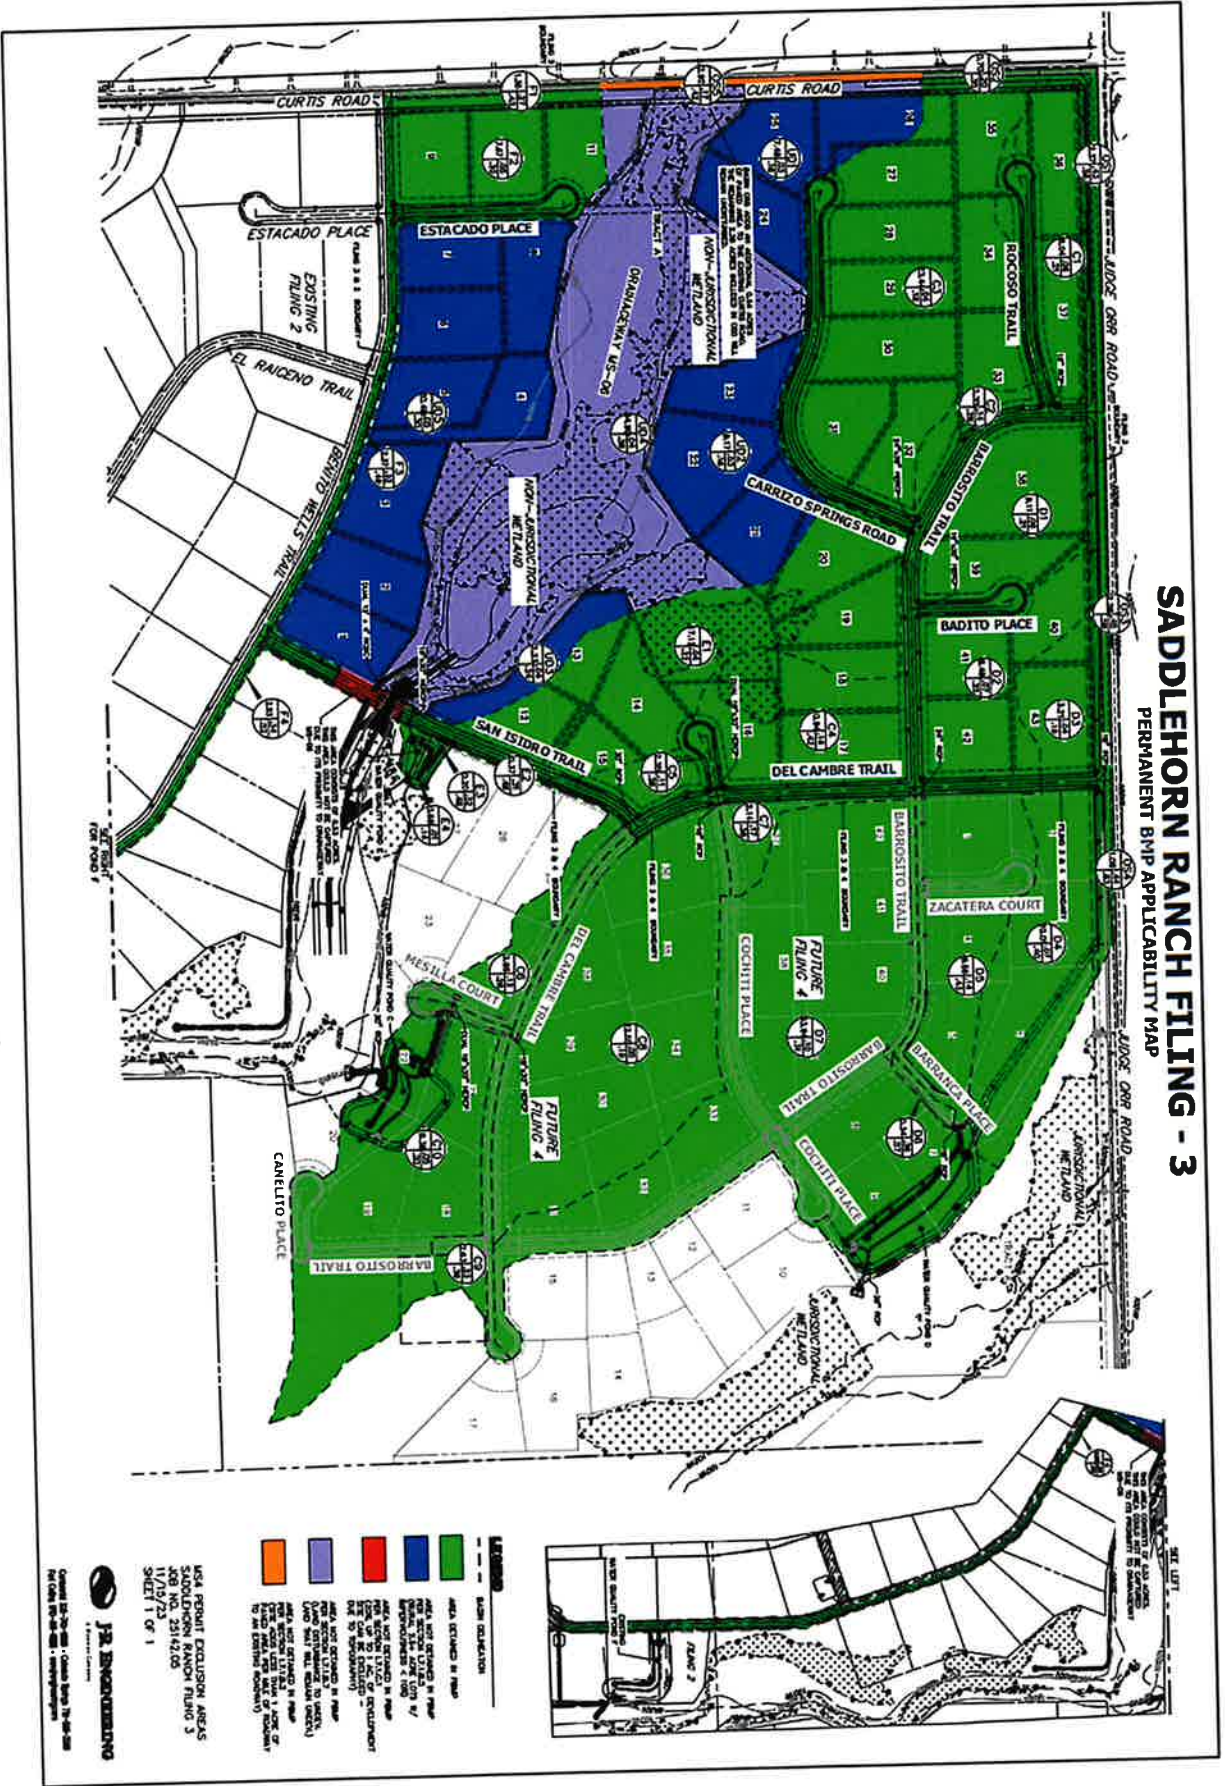
- LEGEND**
- █ BMP NOT APPLICABLE
  - █ BMP APPLICABLE
  - █ BMP APPLICABLE (EXCEPT FOR THE AREAS SHOWN IN RED)
  - █ BMP APPLICABLE (EXCEPT FOR THE AREAS SHOWN IN ORANGE)

- █ BMP APPLICABLE (EXCEPT FOR THE AREAS SHOWN IN PURPLE)
  - █ BMP APPLICABLE (EXCEPT FOR THE AREAS SHOWN IN YELLOW)
- NOTES:**
- 1. BMP NOT APPLICABLE AREAS ARE THOSE AREAS WHERE THE USE OF BMP IS NOT FEASIBLE OR ECONOMICALLY JUSTIFIED.

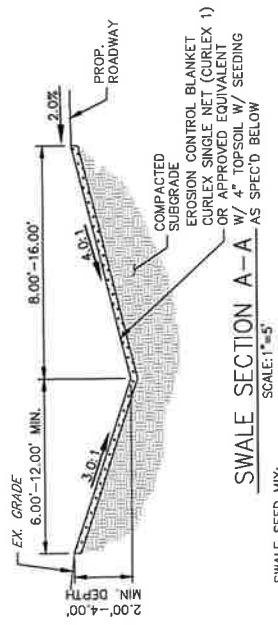
SWALE SECTION A-A  
SCALE: 1"=5'

SWALE SEED MIX:  
EROSION CONTROL BLANKET WITH PAMNEE BUTTES SEED INC. - "LOW GROW NATIVE MIX"  
-IDAHO FESCUE  
-SANDBERG BLUEGRASS  
-ROCKY MOUNTAIN FESCUE  
-BIG BLUEGRASS

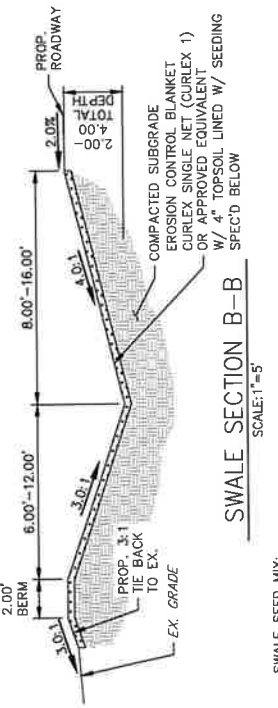
SWALE SECTION B-B  
SCALE: 1"=5'

SWALE SEED MIX:  
EROSION CONTROL BLANKET WITH PAMNEE BUTTES SEED INC. - "LOW GROW NATIVE MIX"  
-IDAHO FESCUE  
-SANDBERG BLUEGRASS  
-ROCKY MOUNTAIN FESCUE  
-BIG BLUEGRASS

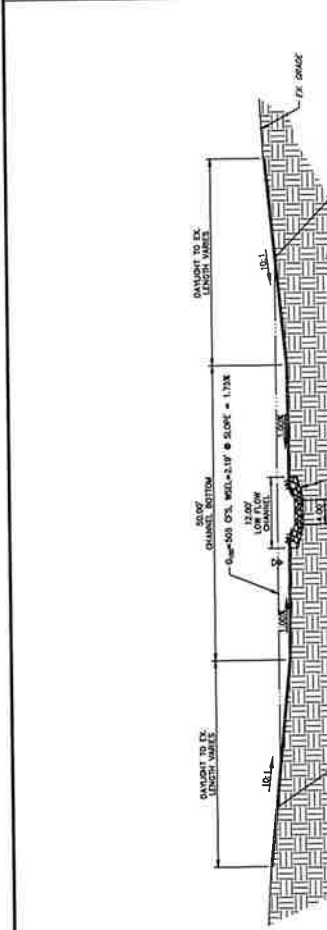
1. TYPICAL SECTION FOR CHANNEL WEST OF SAN EDUARDO TRAIL. CHANNEL WITH PARALLEL BATTERIES SHALL BE 12" DRAIN MATTE W/ 18" COMPACTED SUBGRADE.
2. DETAILS FOR THE TOP & BOTTOM MEASURES CAN BE FOUND ON SHEET #4.

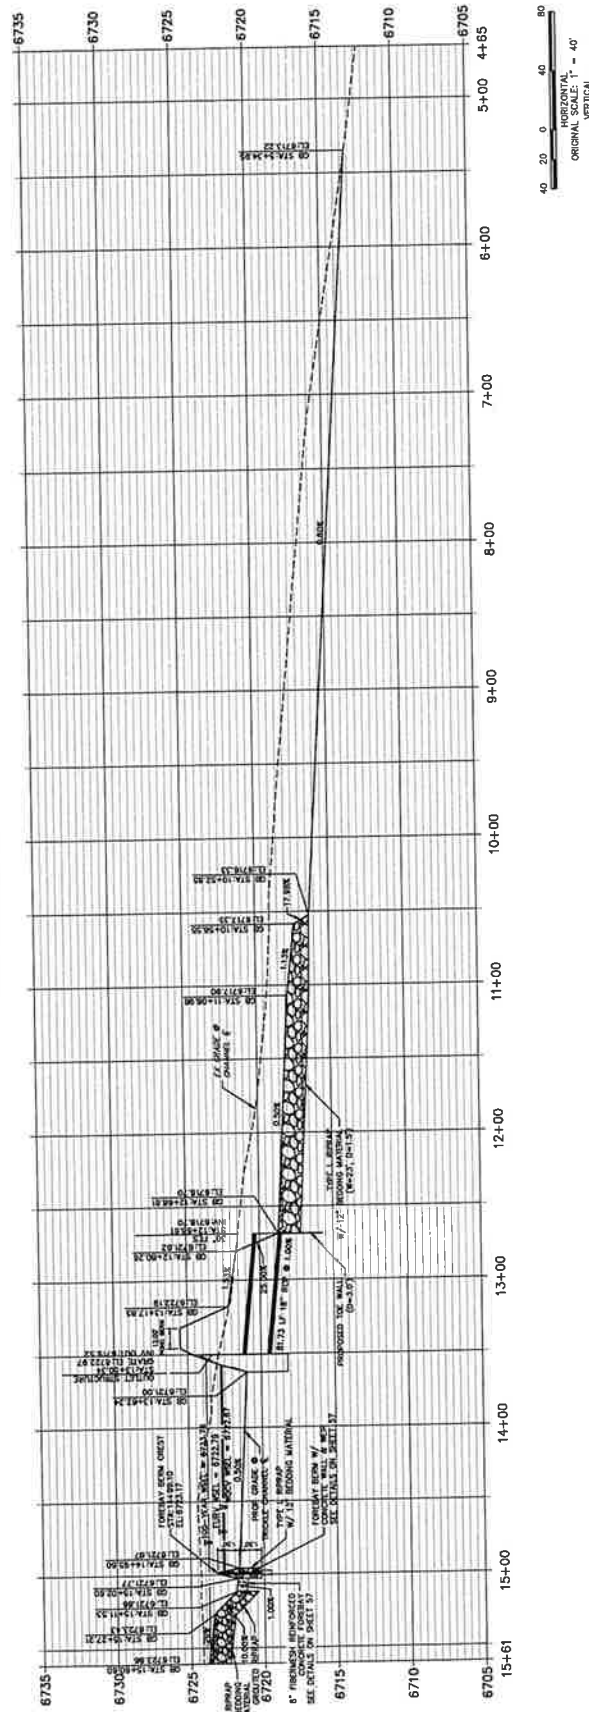
**POND E PROFILE**  
**STA 4+64.77 TO 15+60.60**

HORIZONTAL SCALE: 1" = 40'  
VERTICAL SCALE: 1" = 4'
