Stormwater Management Facility Operation and Maintenance (O&M) Plan Template

Saddlehorn Ranch - Filing 3 and 4

**Stormwater Management Facility
Inspection and Maintenance (I&M) Plan**

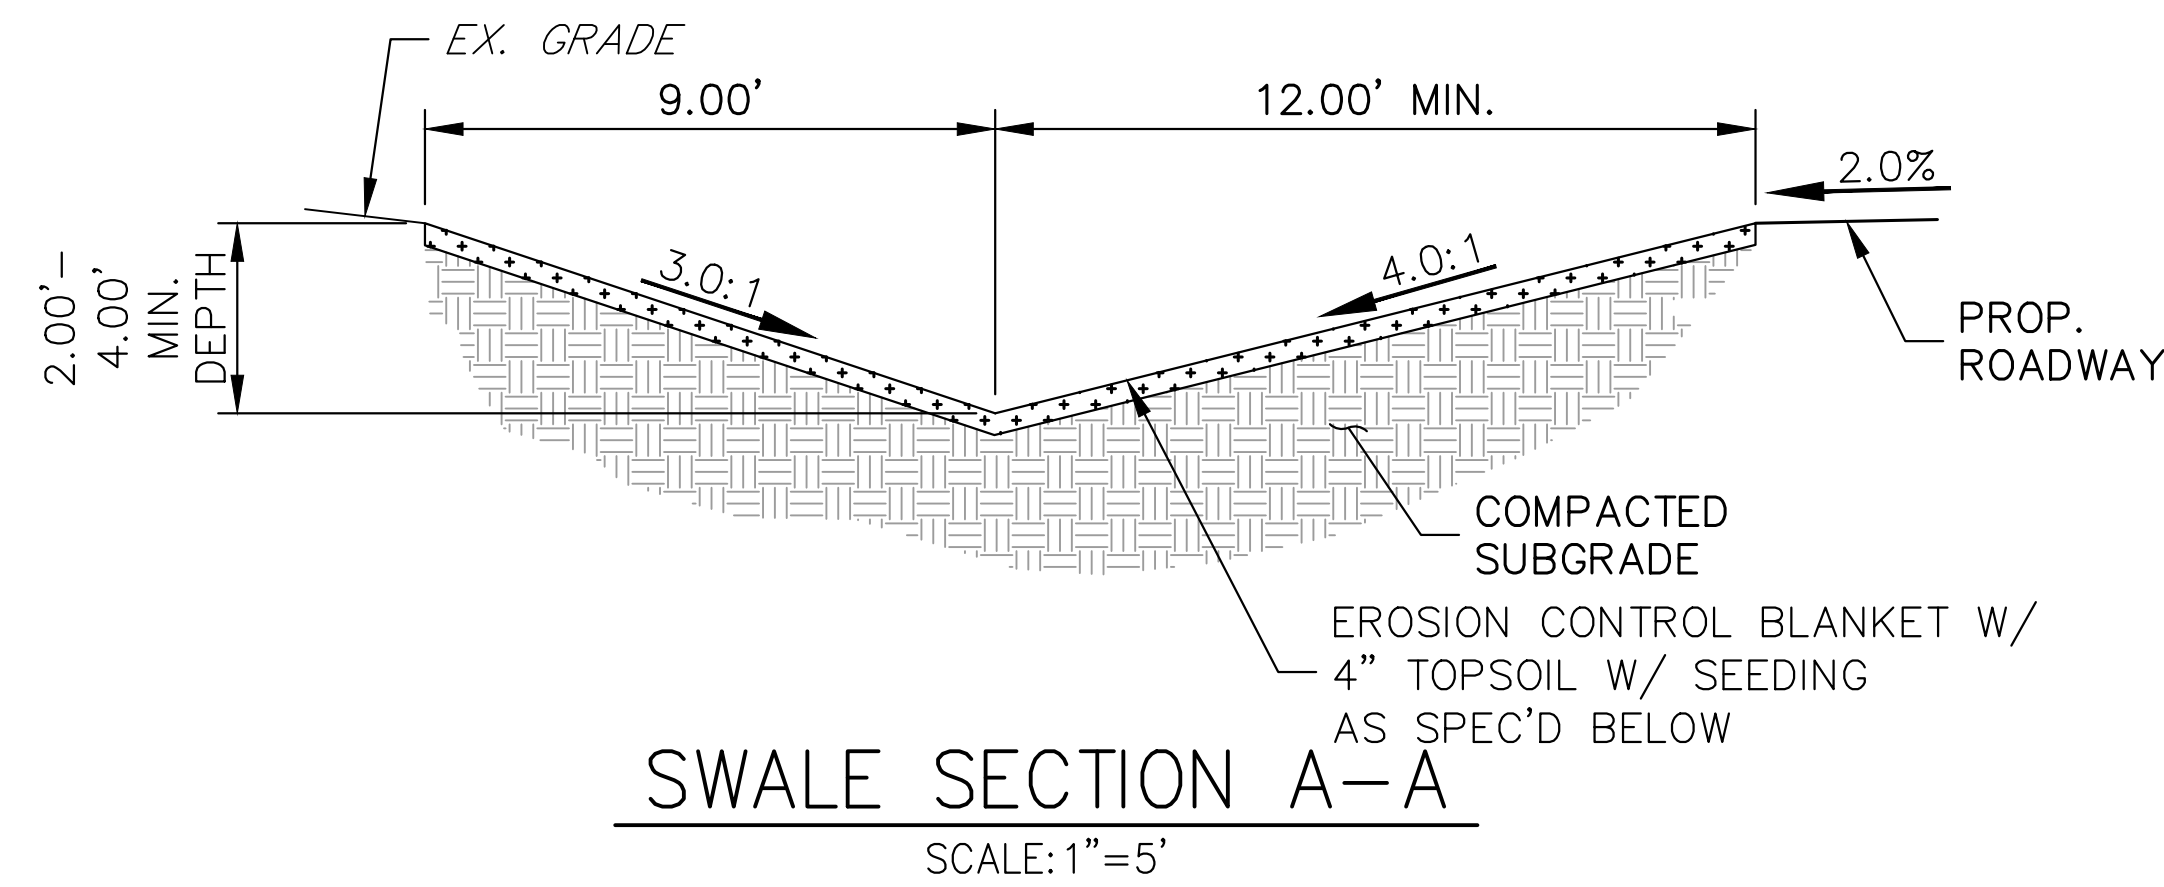
SWALE SECTION A-A

SWALE SEED MIX:
 EROSION CONTROL BLANKET WITH PAWNEE BUTTES SEED INC. – "LOW GROW NATIVE MIX"
 -IDAHO FESCUE
 -SANDBERG BLUEGRASS
 -ROCKY MOUNTAIN FESCUE
 -BIG BLUEGRASS

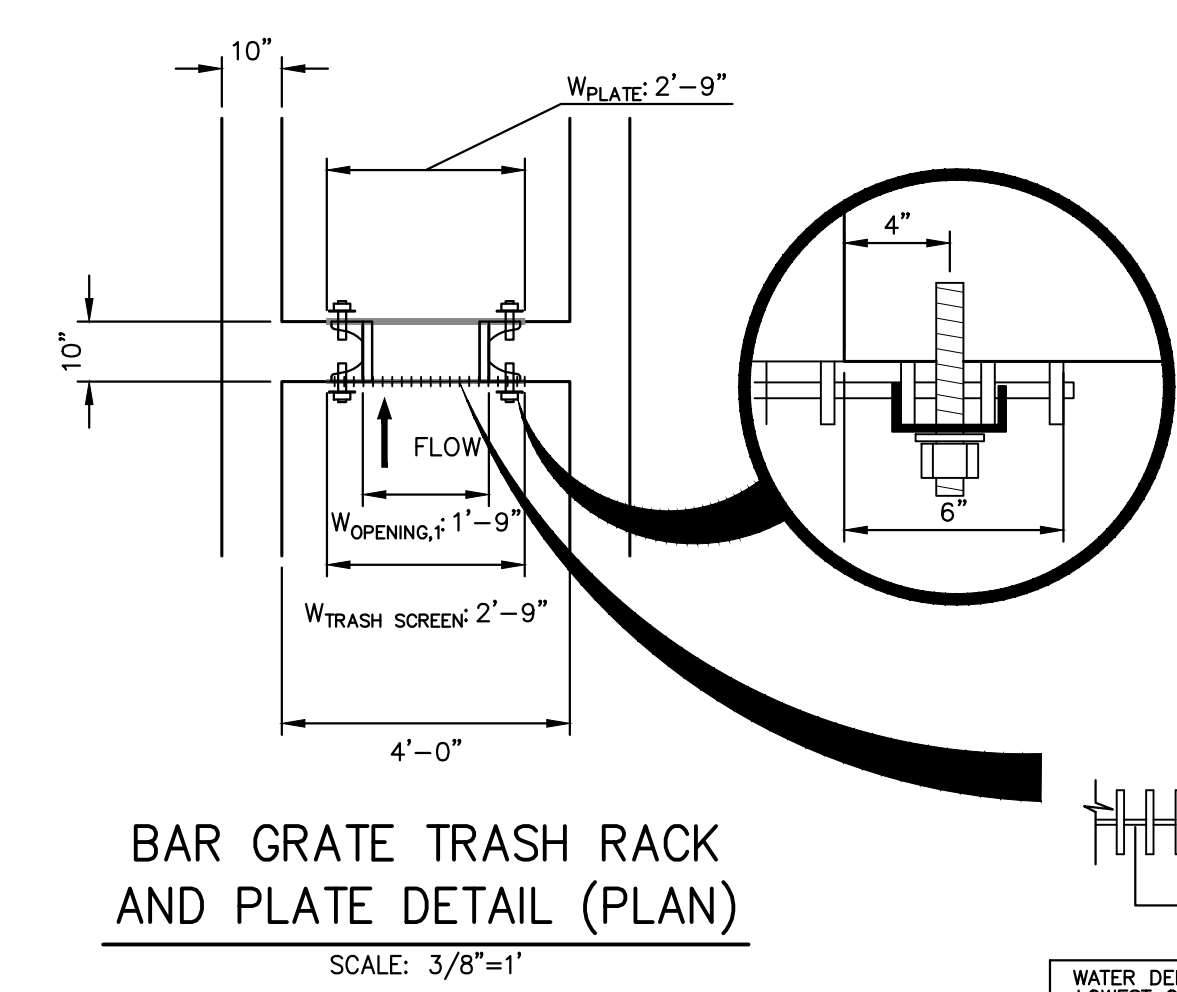
BAR GRATE DETAIL
N.T.S.

WATER DEPTH ABOVE LOWEST OPENING, H	MINIMUM BEARING BAR SIZE, BARS ALIGNED VERTICALLY
2.0 FT.	1" x 3/16"
3.0 FT.	1-1/4" x 3/16"
4.0 FT.	1-3/4" x 3/16"
5.0 FT.	2" x 3/16"
6.0 FT.	2-1/4" x 3/16"

R VALUE=(NET OPEN AREA)/GROSS RACK AREA
=0.71 FOR CROSS RODS ON 2" CENTERS
=0.77 FOR CROSS RODS ON 4" CENTERS
