Stormwater Management Facility Operation and Maintenance (O&M) Plan Template

Saddlehorn Ranch - Filing 3 and 4

**Stormwater Management Facility
Inspection and Maintenance (I&M) Plan**

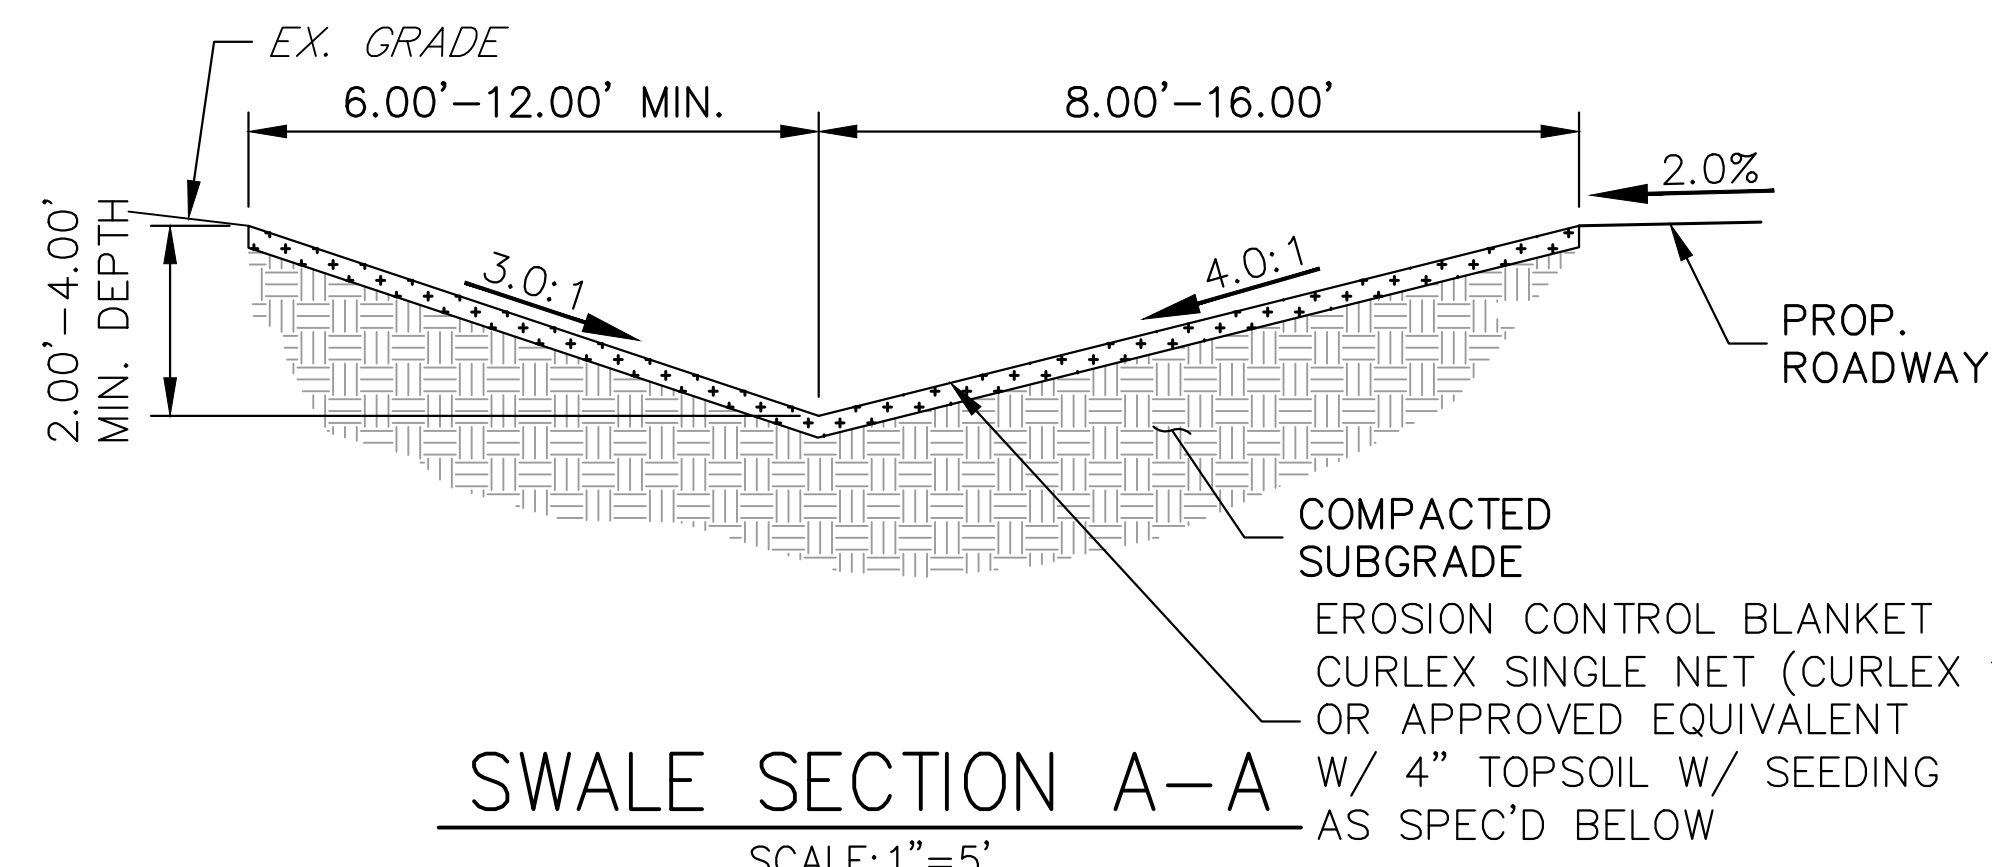
SWALE SECTION A-A

SCALE: 1"=5'

SWALE SEED MIX:
 EROSION CONTROL BLANKET WITH PAWNEE BUTTES SEED INC. - "LOW GROW NATIVE MIX"
 -IDAHO FESCUE
 -SANDBERG BLUEGRASS
 -ROCKY MOUNTAIN FESCUE
 -BIG BLUEGRASS

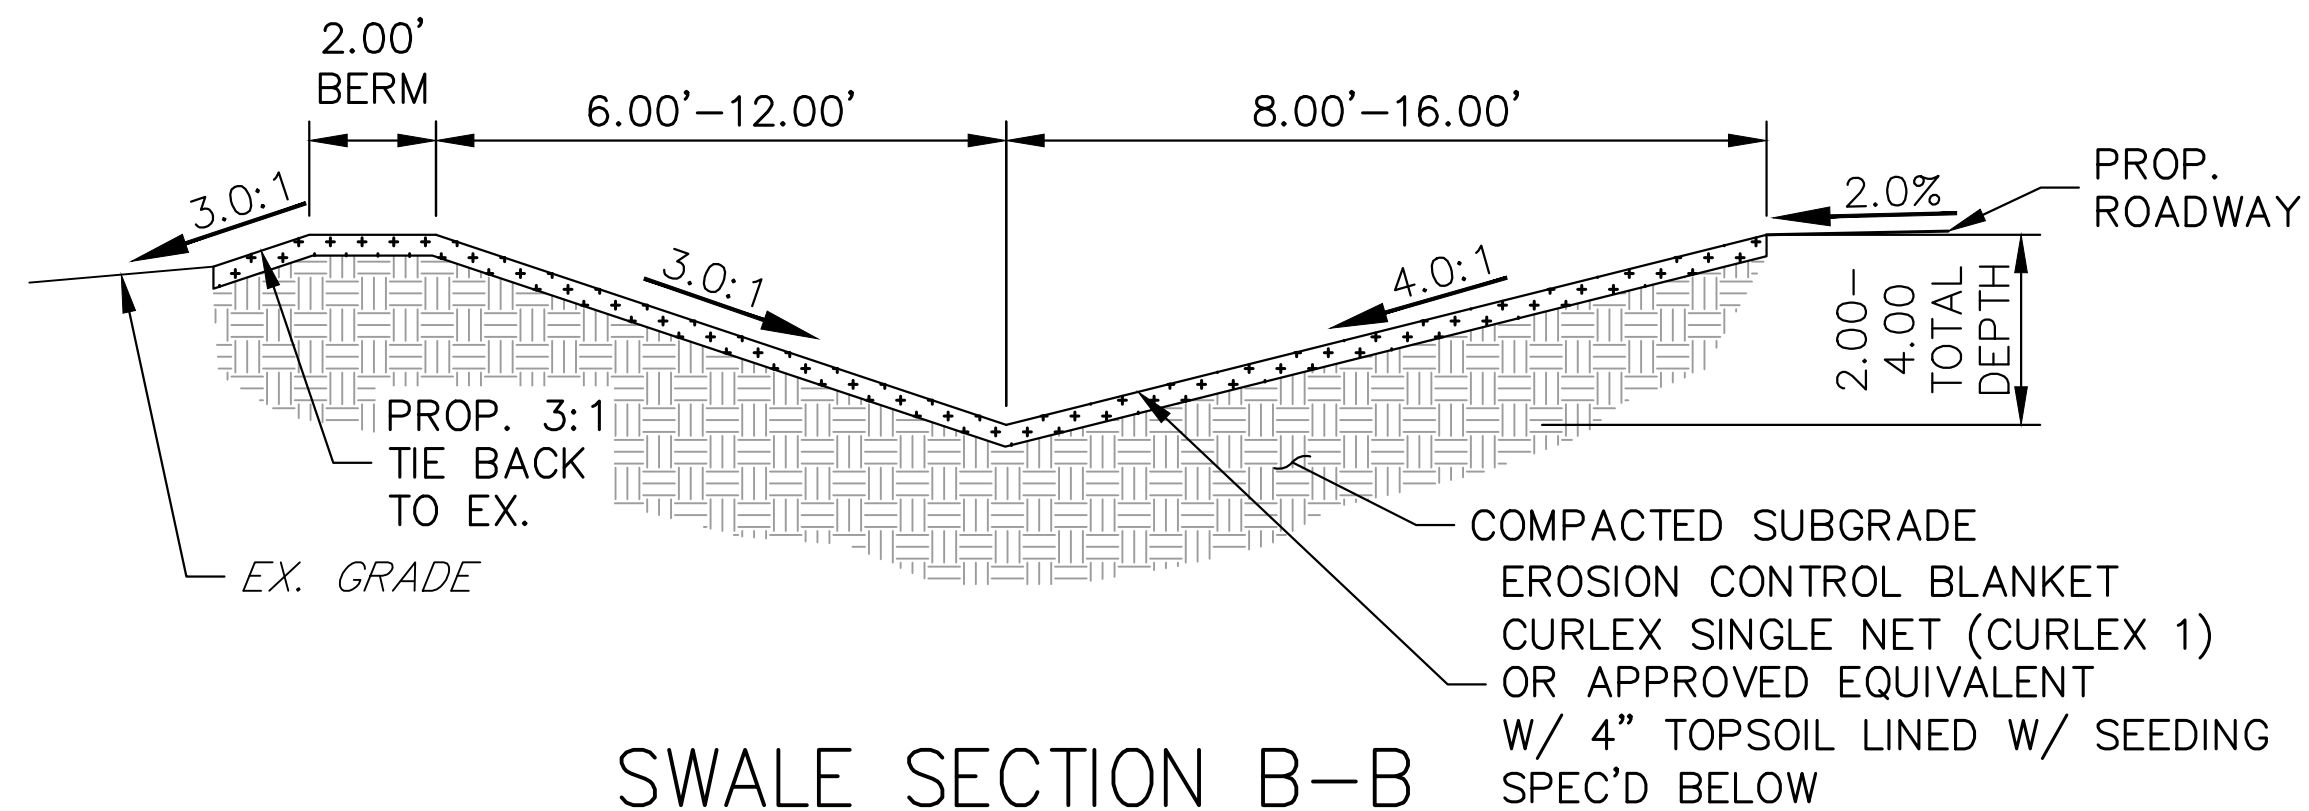
SWALE SECTION B-B

SCALE: 1"=5'

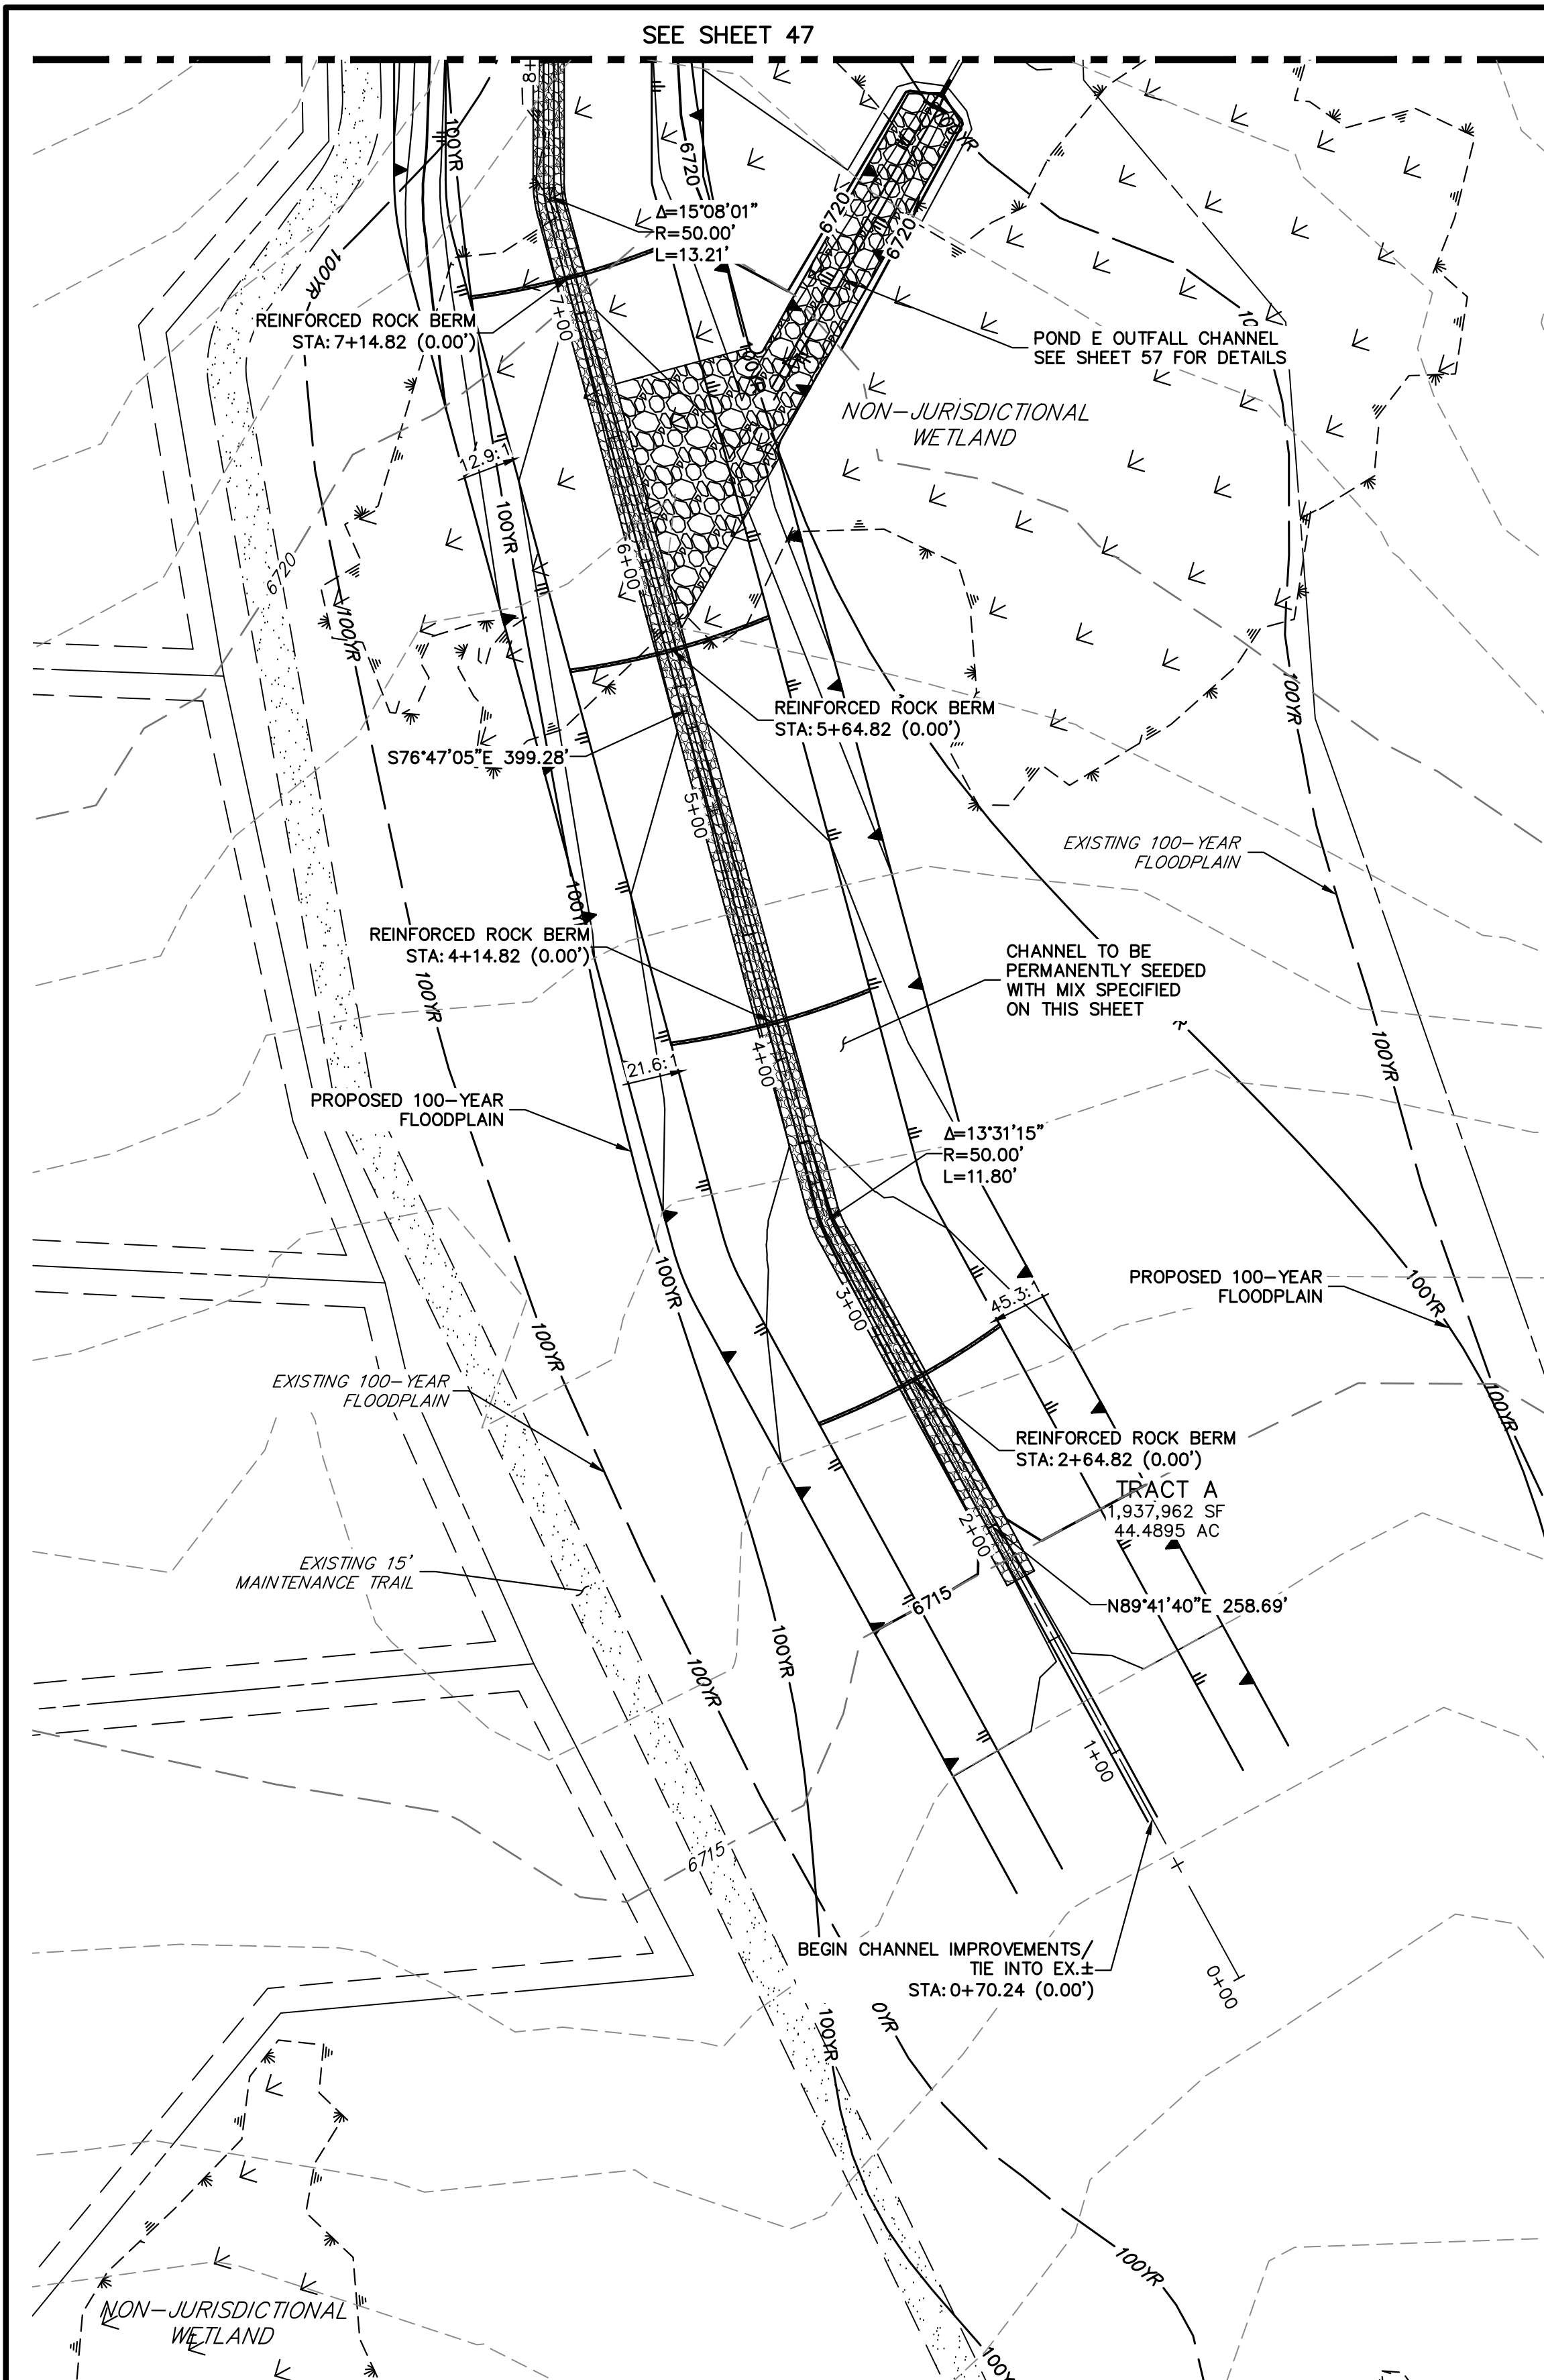
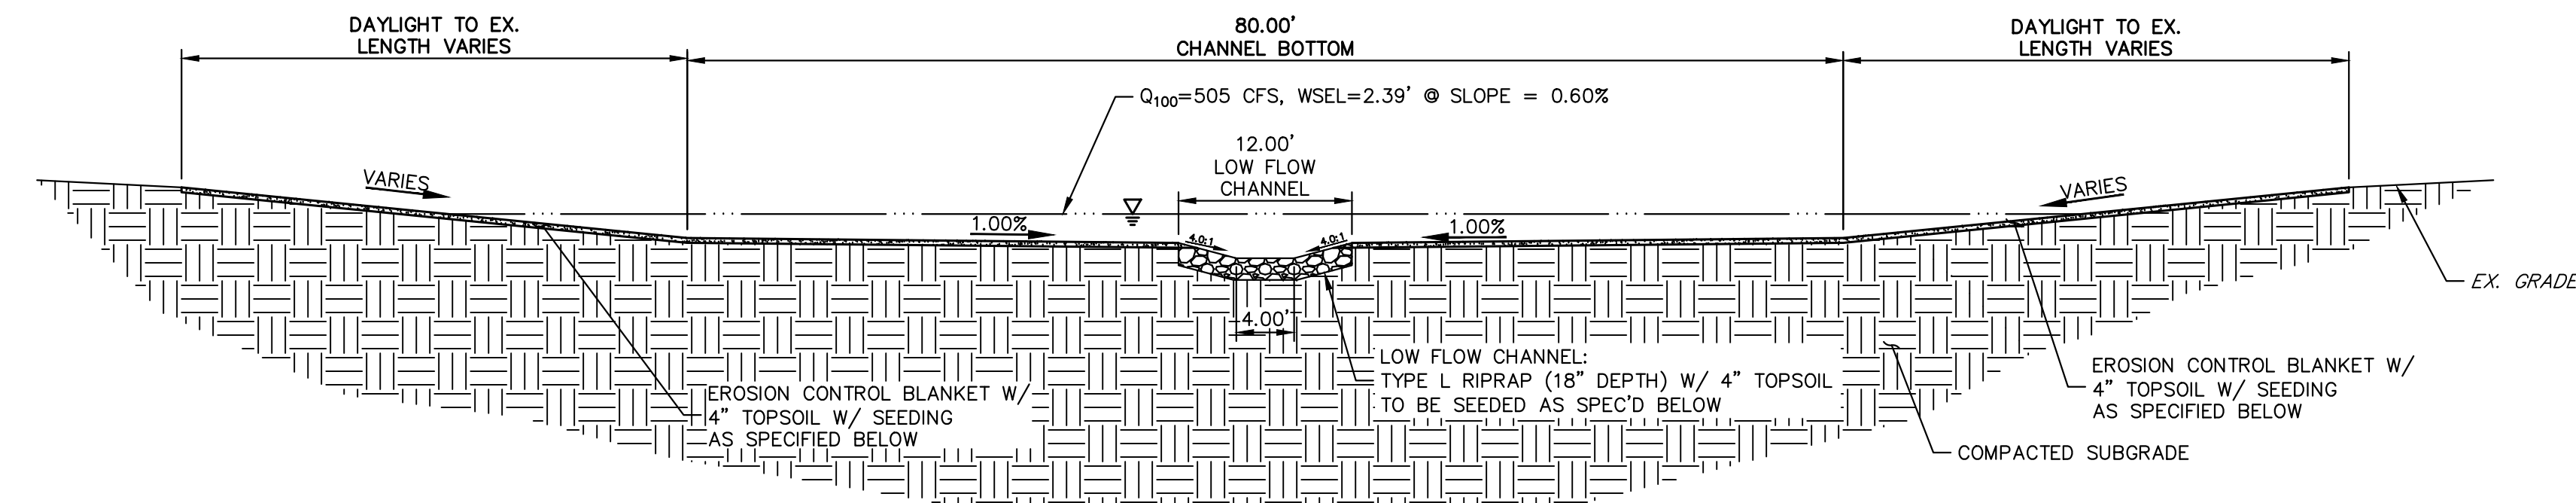
MS-06 CHANNEL IMPROVEMENTS - TYPICAL SECTION

SCALE: 1"=10'
 TYPICAL SECTION FOR CHANNEL EAST OF SAN ISIDRO TRAIL
 CHANNEL SEED MIX: EROSION CONTROL BLANKET WITH PAWNEE BUTTES SEED INC. - "LOW GROW NATIVE MIX"
 -IDAHO FESCUE
 -SANDBERG BLUEGRASS
 -ROCKY MOUNTAIN FESCUE
 -BIG BLUEGRASS

Unresolved:
Report needs to also address maintenance
of drainage way MS-6 at culvert crossing
San Isidro.

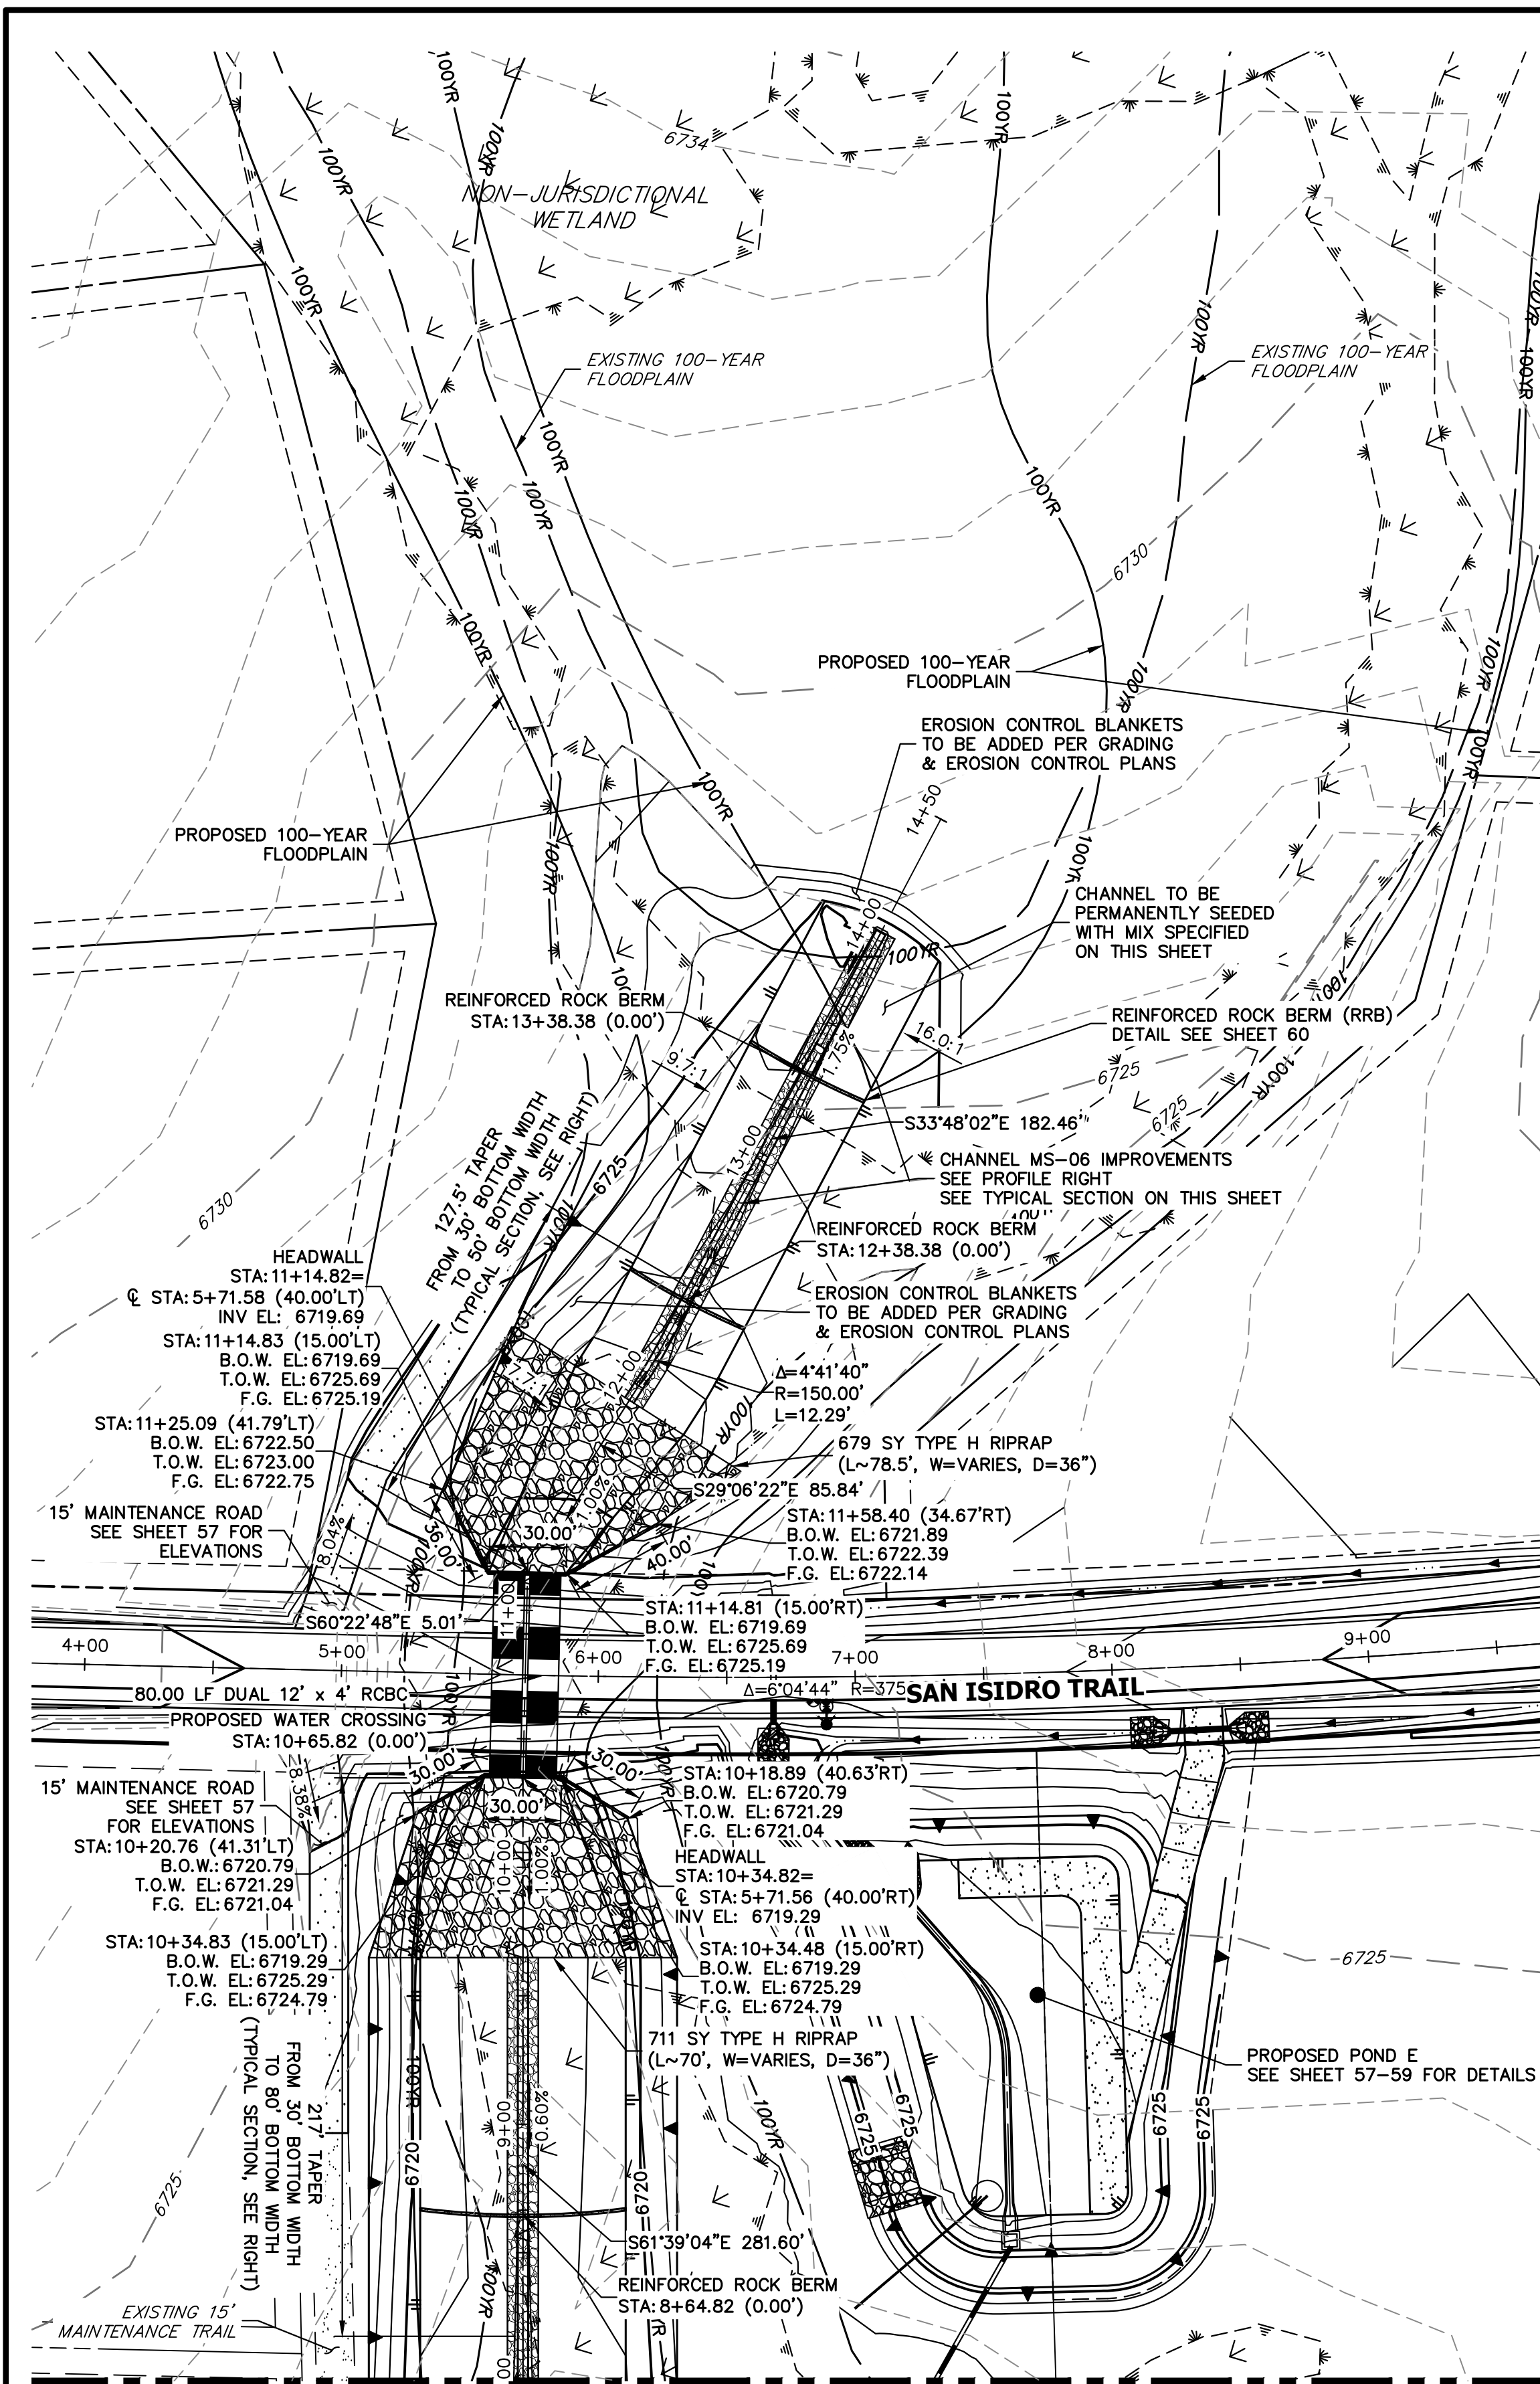
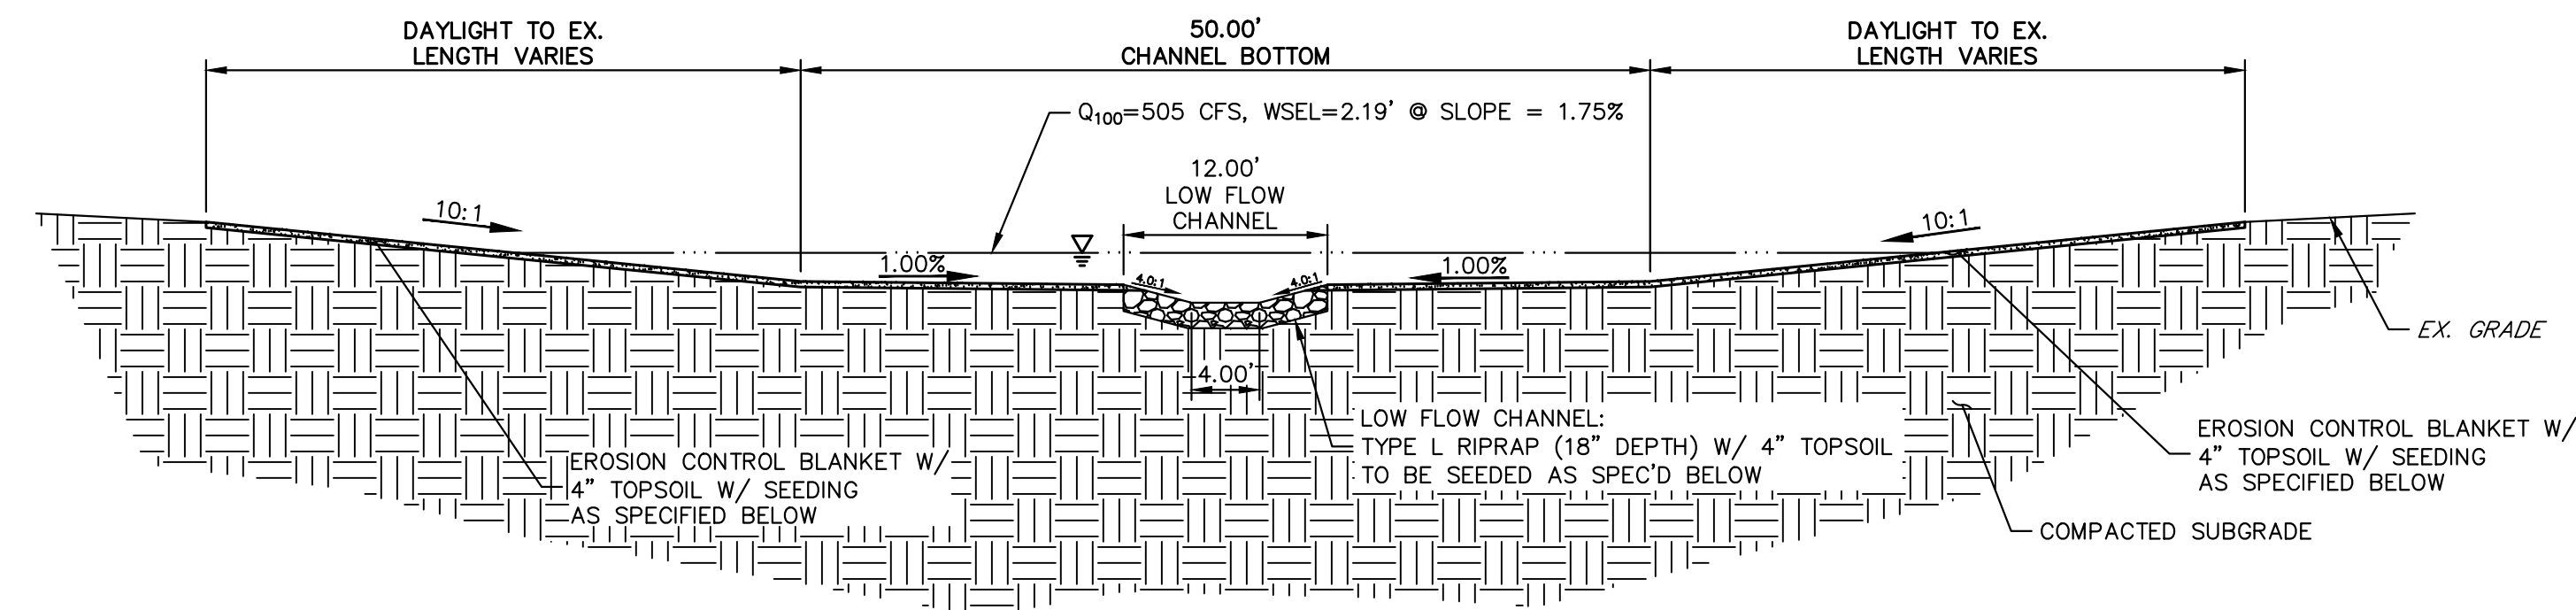
MS-06 CHANNEL IMPROVEMENTS - TYPICAL SECTION

SCALE: 1"=10'
 TYPICAL SECTION FOR CHANNEL WEST OF SAN ISIDRO TRAIL
 CHANNEL SEED MIX: EROSION CONTROL BLANKET WITH PAWNEE BUTTES SEED INC. - "LOW GROW NATIVE MIX"
 - IDAHO FESCUE
 - SANDBERG BLUEGRASS
 - ROCKY MOUNTAIN FESCUE
 - BIG BLUEGRASS

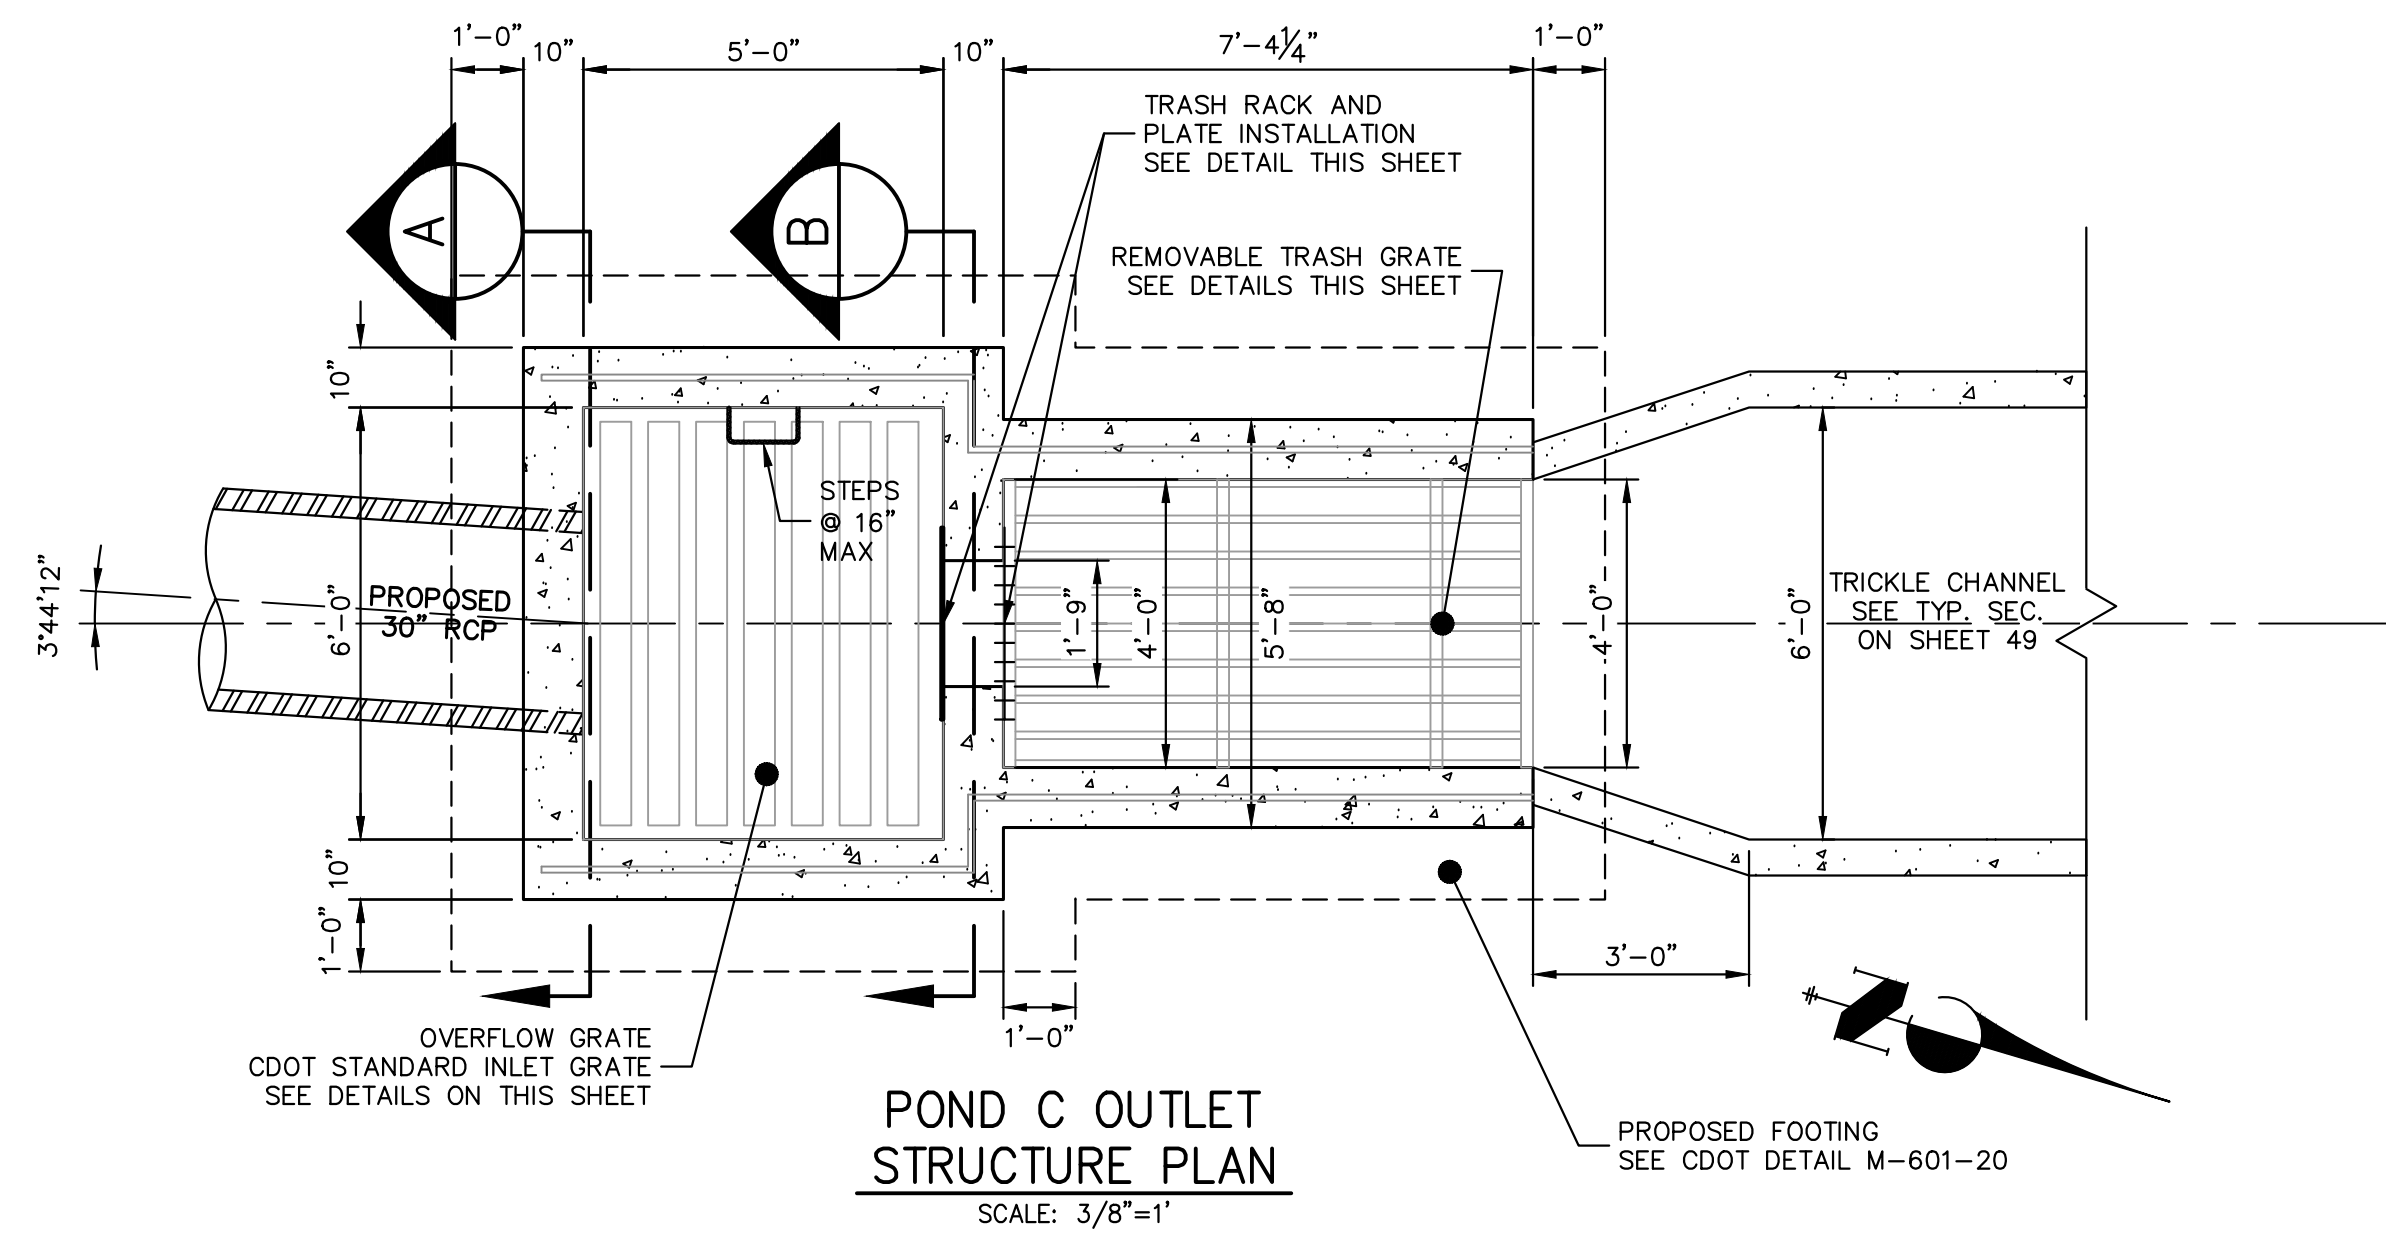
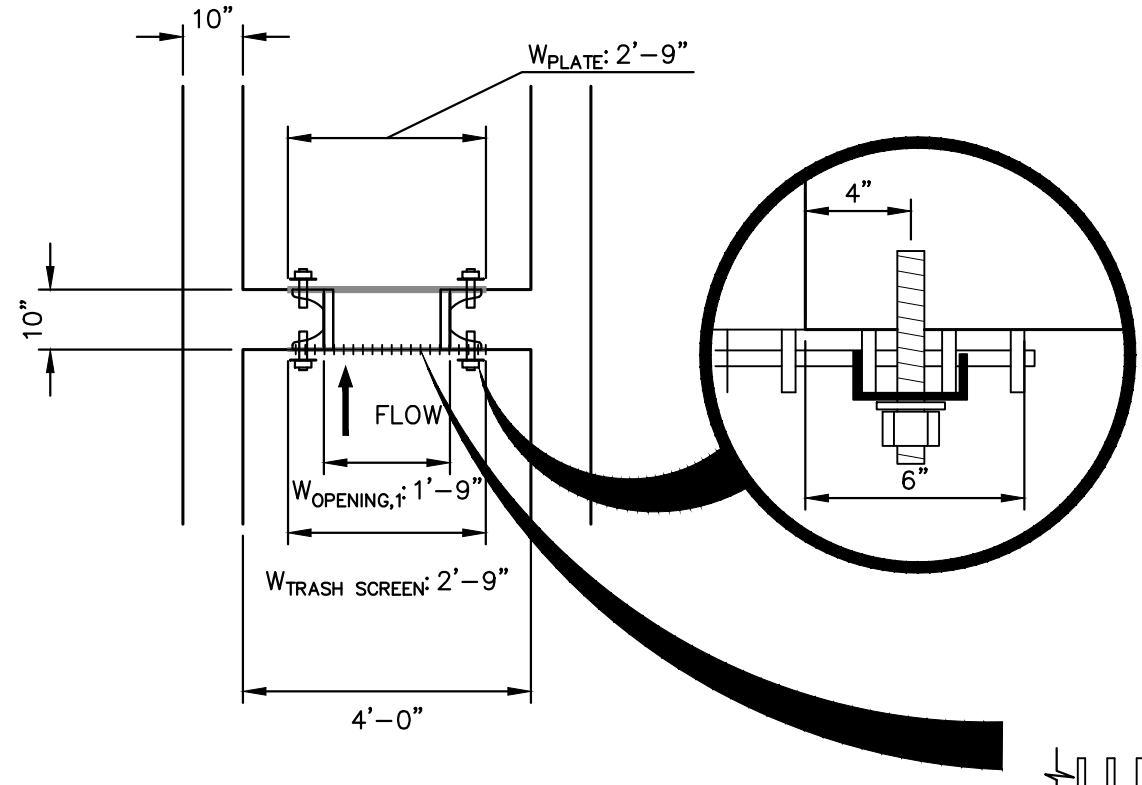
WATER DEPTH ABOVE LOWEST OPENING, H	MINIMUM BEARING BAR SIZE, BARS ALIGNED VERTICALLY
2.0 FT.	1" x 3/16"
3.0 FT.	1-1/4" x 3/16"
4.0 FT.	1-3/4" x 3/16"
5.0 FT.	2" x 3/16"
6.0 FT.	2-1/4" x 3/16"

R VALUE=(NET OPEN AREA)/GROSS RACK AREA
 =0.71 FOR CROSS RODS ON 2" CENTERS
 =0.77 FOR CROSS RODS ON 4" CENTERS
BAR GRATE DETAIL
 N.T.S.
