**Stormwater Management Facility
Operation and Maintenance (O&M) Plan
Template**

Saddlehorn Ranch - Filing 3 and 4

**Stormwater Management Facility
Inspection and Maintenance (I&M) Plan**

SADDLEHORN RANCH –
FILING 3
I&M DETAIL SHEET

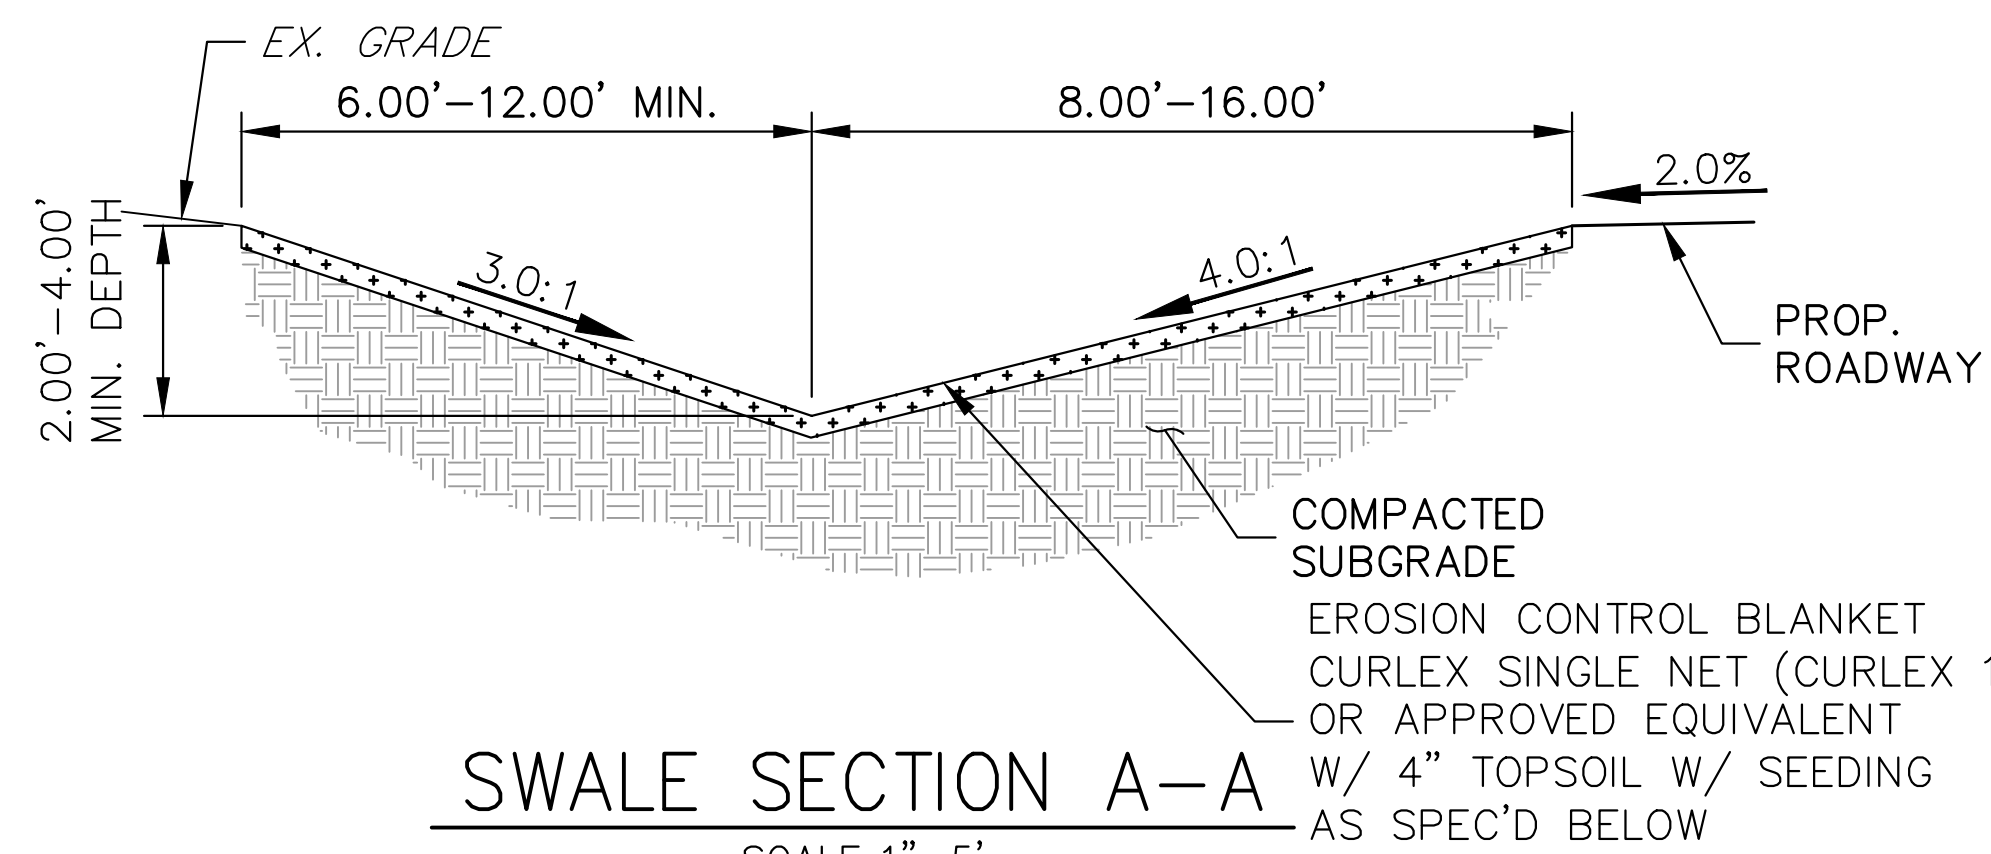
SWALE SECTION A-A

SWALE SEED MIX:
EROSION CONTROL BLANKET WITH PAWNEE BUTTES SEED INC. - "LOW GROW NATIVE MIX"
-IDAHO FESCUE
-SANDBERG BLUEGRASS
-ROCKY MOUNTAIN FESCUE
-BIG BLUEGRASS

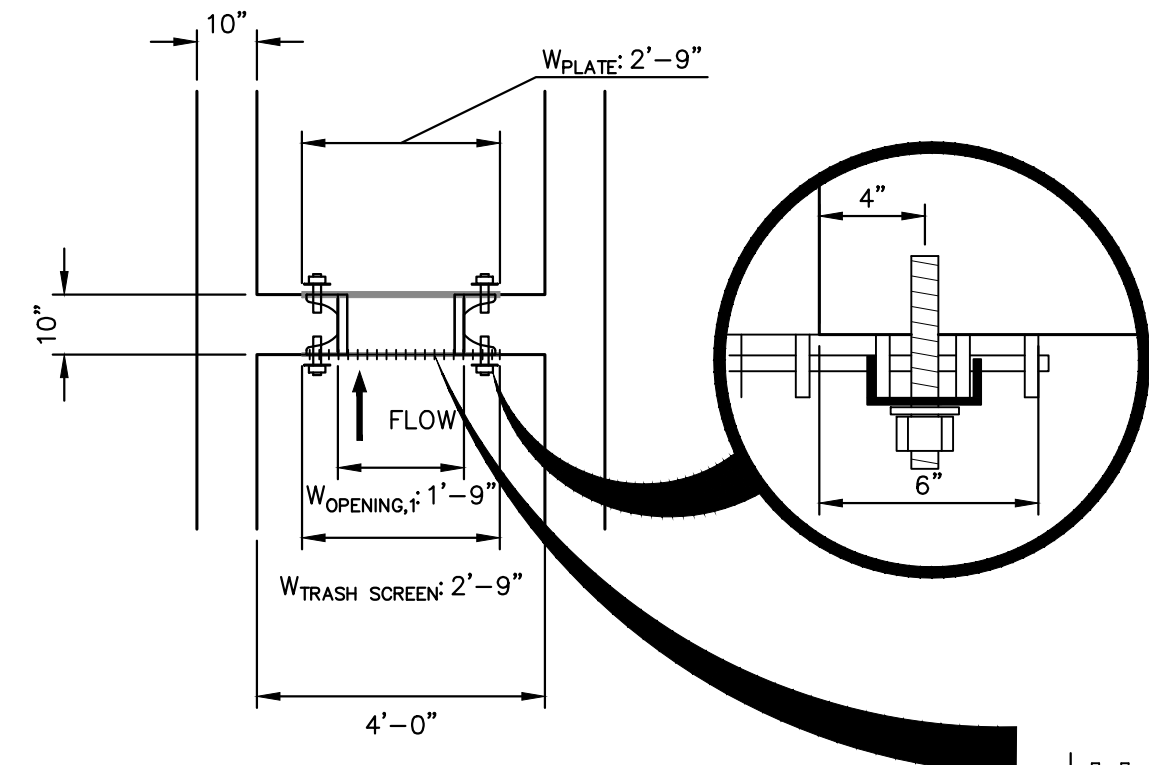
BAR GRATE DETAIL
N.T.S.

WATER DEPTH ABOVE LOWEST OPENING, H	MINIMUM BEARING BAR SIZE
2.0 FT.	1" x 3/16"
3.0 FT.	1-1/4" x 3/16"
4.0 FT.	1-3/4" x 3/16"
5.0 FT.	2" x 3/16"
6.0 FT.	2-1/4" x 3/16"

R VALUE=(NET OPEN AREA)/GROSS RACK AREA
=0.71 FOR CROSS RODS ON 2" CENTERS
=0.77 FOR CROSS RODS ON 4" CENTERS

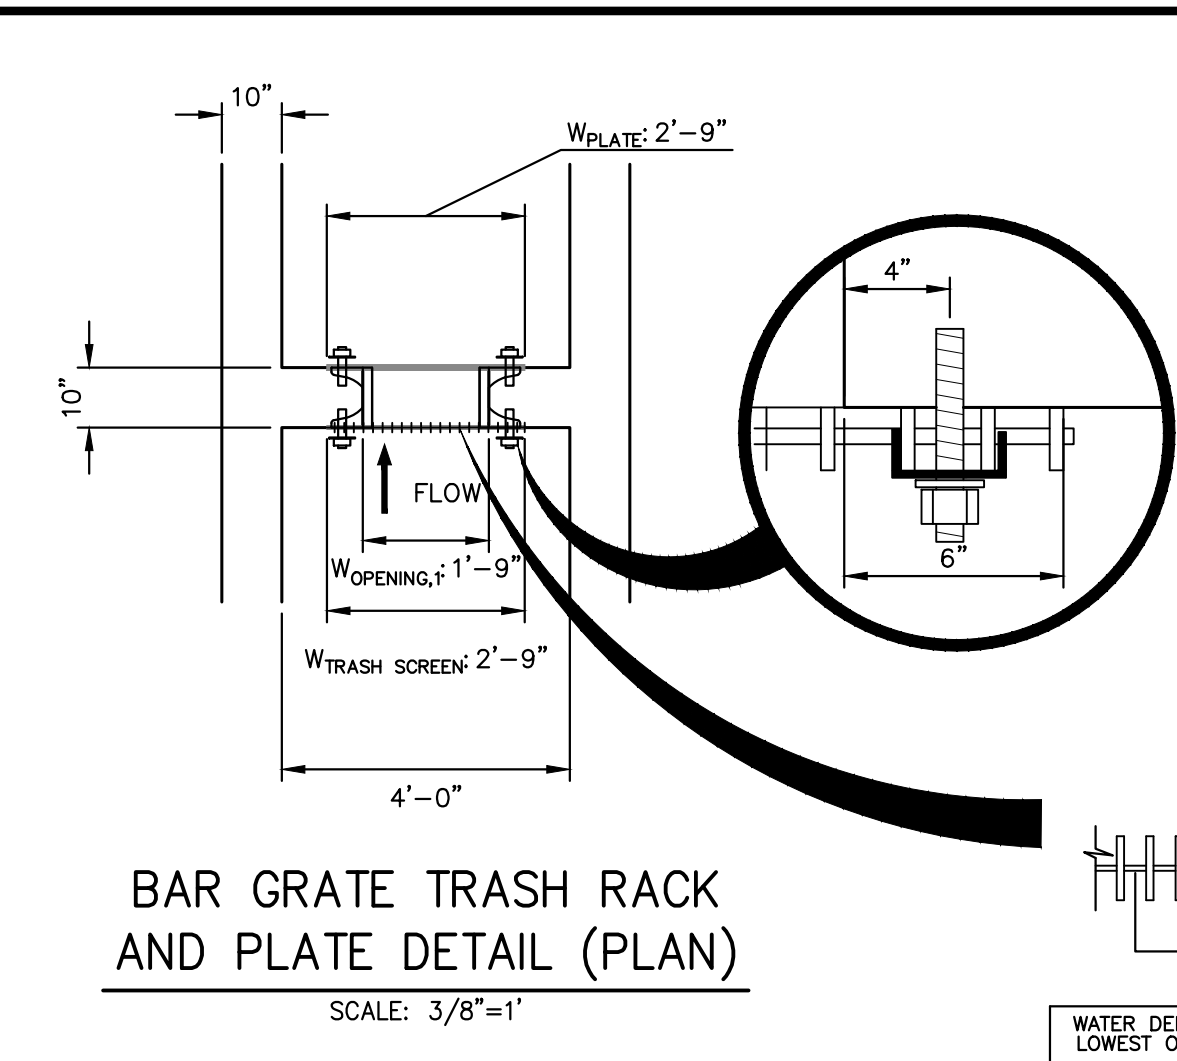
BAR GRATE DETAIL
N.T.S.

WATER DEPTH ABOVE LOWEST OPENING, H	MINIMUM BEARING BAR SIZE, BARS ALIGNED VERTICALLY
2.0 FT.	1" x 3/16"
3.0 FT.	1-1/4" x 3/16"
4.0 FT.	1-3/4" x 3/16"
5.0 FT.	2" x 3/16"
6.0 FT.	2-1/4" x 3/16"

R VALUE=(NET OPEN AREA)/GROSS RACK AREA
 =.71 FOR CROSS RODS ON 2" CENTERS
 =.77 FOR CROSS RODS ON 4" CENTERS
