Stormwater Management Facility Operation and Maintenance (O&M) Plan Template

Saddlehorn Ranch - Filing 3 and 4

**Stormwater Management Facility
Inspection and Maintenance (I&M) Plan**

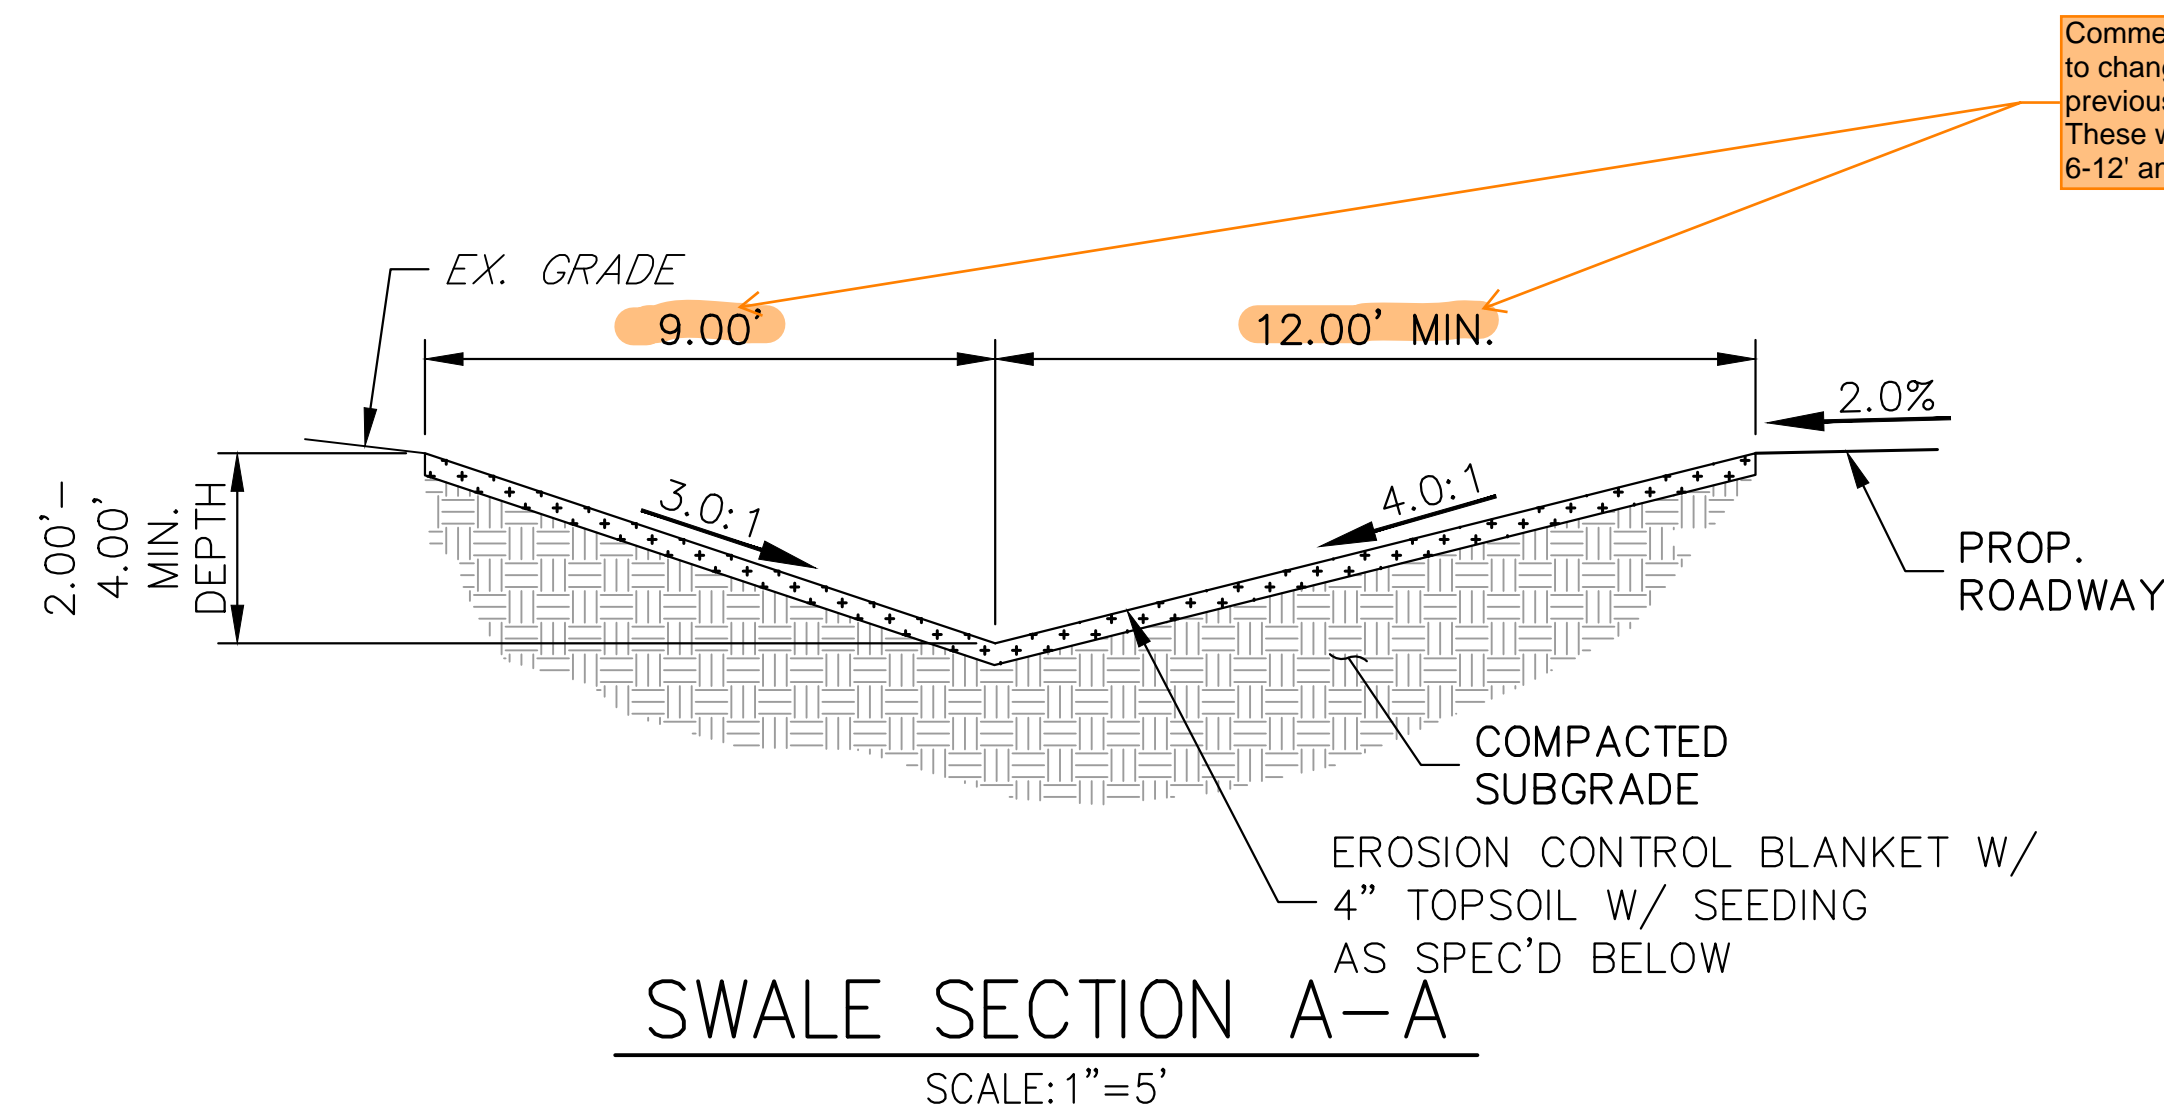
SWALE SECTION A-A
SCALE: 1"=5'

SWALE SEED MIX:
EROSION CONTROL BLANKET WITH PAWNEE BUTTES SEED INC. – "LOW GROW NATIVE MIX"
-IDAHO FESCUE
-SANDBERG BLUEGRASS
-ROCKY MOUNTAIN FESCUE
-BIG BLUEGRASS

Comment generated due to changes from the previous submittal: These widths should be 6-12' and 8-16'.

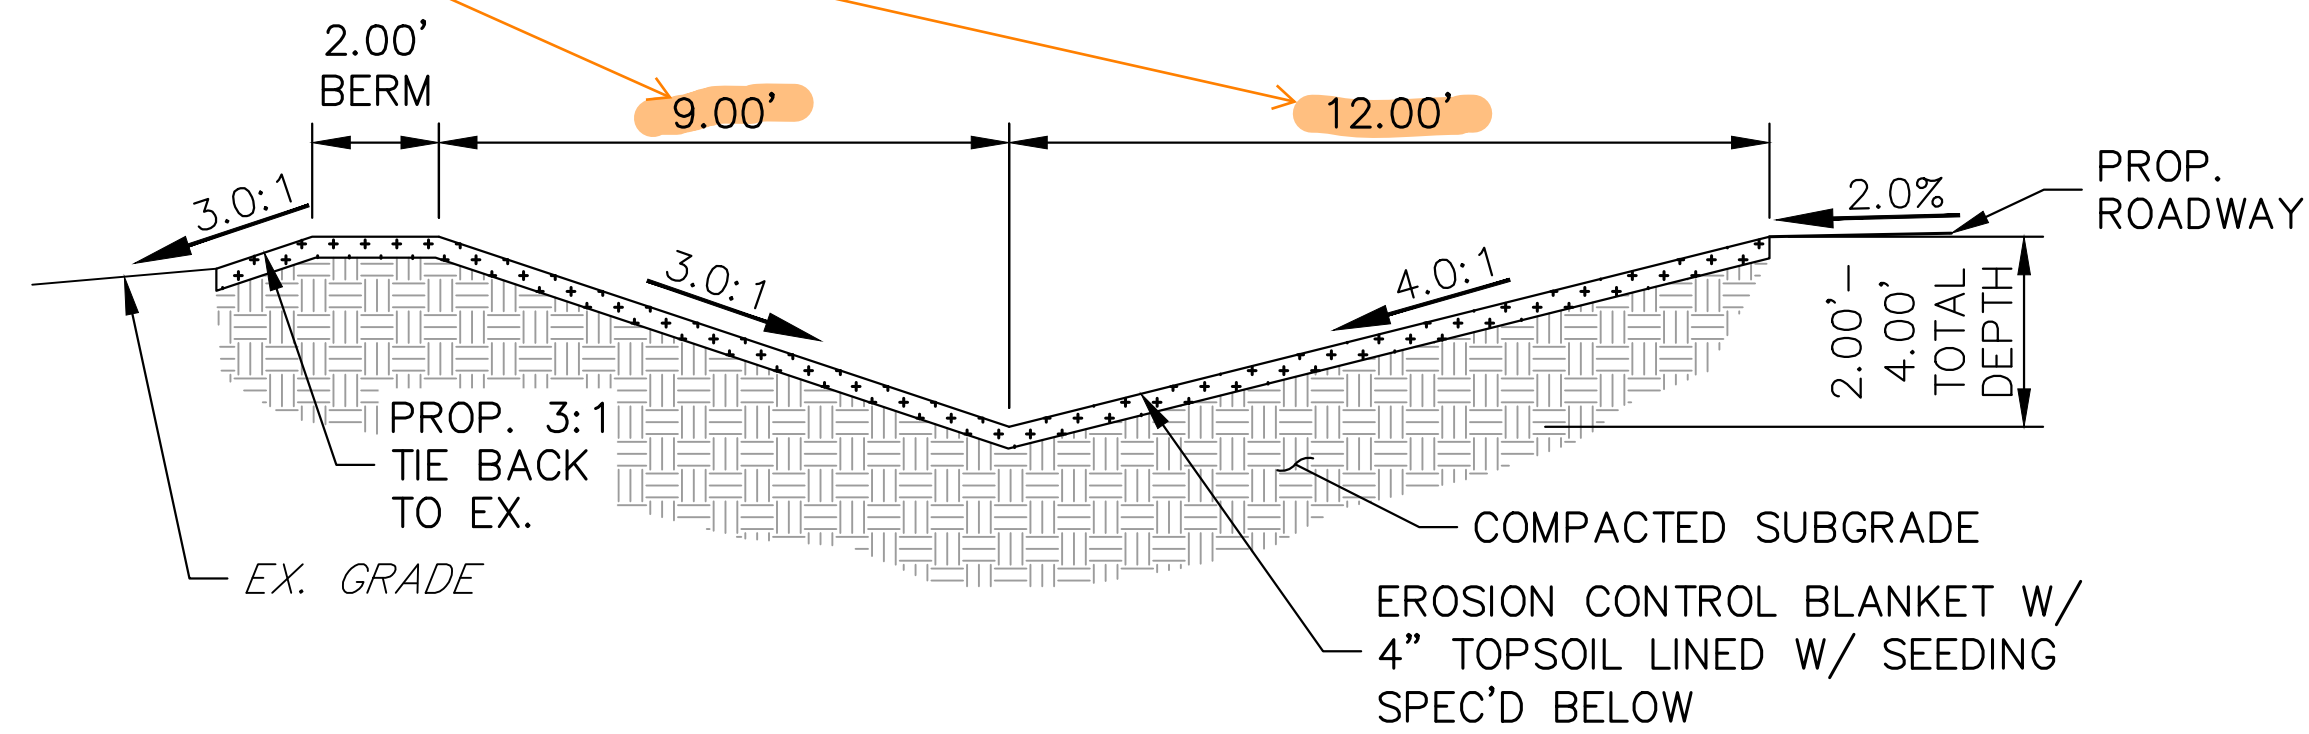
SWALE SECTION B-B
SCALE: 1"=5'

SWALE SEED MIX:
EROSION CONTROL BLANKET WITH PAWNEE BUTTES SEED INC. – "LOW GROW NATIVE MIX"
-IDAHO FESCUE
-SANDBERG BLUEGRASS
-ROCKY MOUNTAIN FESCUE
-BIG BLUEGRASS

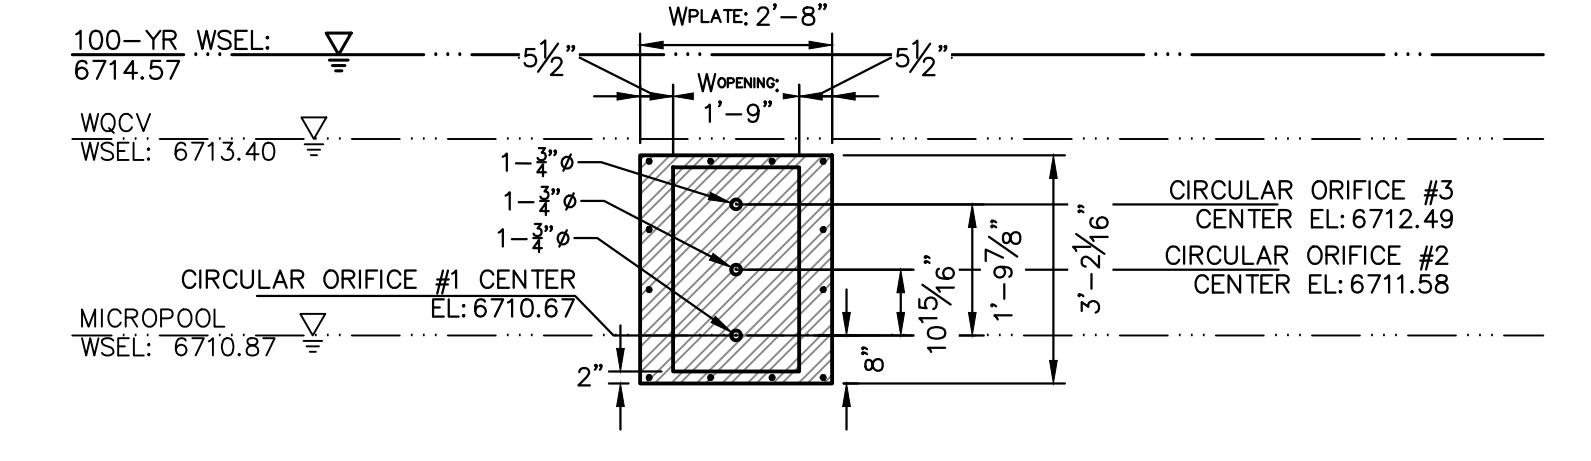
ORIFICE PLATE DETAIL
SCALE: 3/8"=1'

3/8" THICK ORIFICE PLATE, GALVANIZED STEEL WITH 3 - 1-3/8" CIRCULAR ORIFICES
BOLT PLATE TO CONCRETE @ 10" O.C. MAX.
PROVIDE GASKET BETWEEN PLATE AND CONCRETE

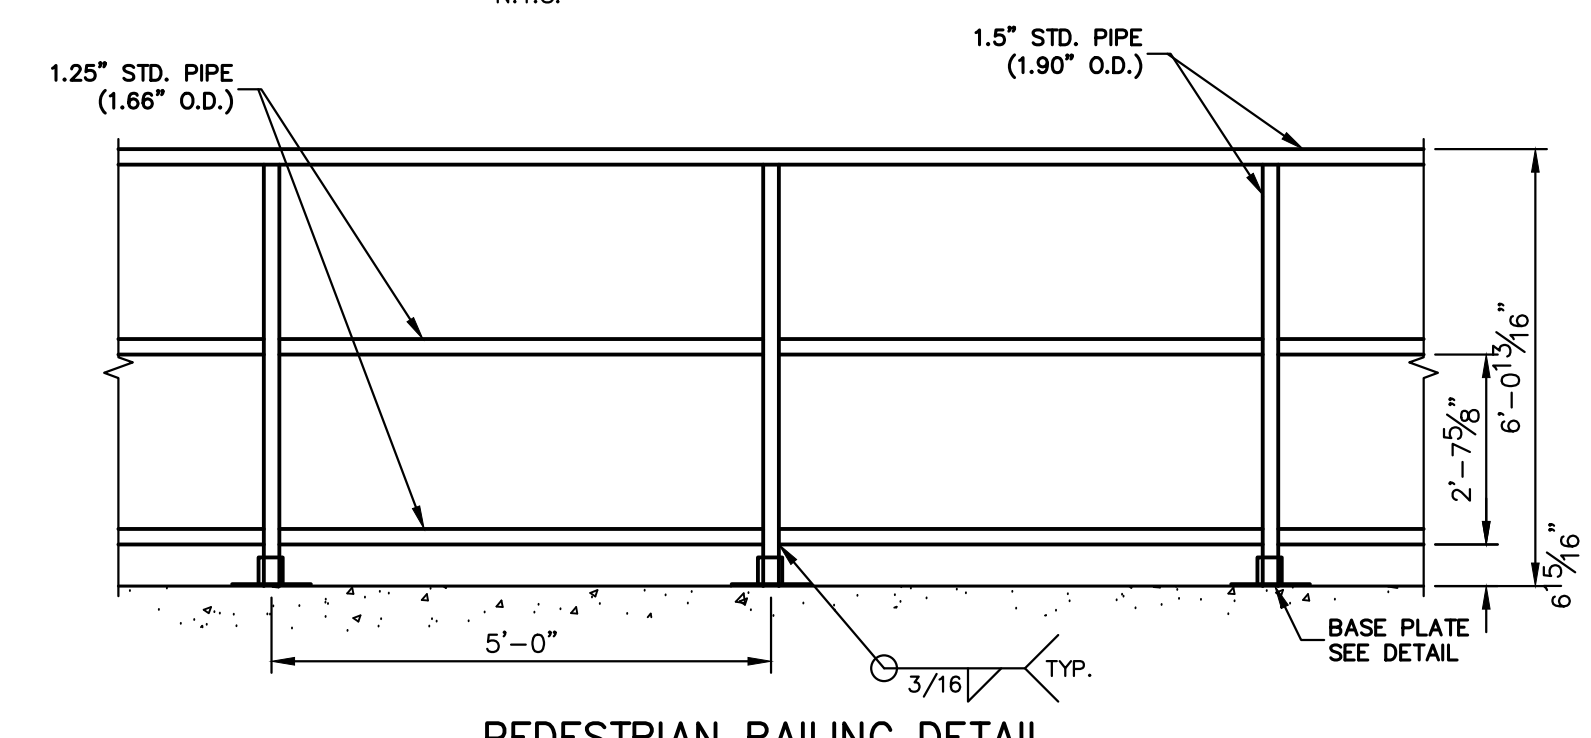
PEDESTRIAN RAILING DETAIL
SCALE: N.T.S.
RAILING TO BE HOT-DIPPED GALVANIZED
