**Preliminary Acceptance Punchlist**  
**El Paso County – Department of Public Works - Stormwater Section**

Project Name:	Rolling Hills Ranch Filing 3
EDARP Filing Number(s):	SF2116
ESQCP Number:	ESQ2329
Attendees:	DPW SW: Dylan Finley DPW Development Services: Brad Walters, David Parkerson, Spencer Pirzadeh, Gilbert LaForce Developer: Lawrence Grahem
Date of Walk-Thru:	08/02/2023
Walk-Thru Number:	1

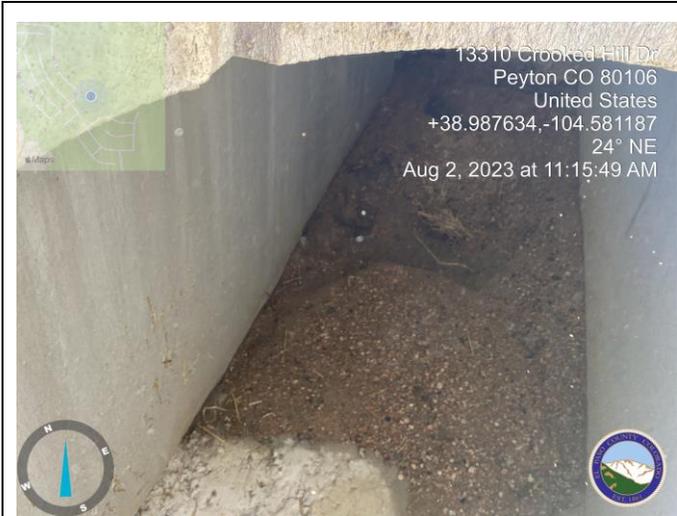
Photo 1: Inlet at Rolling Ranch Dr. and Crooked Hill Dr.

- Inlets need to be cleaned of sediment:
  - Inlet #21: Rolling Ranch Dr. and Crooked Hill Dr. (Photo 1)
  - Inlet #20: Coastal Hills and Crooked Hill Dr. (Photo 2)
  - Inlet #19: Crooked Bluff Dr. and Crooked Hill (Photo 3)
  - Inlet #22: Along Rolling Ranch Dr. (Photo 4)

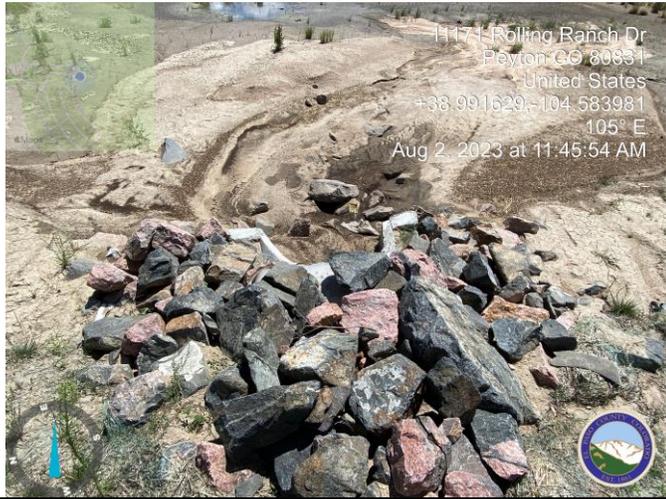
- Storm #1, install outlet protection per plans. Riprap overburdened with sediment. (Photo 5)

Photo 5: Storm #1, install outlet protection per plans. Riprap overburdened with sediment. Remove sediment and reestablish outlet protection.
