## **Stormwater Management Facility Operation and Maintenance (O&M) Plan**

***Homestead North Filing No. 3***

***JR Engineering;  
5475 Tech Center Drive  
Colorado Springs, CO 80919***

***10/25/2022***

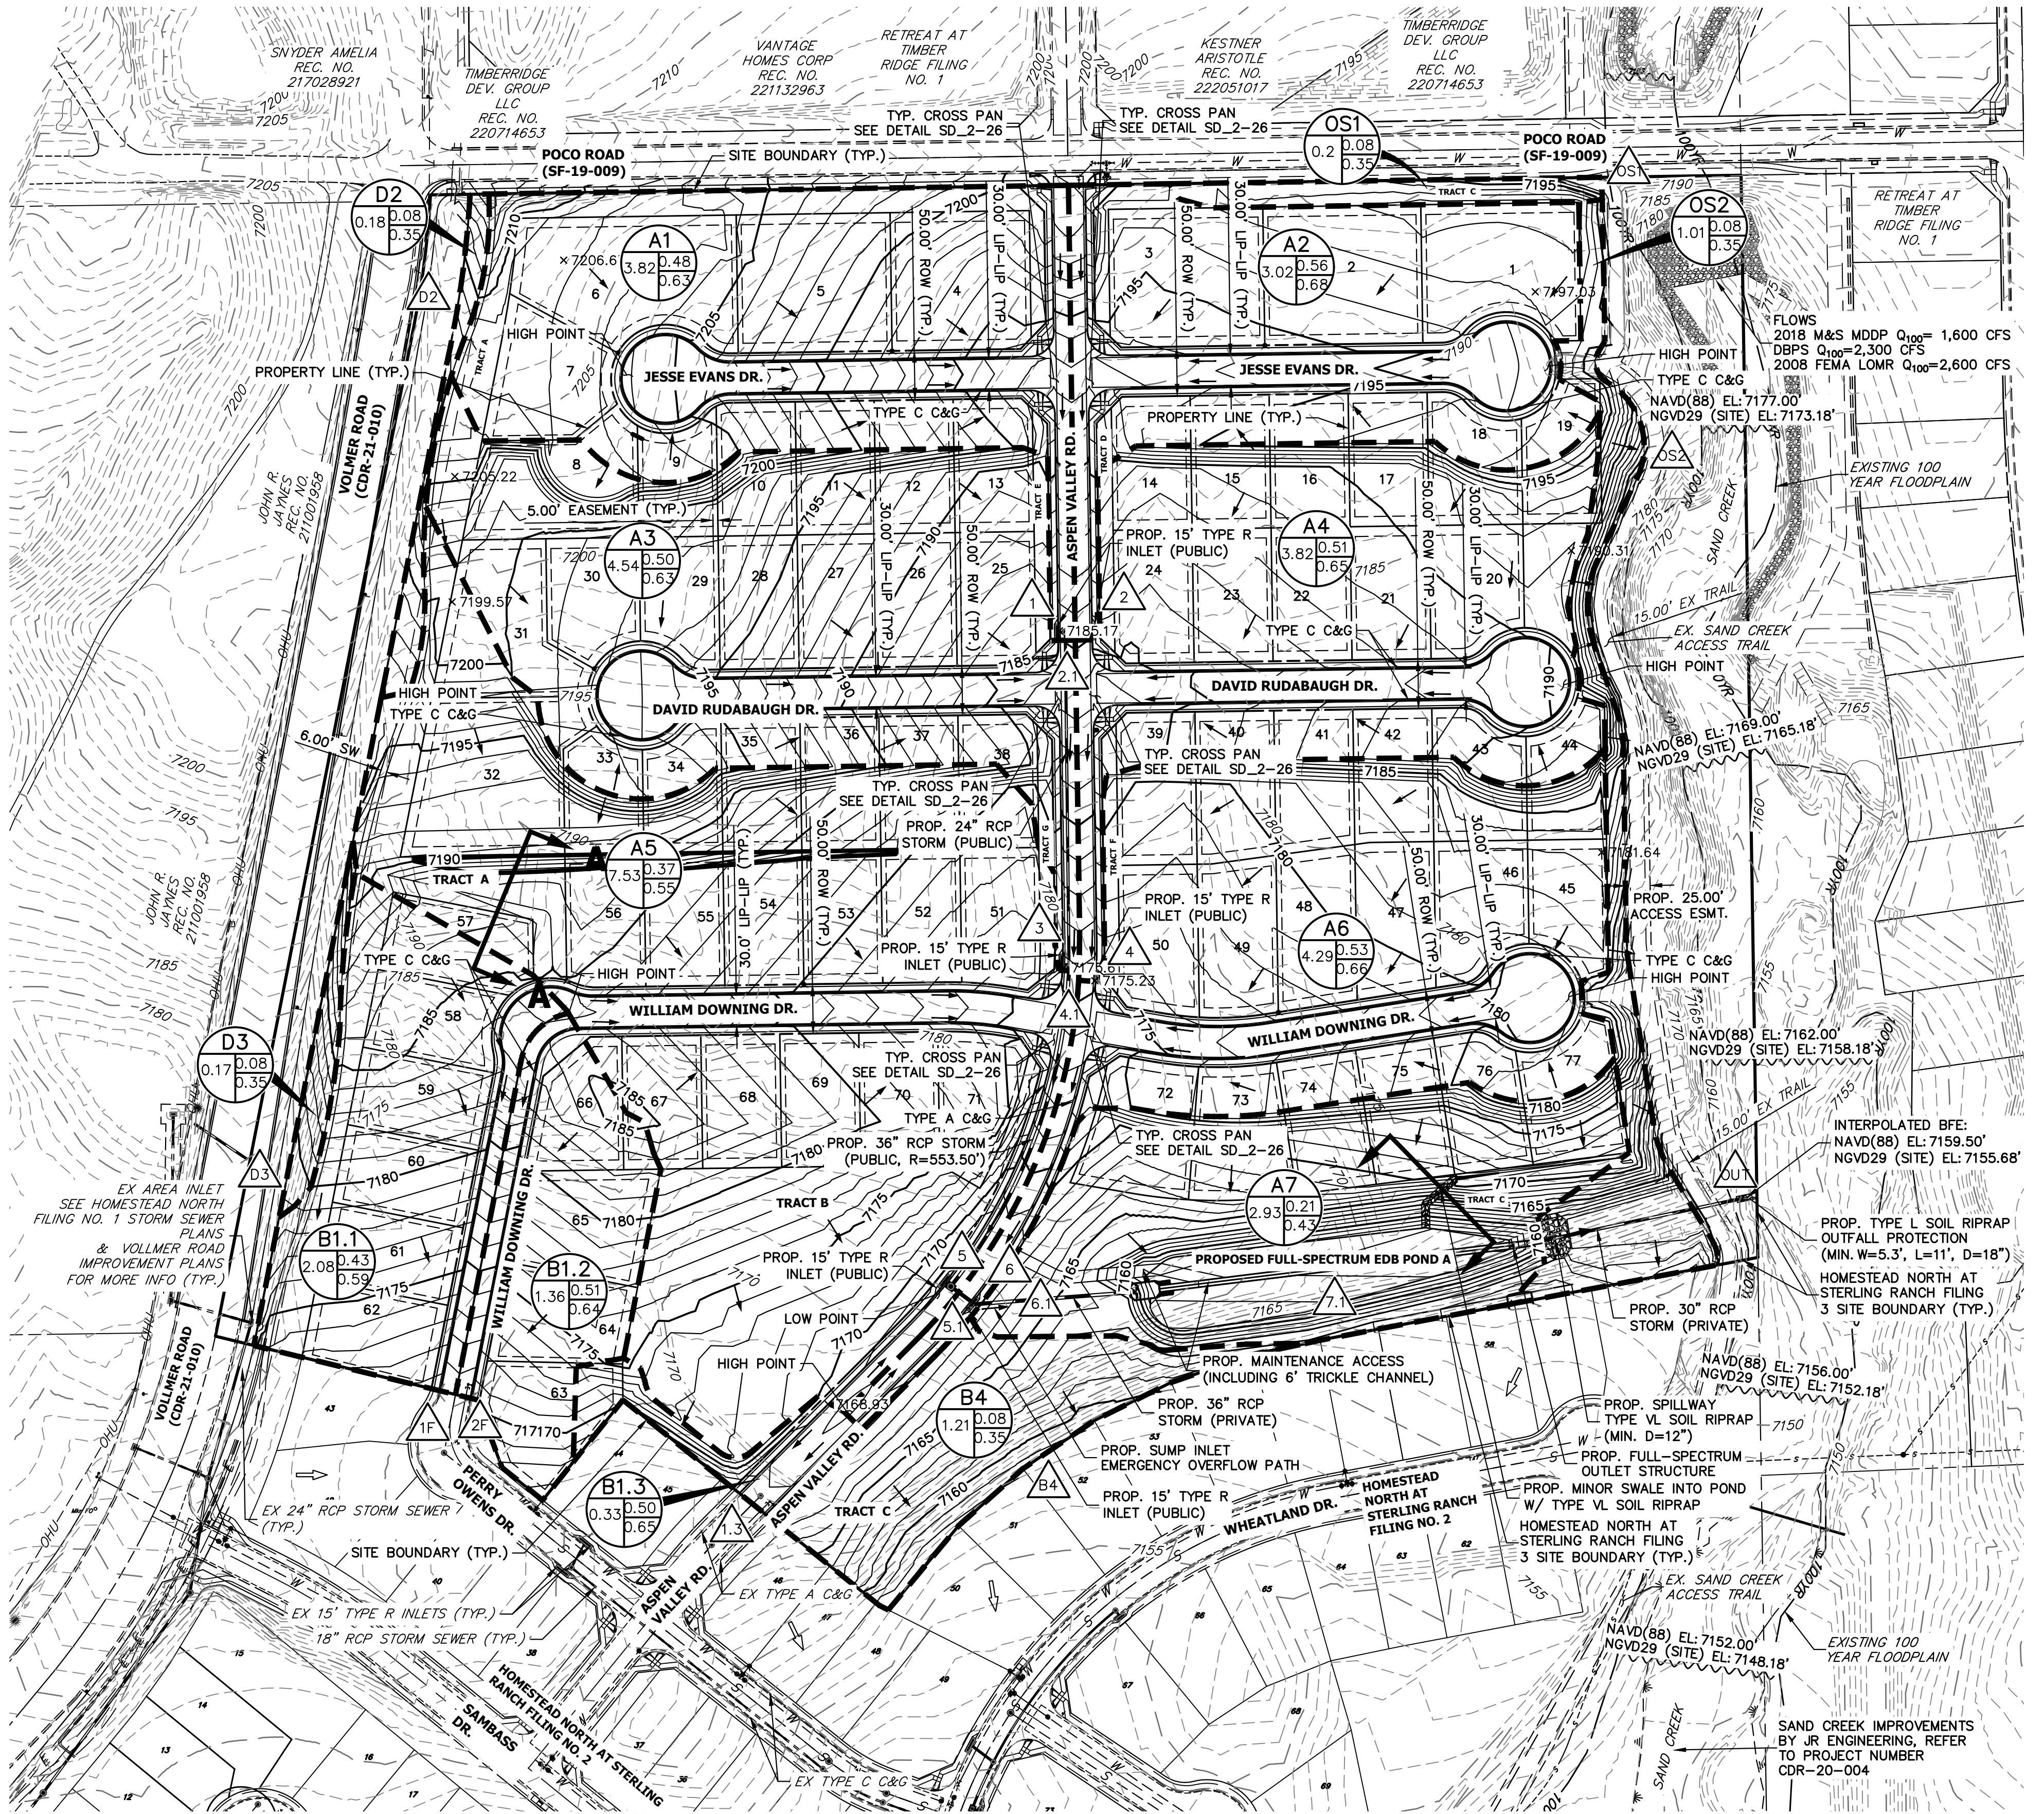
# HOMESTEAD NORTH AT STERLING RANCH FILING NO. 3 PROPOSED CONDITIONS DRAINAGE MAP

Tributary Sub-basin	Area (acres)	Percent Impervious	C <sub>s</sub>	C <sub>100</sub>	t <sub>c</sub> (min)	Q <sub>s</sub> (cfs)	Q <sub>100</sub> (cfs)
A1	3.82	40%	0.36	0.55	12.3	5.2	13.5
A2	3.02	48%	0.42	0.60	14.8	4.5	10.8
A3	4.54	47%	0.38	0.57	15.2	6.1	15.1
A4	3.82	49%	0.41	0.58	12.0	6.0	14.4
A5	7.53	34%	0.29	0.50	16.0	7.6	21.7
A6	4.29	51%	0.41	0.59	13.7	6.5	15.5
A7	2.93	15%	0.16	0.41	9.4	2.0	8.5
B1.1	2.08	40%	0.33	0.53	10.6	2.8	7.5
B1.2	1.36	48%	0.38	0.57	11.0	2.1	5.1
B1.3	0.33	51%	0.47	0.64	10.2	0.7	1.4
B4	1.21	2%	0.09	0.36	9.3	0.5	3.1
OS1	0.20	2%	0.09	0.36	5.0	0.1	0.6
OS2	1.01	2%	0.09	0.36	6.5	0.4	2.9
D2	0.18	2%	0.09	0.36	5.6	0.1	0.5
D3	0.17	2%	0.09	0.36	5.0	0.1	0.5

DP	Q <sub>s</sub>		Q <sub>100</sub>	
	Total	i/B	Total	i/B
1	5.2	10.9	13.5	2.6
2	4.5	9.5	10.8	1.3
2.1	9.3	19.6		
3	6.1	12.6	17.5	4.9
4	6.0	11.3	14.4	3.1
4.1	20.6	42.1		
5	7.6	25.8	25.8	0.0
5.1	27.9	66.1		
6	6.5	18.8	18.8	0.0
6.1	34.0	83.2		
7.1	35.4	92.6		
1F	2.8	7.5		
2F	2.1	5.1		
1.3	0.7	1.4		
B4	0.5	3.1		
OS1	0.1	0.6		
OS2	0.4	2.9		
D2	0.1	0.5		
D3	0.1	0.5
