**PRIVATE DETENTION BASIN /
STORMWATER QUALITY BEST MANAGEMENT PRACTICE
MAINTENANCE AGREEMENT AND EASEMENT**

Stormwater Management Facility Operation and Maintenance (O&M) Plan

HOMESTEAD NORTH AT STERLING RANCH FILING NO. 3 PROPOSED CONDITIONS DRAINAGE MAP

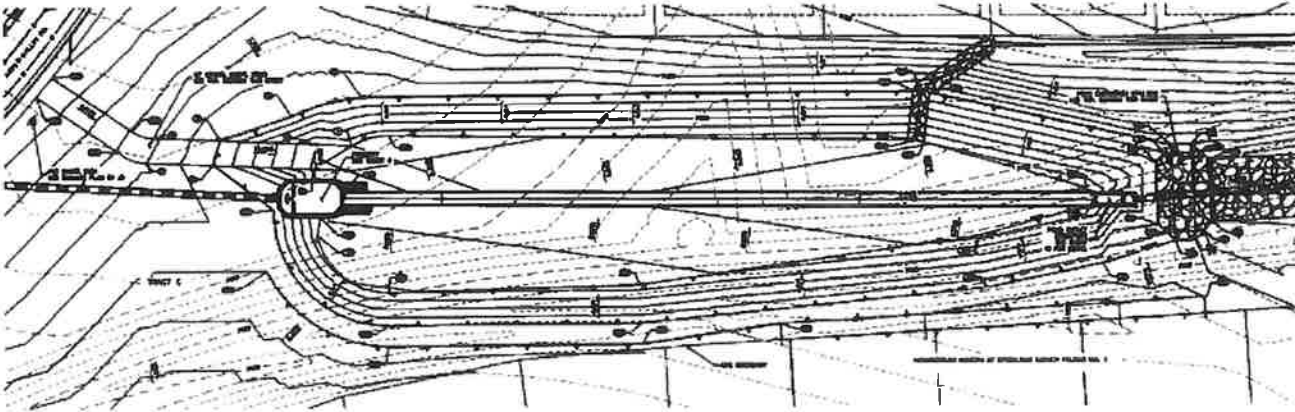
POND EAST OF ASPEN VALLEY ROAD

Legal Description: Tract H, Homestead North at Sterling Ranch Filing No. 3
