**STORMWATER MANAGEMENT FACILITY  
OPERATION AND MAINTENANCE (O&M) MANUAL**

**MONUMENT STEEL STRUCTURES  
LOT 2 OF GREATER EUROPE MISSION SUBDIVISION FILING NUMBER 1  
18910 BASE CAMP ROAD  
EL PASO COUNTY, COLORADO**

CONSTRUCTION DOCUMENTS  
**MONUMENT STEEL STRUCTURES**  
EXTENDED DETENTION BASIN PLAN  
18910 BASE CAMP ROAD  
MONUMENT, COLORADO

CONSTRUCTION DOCUMENTS  
**MONUMENT STEEL STRUCTURES**  
 OUTLET STRUCTURE  
 18910 BASE CAMP ROAD  
 MONUMENT, COLORADO

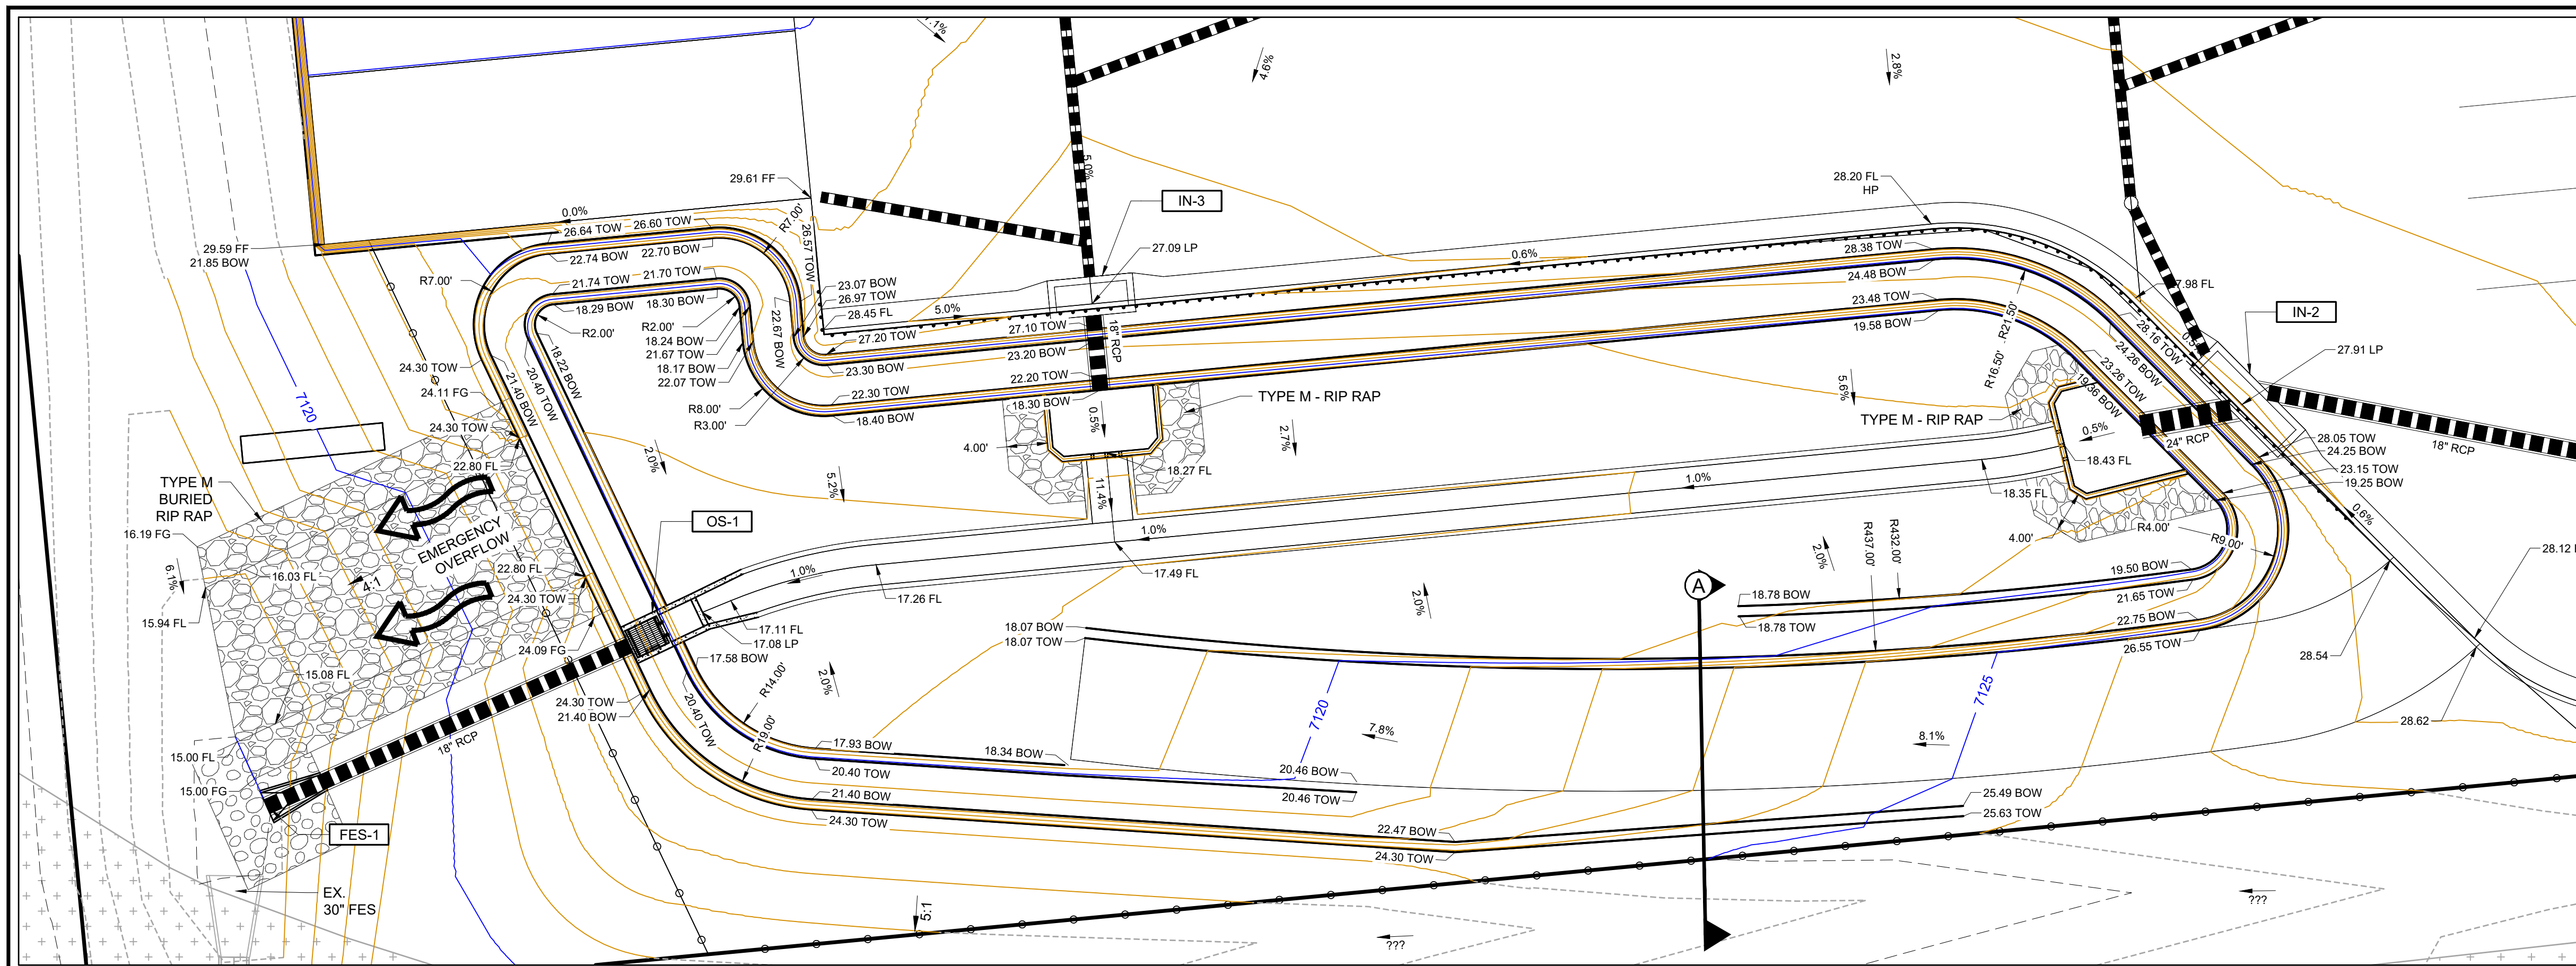
- ① RETAINING WALLS
- ② DETENTION POND
- ③ DETENTION POND MAINTENANCE ACCESS
- ④ OUTLET STRUCTURE
- ⑤ NOT USED
- ⑥ DRAINAGE SWALE
- ⑦ STORM INLET
