El Paso County Stormwater Management Plan

Clear View Properties I, LLC Clear View Industrial Park Filing No. 2A

June 2020

PCD Filing No.:
CDR208

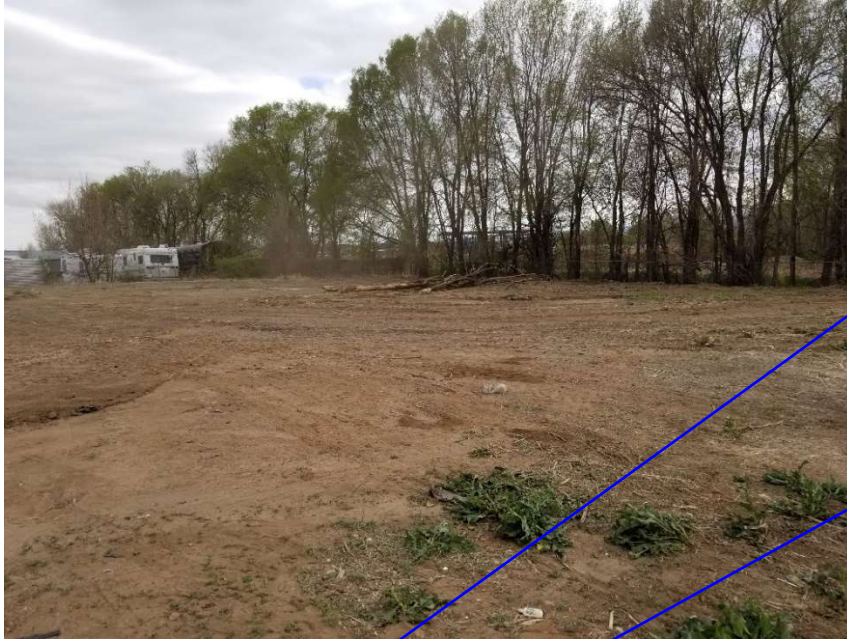
Existing on-site ground cover (Lots 1A and 2A)

This site has been used as a car storage lot for several years, so the majority of the area is dirt, with some various grasses and bushes growing (see attached pictures). There are several trees growing outside the property, along the Fountain Mutual Canal; none of these trees will be impacted by the grading or the construction of the water quality pond. On-site visual inspections conclude that lots 1A, 2A, and 4A have 10% ground cover, with the majority of Lot 3A containing approximately 10% vegetation.
