Standard Operation Procedures
for
Inspection and Maintenance
of
Stormwater Quality Infiltration Basin(s)

**Lot 12 – Rolling Thunder Business Park
10707 Maltese Pt.
Peyton, Colorado**

STORMWATER FACILITY MAP

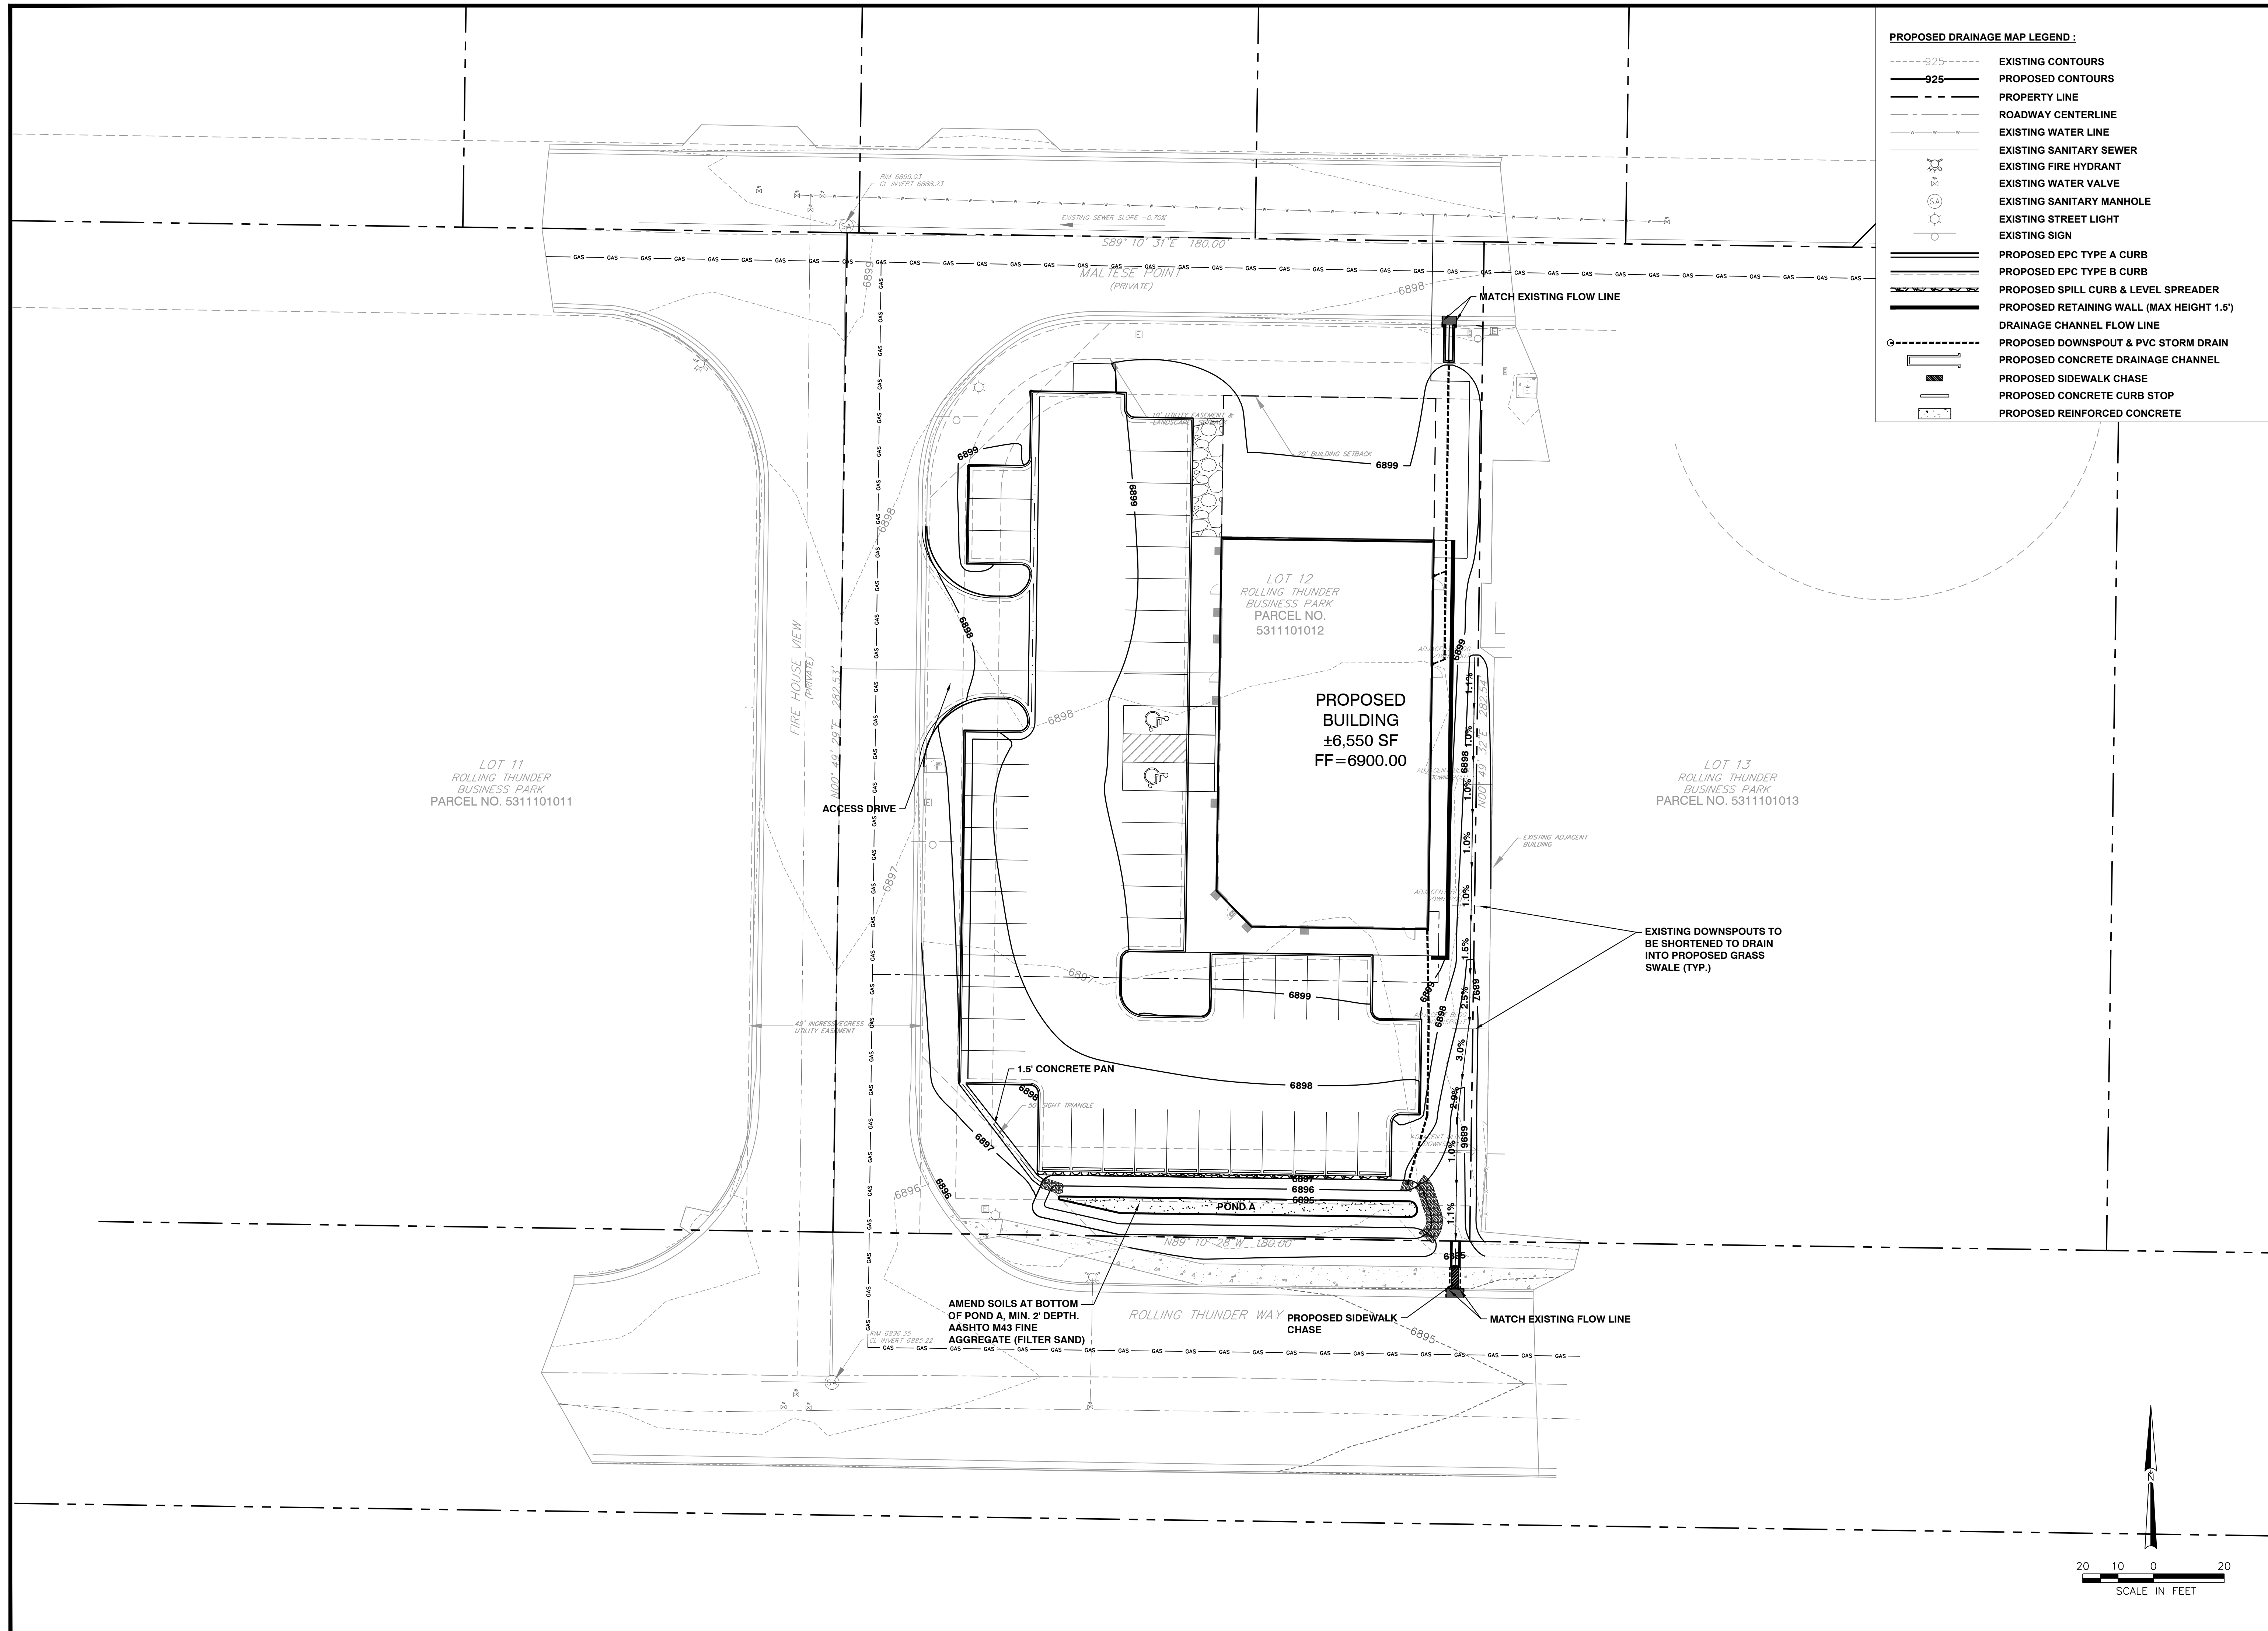
Inspection and maintenance personnel may utilize the attached stormwater facility map containing the location(s) of the access points and maintenance easements of the SQIB(s) within this development.

Inspection and maintenance personnel may utilize the attached stormwater facility map containing the location(s) of the SQIB(s) within this development.

Pond A will be located at the southern edge of Lot 12. Pond A receives stormwater via sheet flow from the parking lot flowing from north to south. Stormwater that does not get fully infiltrated during larger storm events will overflow to a grass swale to the east and eventually to the curb & gutter of Rolling Thunder Way.
