Standard Operation Procedures
for
Inspection and Maintenance
of
Stormwater Quality Infiltration Basin(s)

**Lot 12 – Rolling Thunder Business Park
10707 Maltese Pt.
Peyton, Colorado**

ROLLING THUNDER BUSINESS
PARK - LOT 12
10707 MALTESE PT. PEYTON, CO

**STORMWATER
FACILITY
MAP**

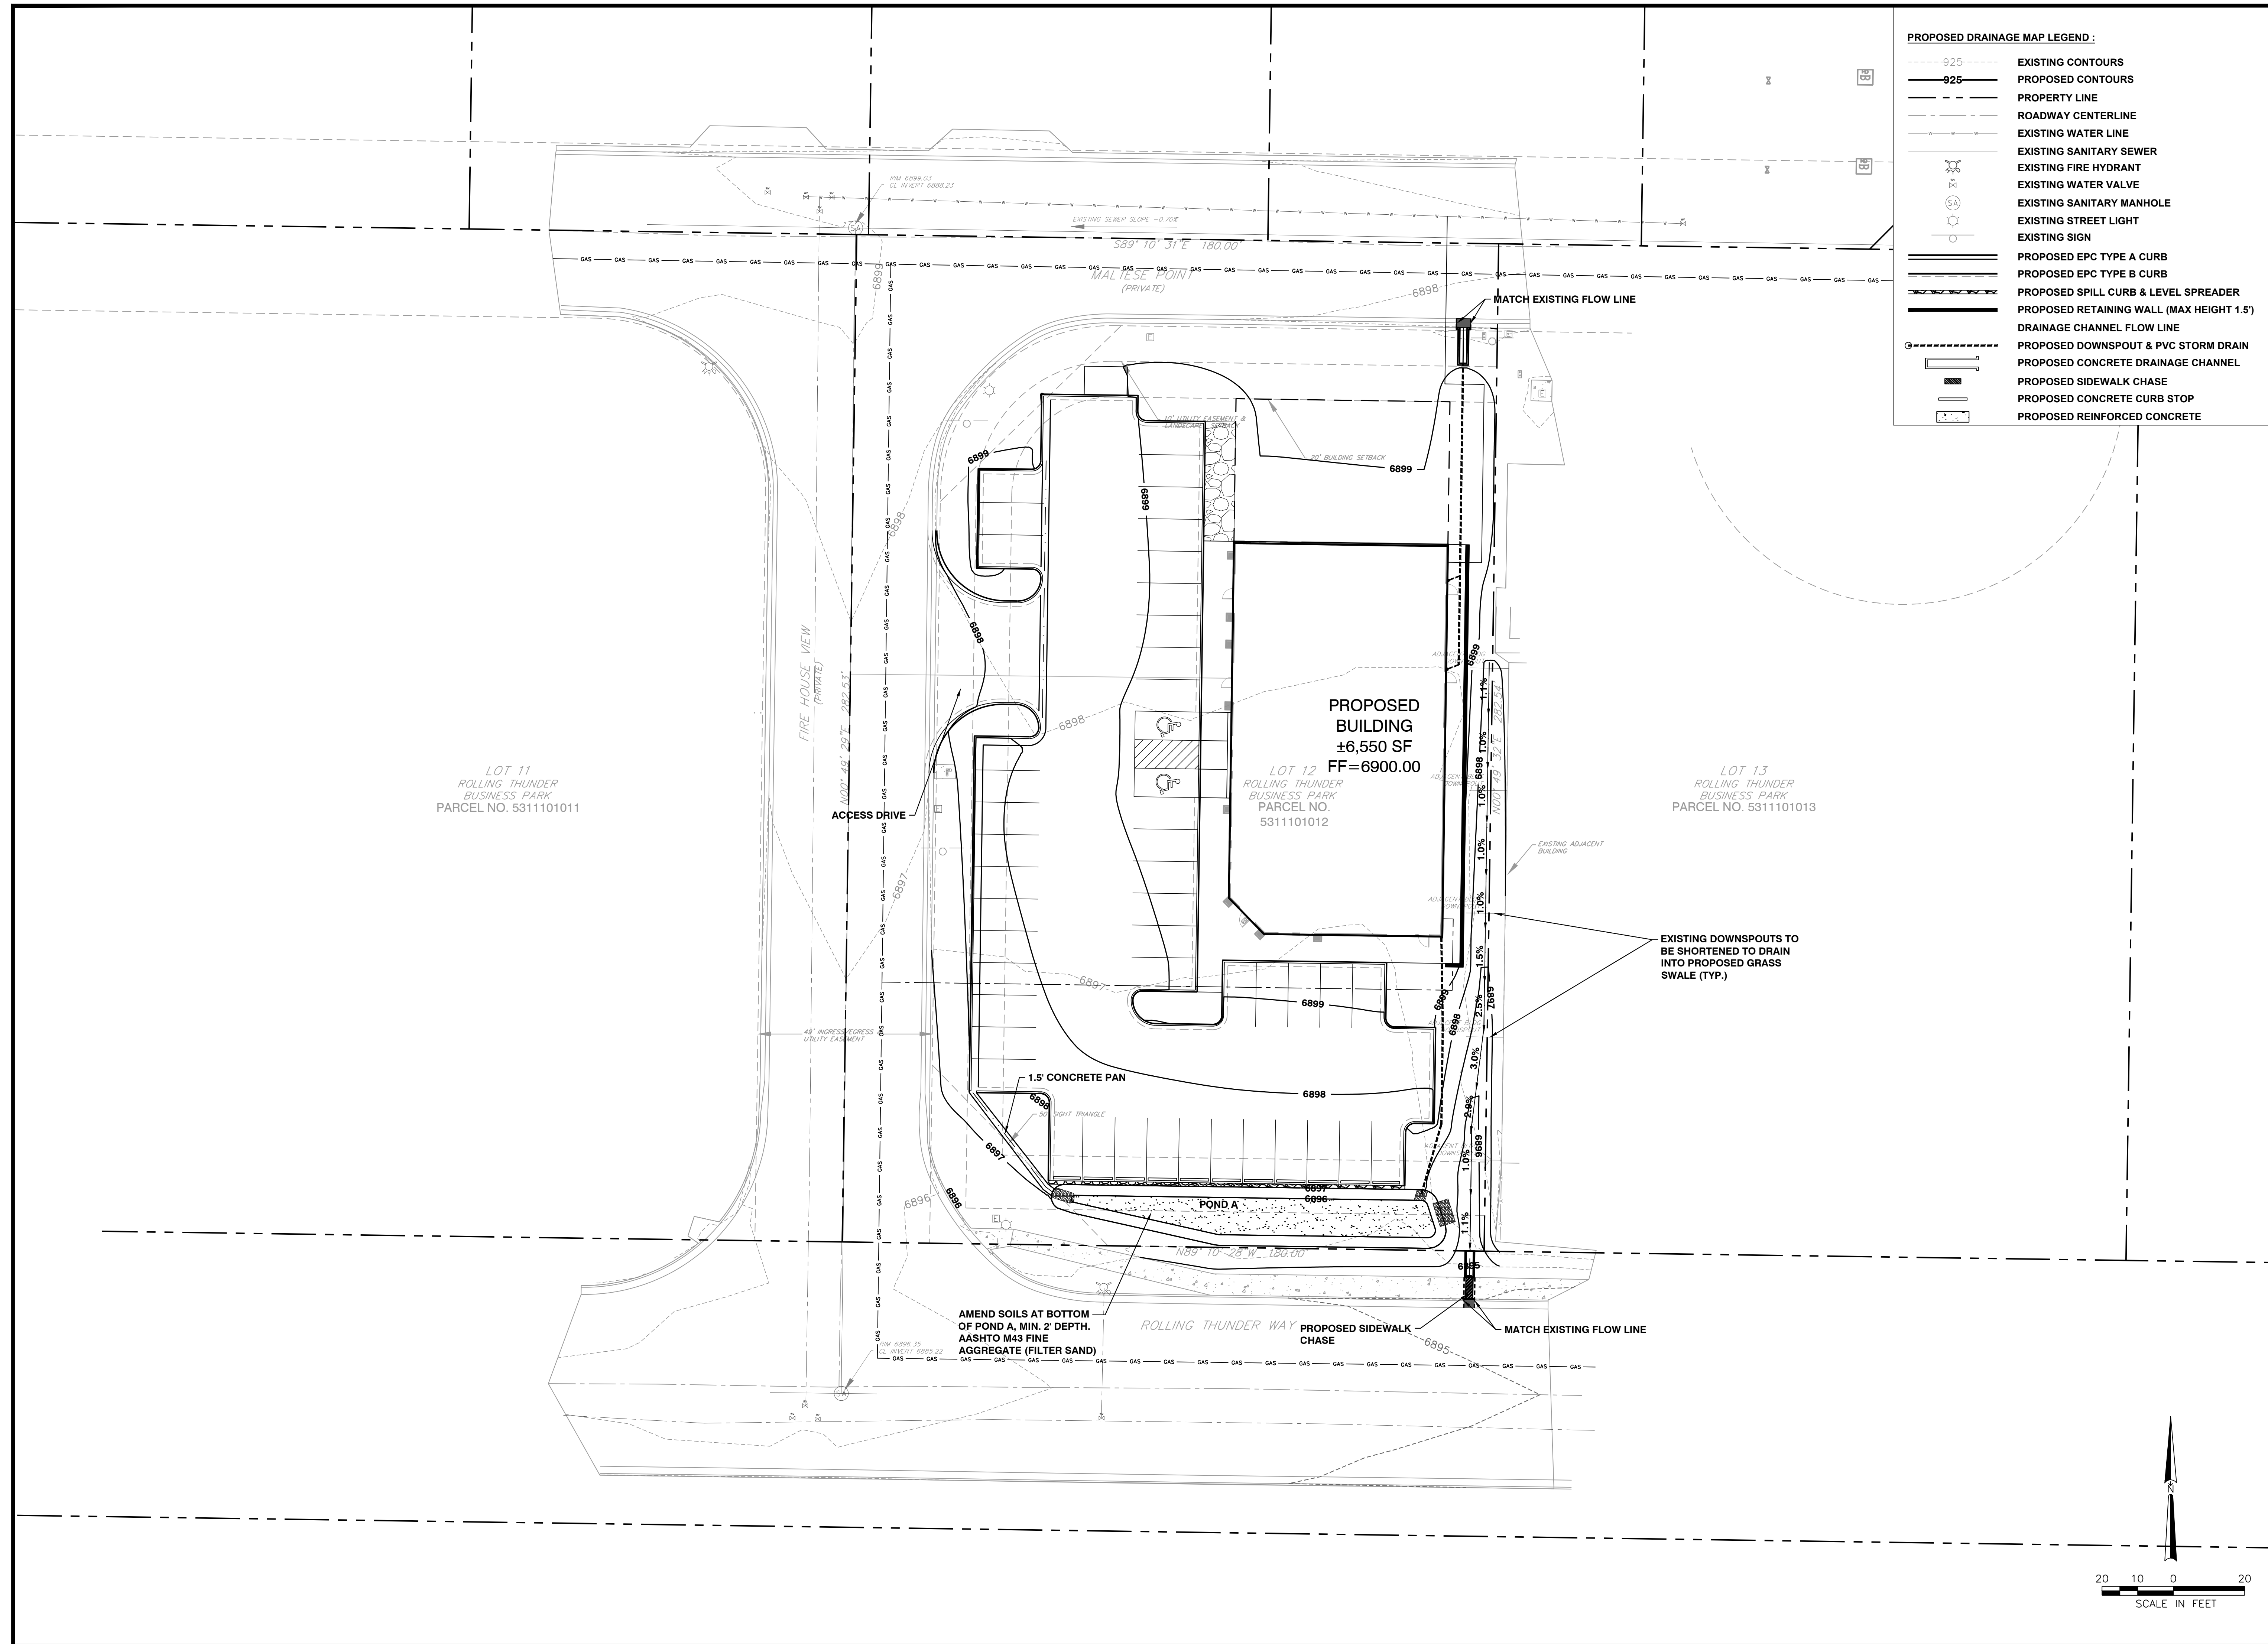
Inspection and maintenance personnel may utilize the attached stormwater facility map containing the location(s) of the access points and maintenance easements of the SQIB(s) within this development.

Inspection and maintenance personnel may utilize the attached stormwater facility map containing the location(s) of the SQIB(s) within this development.

Pond A will be located at the southern edge of Lot 12. Pond A receives stormwater via sheet flow from the parking lot flowing from north to south. Stormwater that does not get fully infiltrated

during larger storm events will overflow to a grass swale to the east and eventually to the curb & gutter of Rolling Thunder Way.
