Standard Operation Procedures
for
Inspection and Maintenance

of
Stormwater Quality Infiltration Basin(s)

**Lot 12 – Rolling Thunder Business Park
10707 Maltese Pt.
Peyton, Colorado**

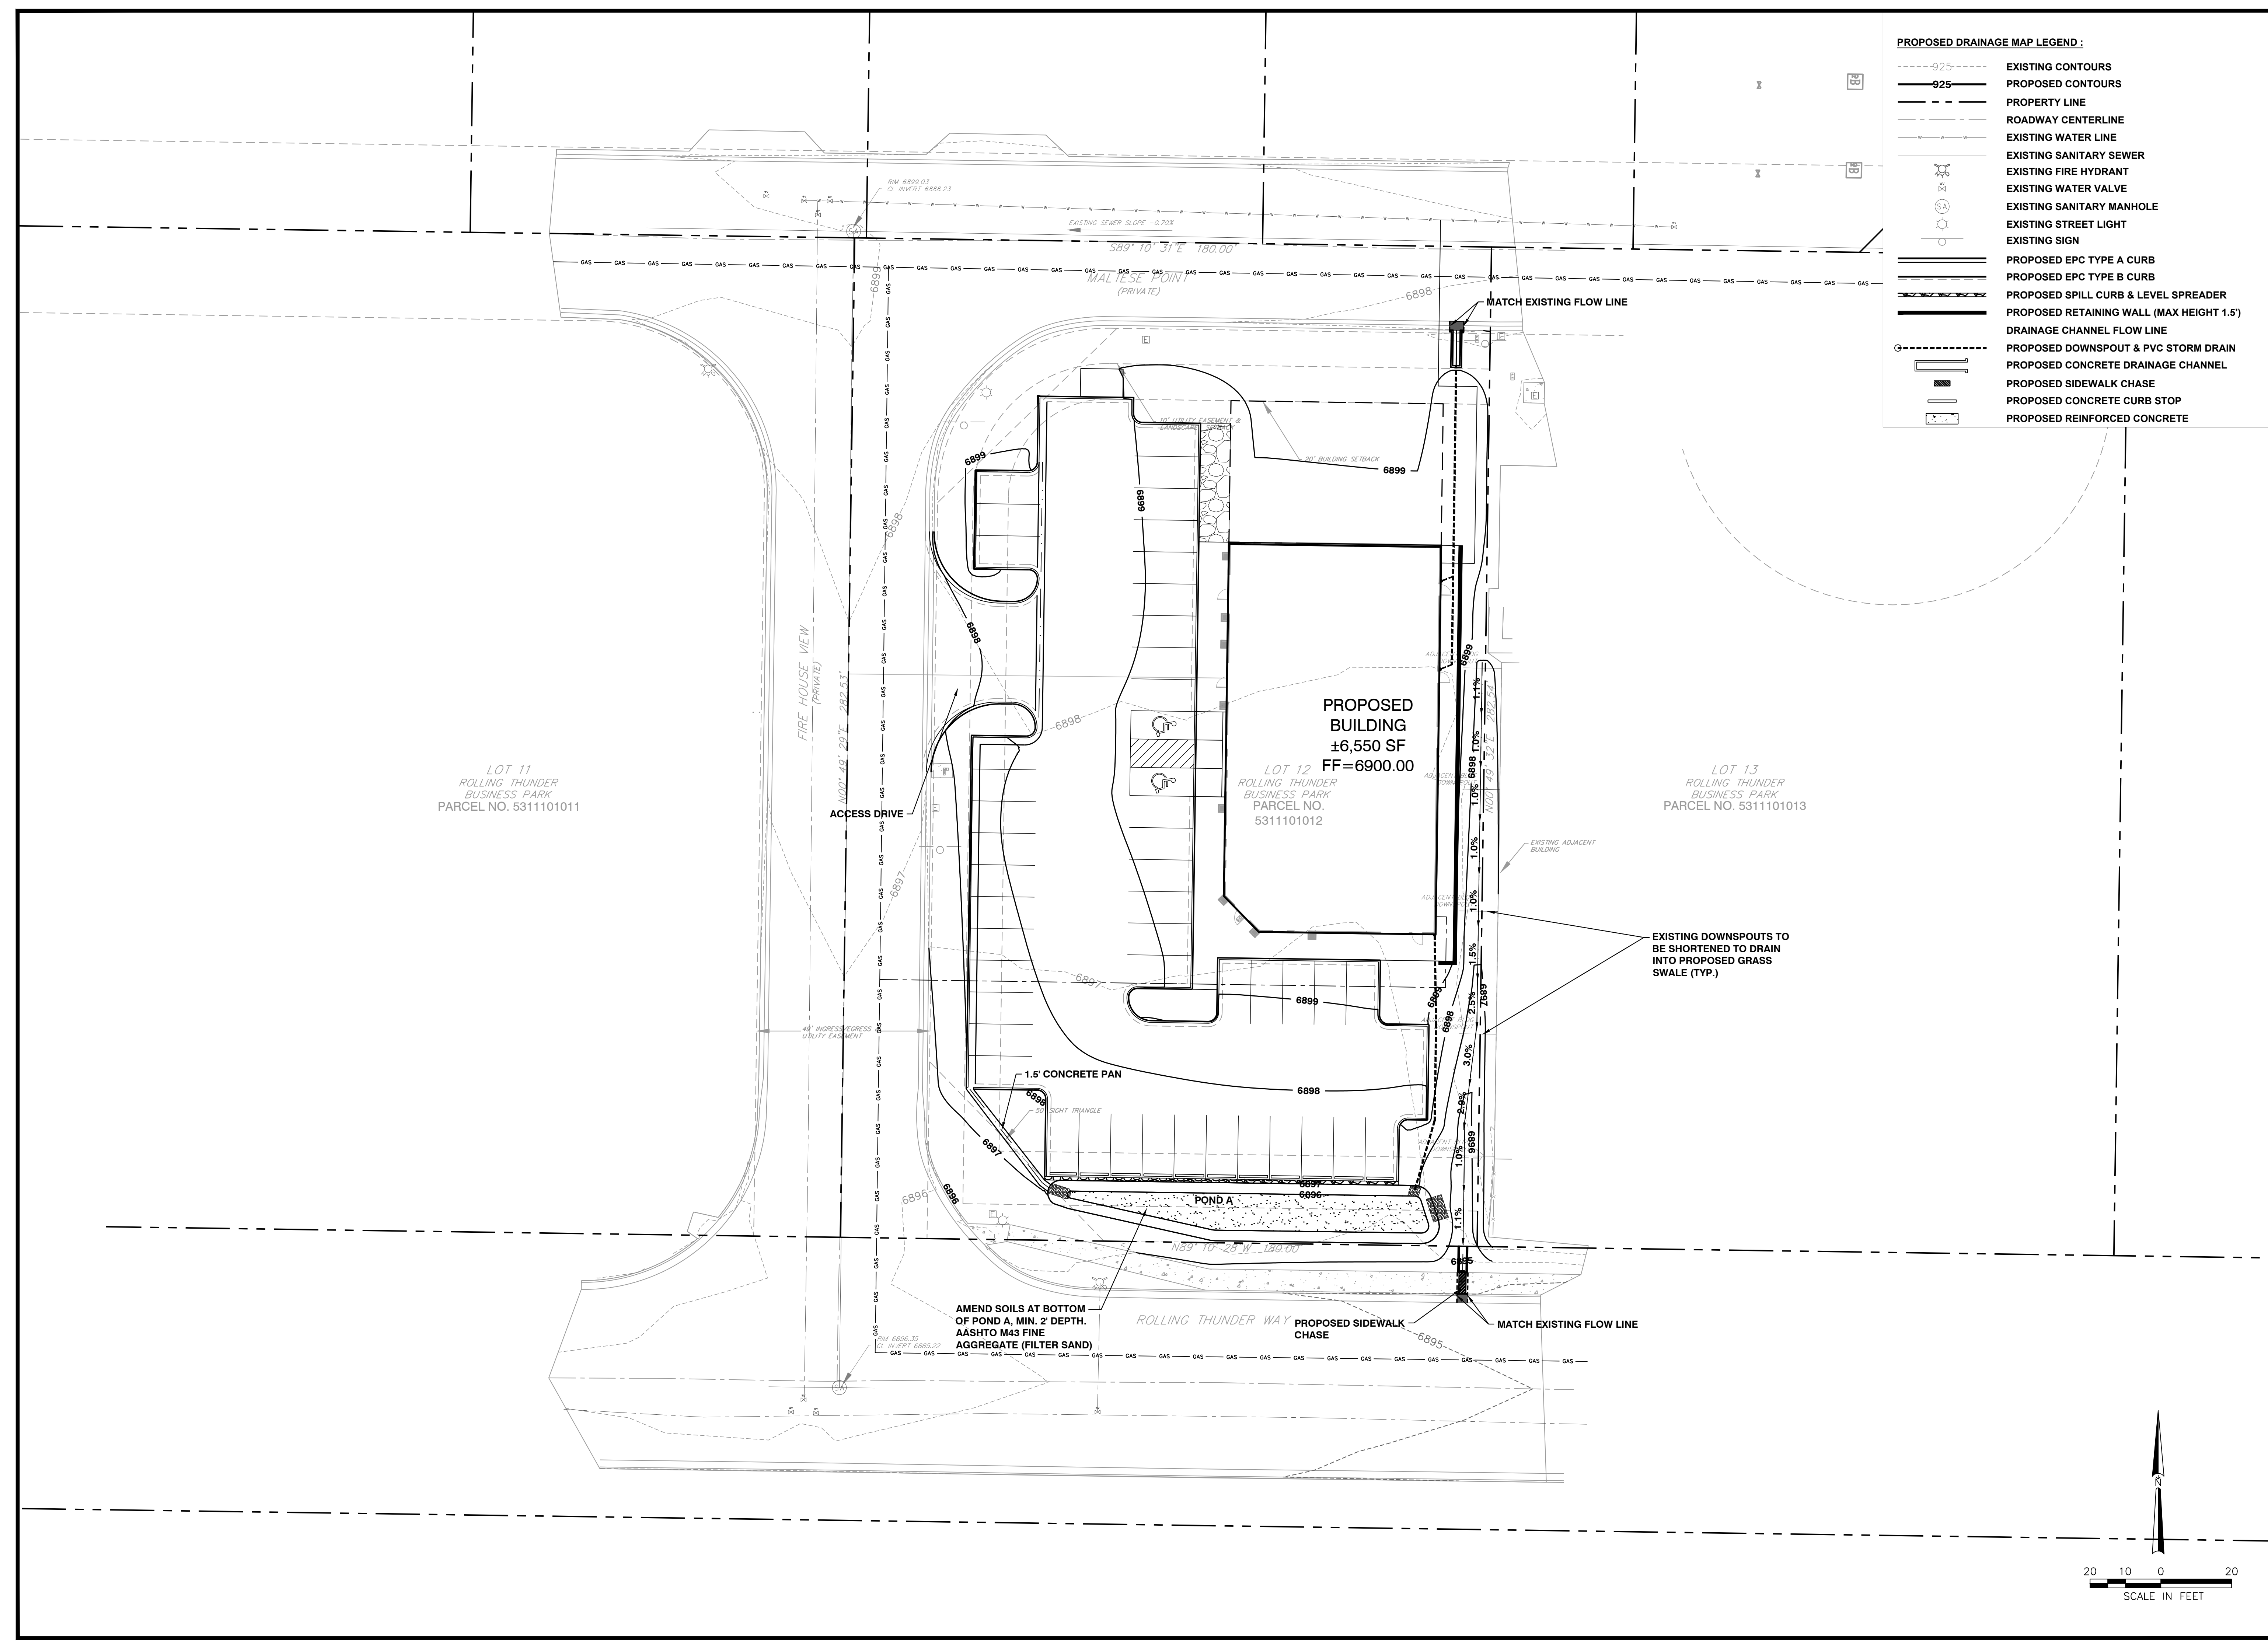
STORMWATER FACILITY MAP

Inspection and maintenance personnel may utilize the attached stormwater facility map containing the location(s) of the access points and maintenance easements of the SQIB(s) within this development.

Inspection and maintenance personnel may utilize the attached stormwater facility map containing the location(s) of the SQIB(s) within this development.

Pond A will be located at the southern edge of Lot 12. Pond A receives stormwater via sheet flow from the parking lot flowing from north to south. Stormwater that does not get fully infiltrated

during larger storm events will overflow to a grass swale to the east and eventually to the curb & gutter of Rolling Thunder Way.
