**PRIVATE DETENTION BASIN /  
STORMWATER QUALITY BEST MANAGEMENT PRACTICE  
MAINTENANCE AGREEMENT AND EASEMENT**

**EXHIBIT B**  
**Stormwater Facilities Areas**  
 Tract A, and the portions of Lots 21, 22, and 23 shown as drainage easements as indicated on the Saddlehorn Ranch Filing No. 2 Plat.

# SADDLEHORN RANCH - FILING 2

## PERMANENT BMP APPLICABILITY MAP

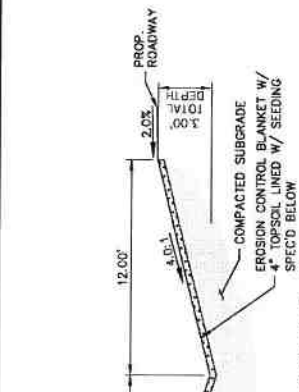
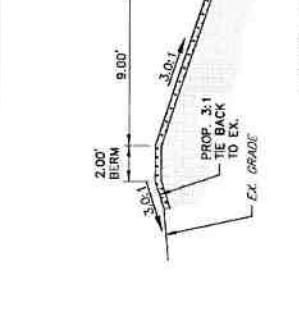
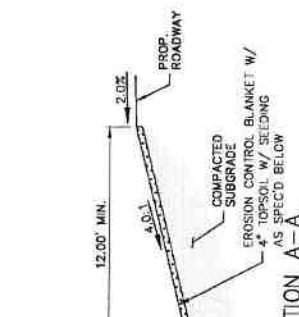
ROADSIDE SWALE NOTES  
 1. SWALE SECTION B-B TO BE USED IN ALL AREAS OF MODERN WALKS CUTTING THROUGH EXISTING SWALES.  
 2. SWALE SECTION A-A TO BE USED IN ALL AREAS OF MODERN WALKS CUTTING THROUGH EXISTING SWALES.  
 3. SWALE SECTION C-C TO BE USED IN ALL AREAS OF MODERN WALKS CUTTING THROUGH EXISTING SWALES.

SWALE SEED MIX:  
 EROSION CONTROL BLANKET WITH PANNEE BUTTES SEED INC. - "LOW GROW NATIVE MIX"  
 -SANGBERG BLUEGRASS  
 -ROCKY MOUNTAIN FESCUE  
 -BIG BLUEGRASS
