**PRIVATE DETENTION BASIN /
STORMWATER QUALITY BEST MANAGEMENT PRACTICE
MAINTENANCE AGREEMENT AND EASEMENT**

C. WHEREAS, Developer desires to plat and develop on the Property a subdivision to be known as Saddlehorn Ranch Filing No. 2; and

SADDLEHORN RANCH - FILING 2

PERMANENT BMP APPLICABILITY MAP

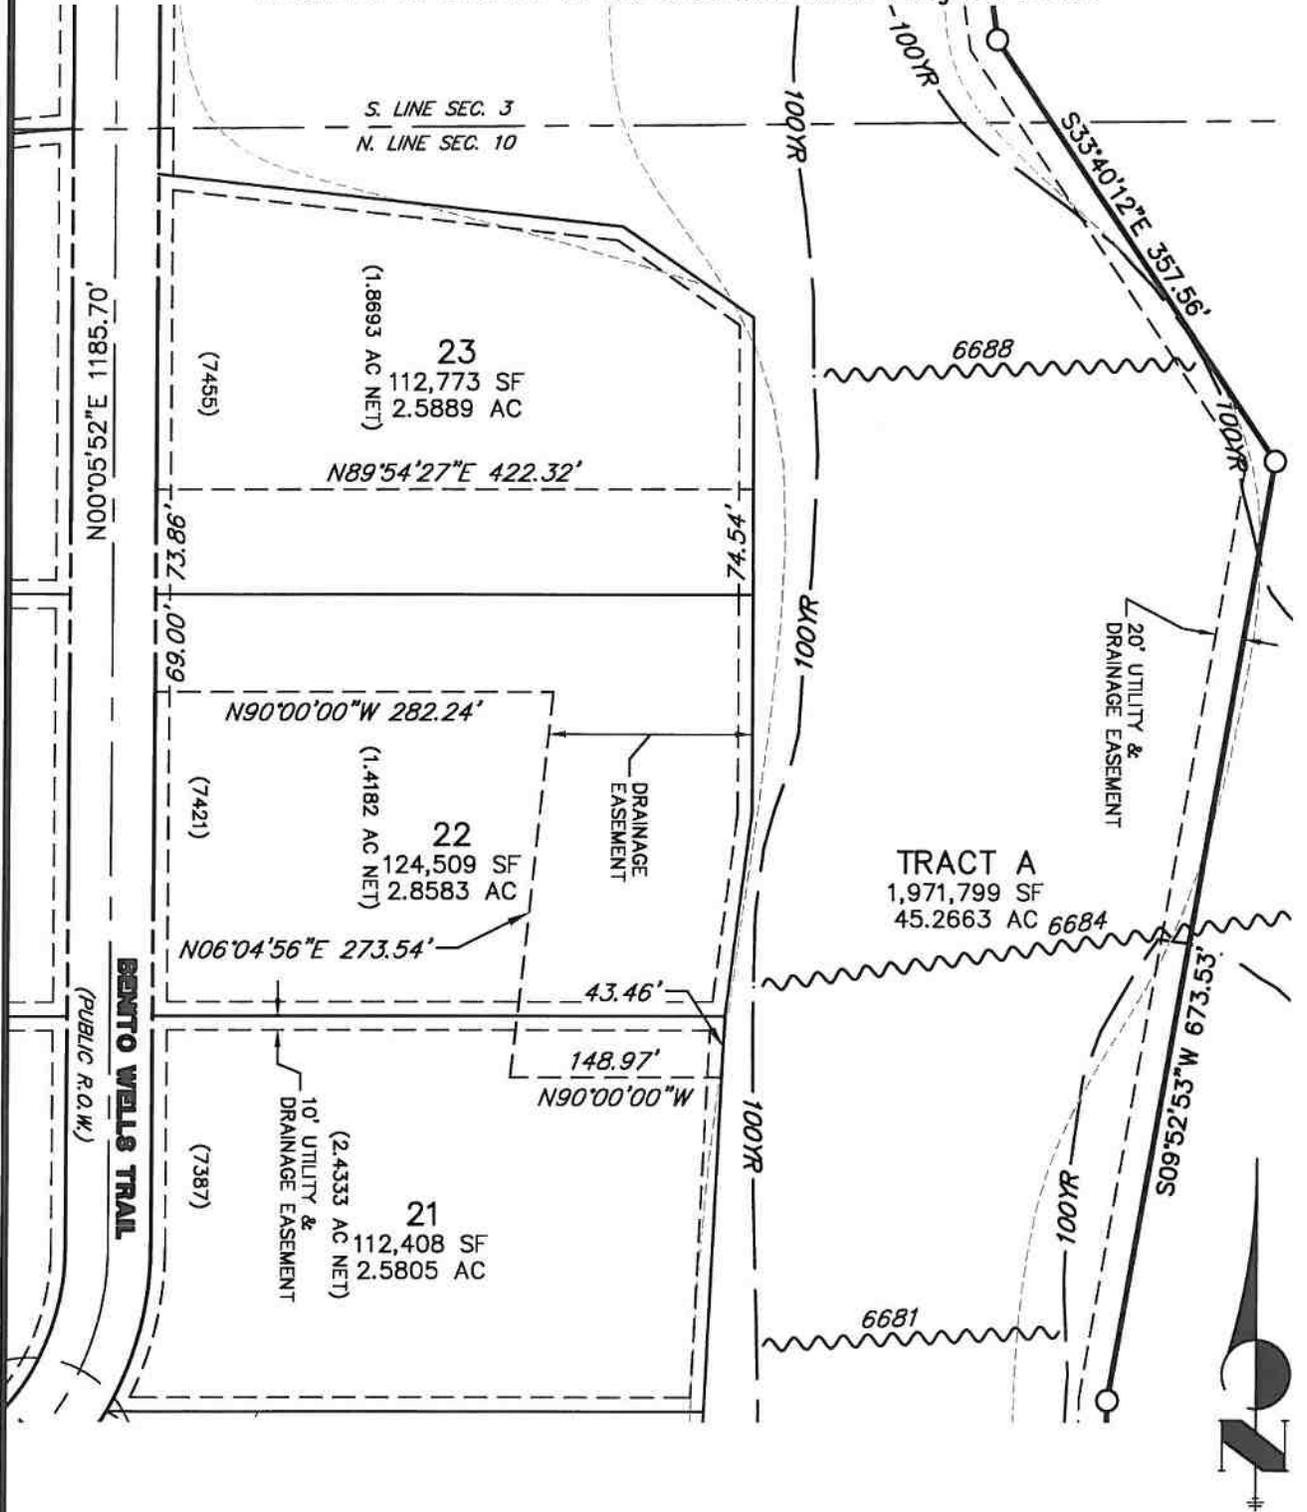
EXHIBIT B
Stormwater Facilities Areas
 Tract A, and the portions of Lots 21, 22, and 23 shown as drainage easements as indicated on the Saddlehorn Ranch Filing No. 2 Plat.
