**Stormwater Management Facility
Operation and Maintenance (O&M) Plan
Template**

Saddlehorn Ranch - Filing 2

SADDLEHORN RANCH - FILING 2
GRASS SWALE AND FACILITIES PLAN

SADDLEHORN RANCH -
FILING 2
POND F GRADING PLAN

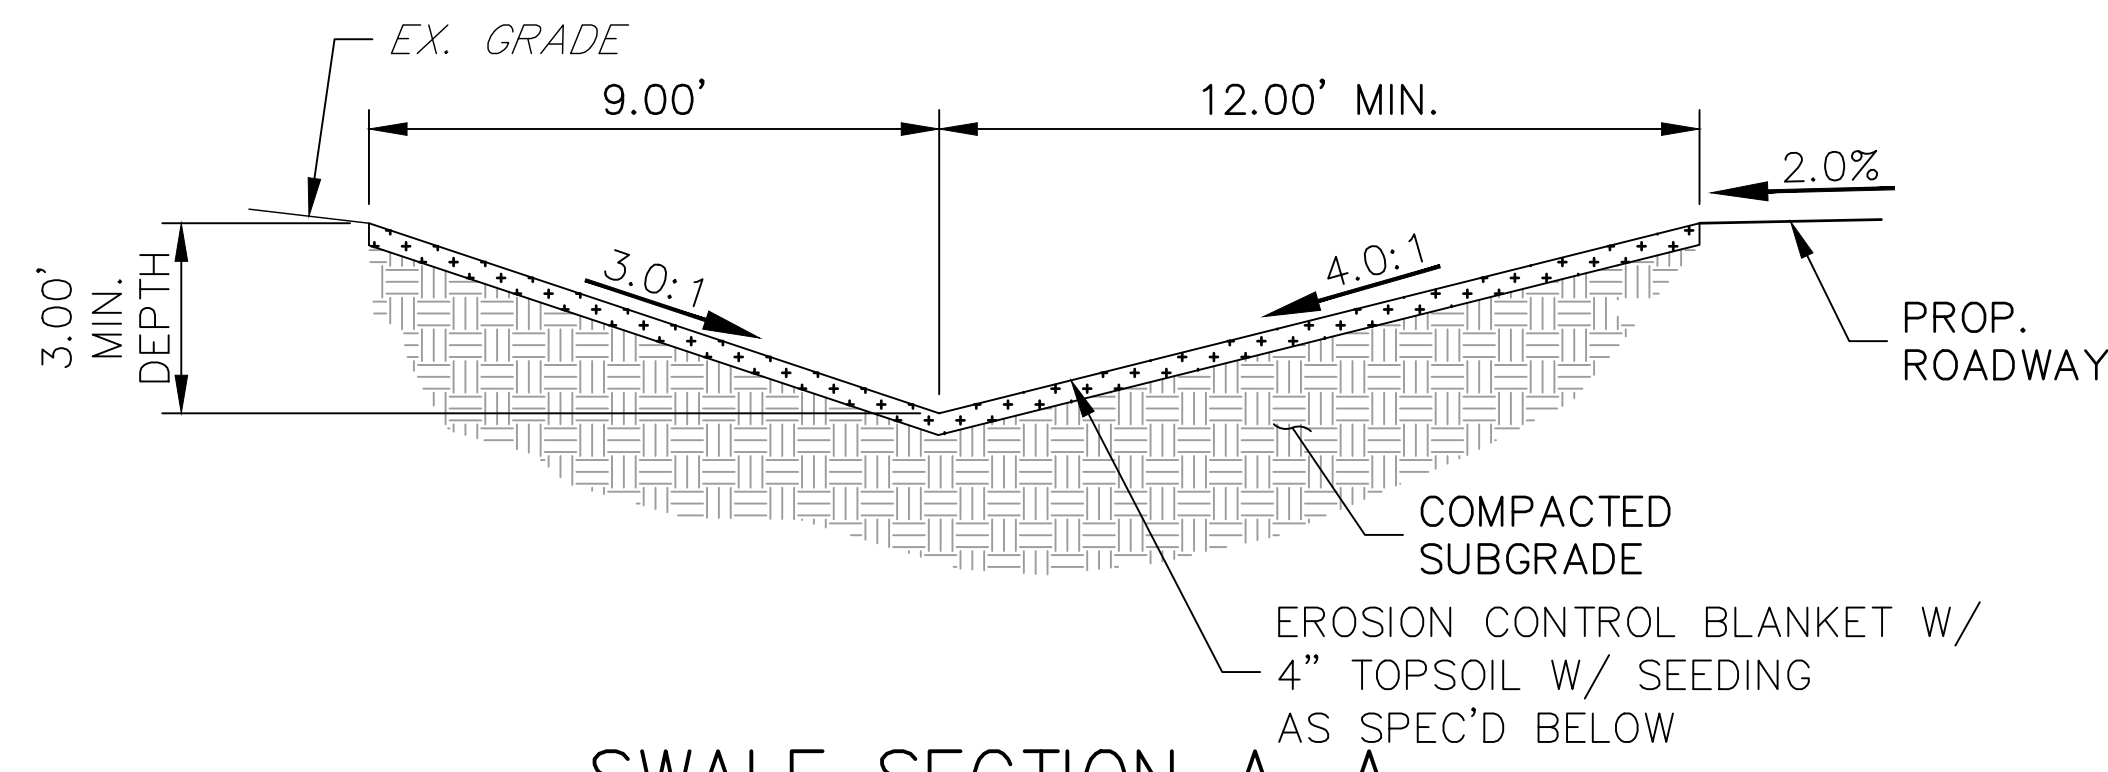
SWALE SECTION A-A
SCALE: 1"=5'

SWALE SEED MIX:
EROSION CONTROL BLANKET WITH PAWNEE BUTTES SEED INC. – "LOW GROW NATIVE MIX"
-IDAHO FESCUE
-SANDBERG BLUEGRASS
-ROCKY MOUNTAIN FESCUE
-BIG BLUEGRASS

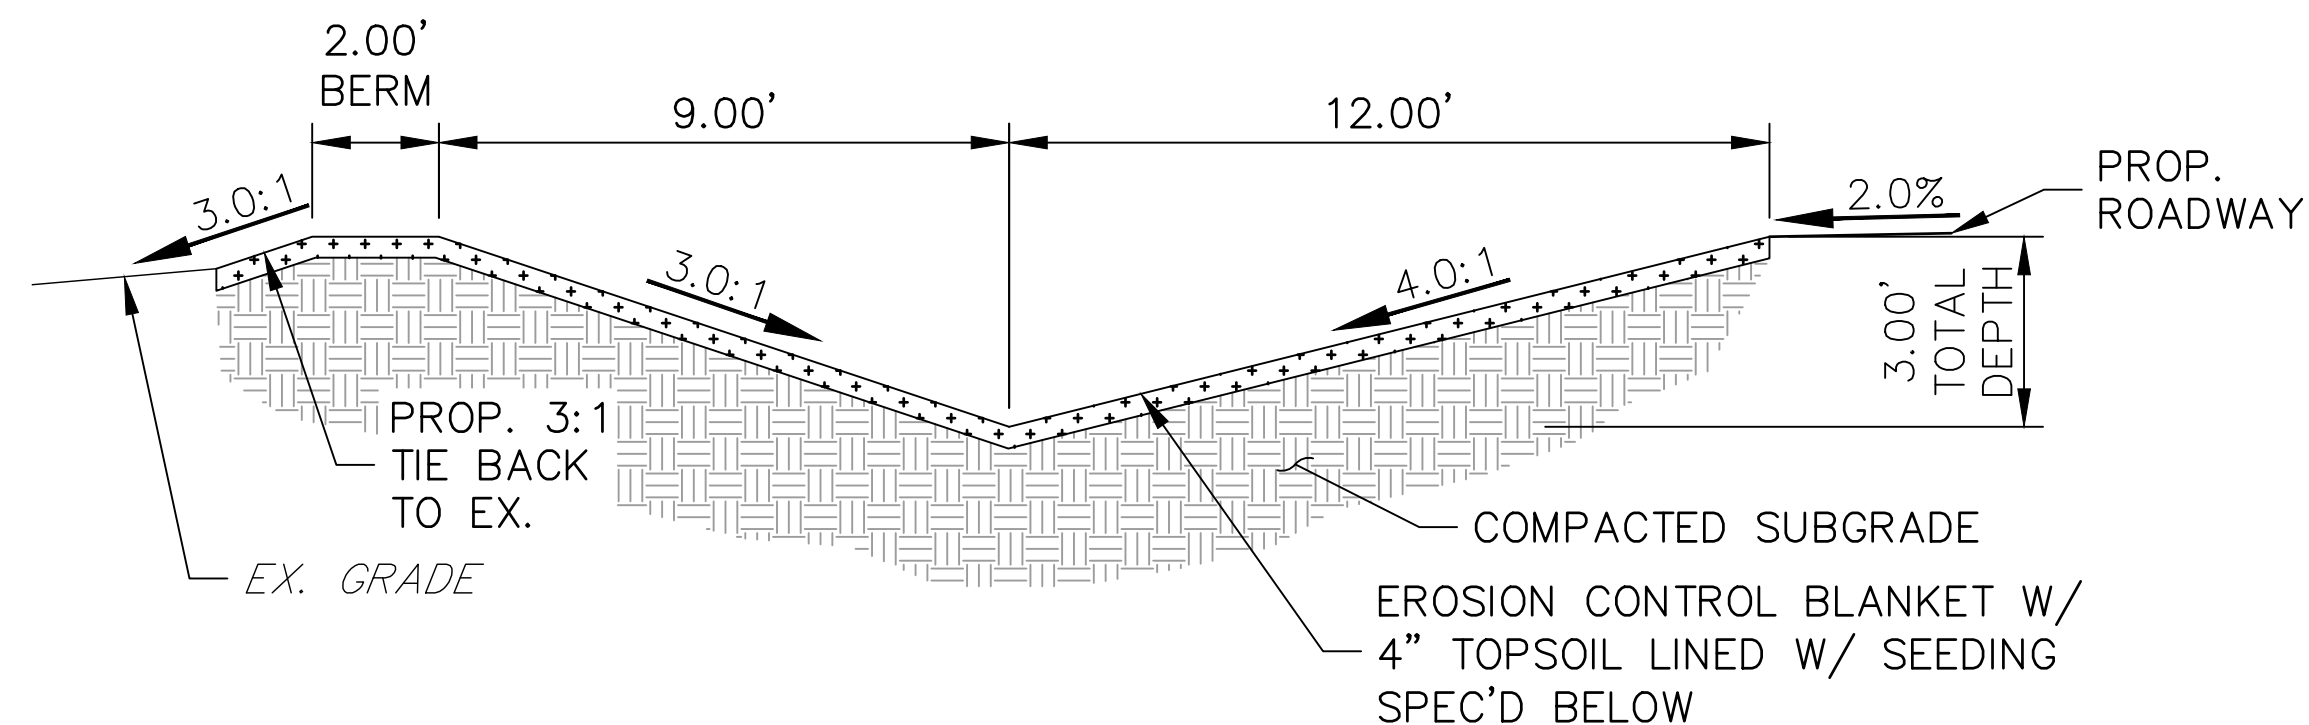
SWALE SECTION B-B
SCALE: 1"=5'

SWALE SEED MIX:
EROSION CONTROL BLANKET WITH PAWNEE BUTTES SEED INC. – "LOW GROW NATIVE MIX"
-IDAHO FESCUE
-SANDBERG BLUEGRASS
-ROCKY MOUNTAIN FESCUE
-BIG BLUEGRASS
