**PRIVATE DETENTION BASIN /  
STORMWATER QUALITY BEST MANAGEMENT PRACTICE  
MAINTENANCE AGREEMENT AND EASEMENT**

C. WHEREAS, Developer desires to plat and develop on the Property a subdivision to be known as Saddlehorn Ranch Filing No. 2; and

# SADDLEHORN RANCH - FILING 2

## PERMANENT BMP APPLICABILITY MAP

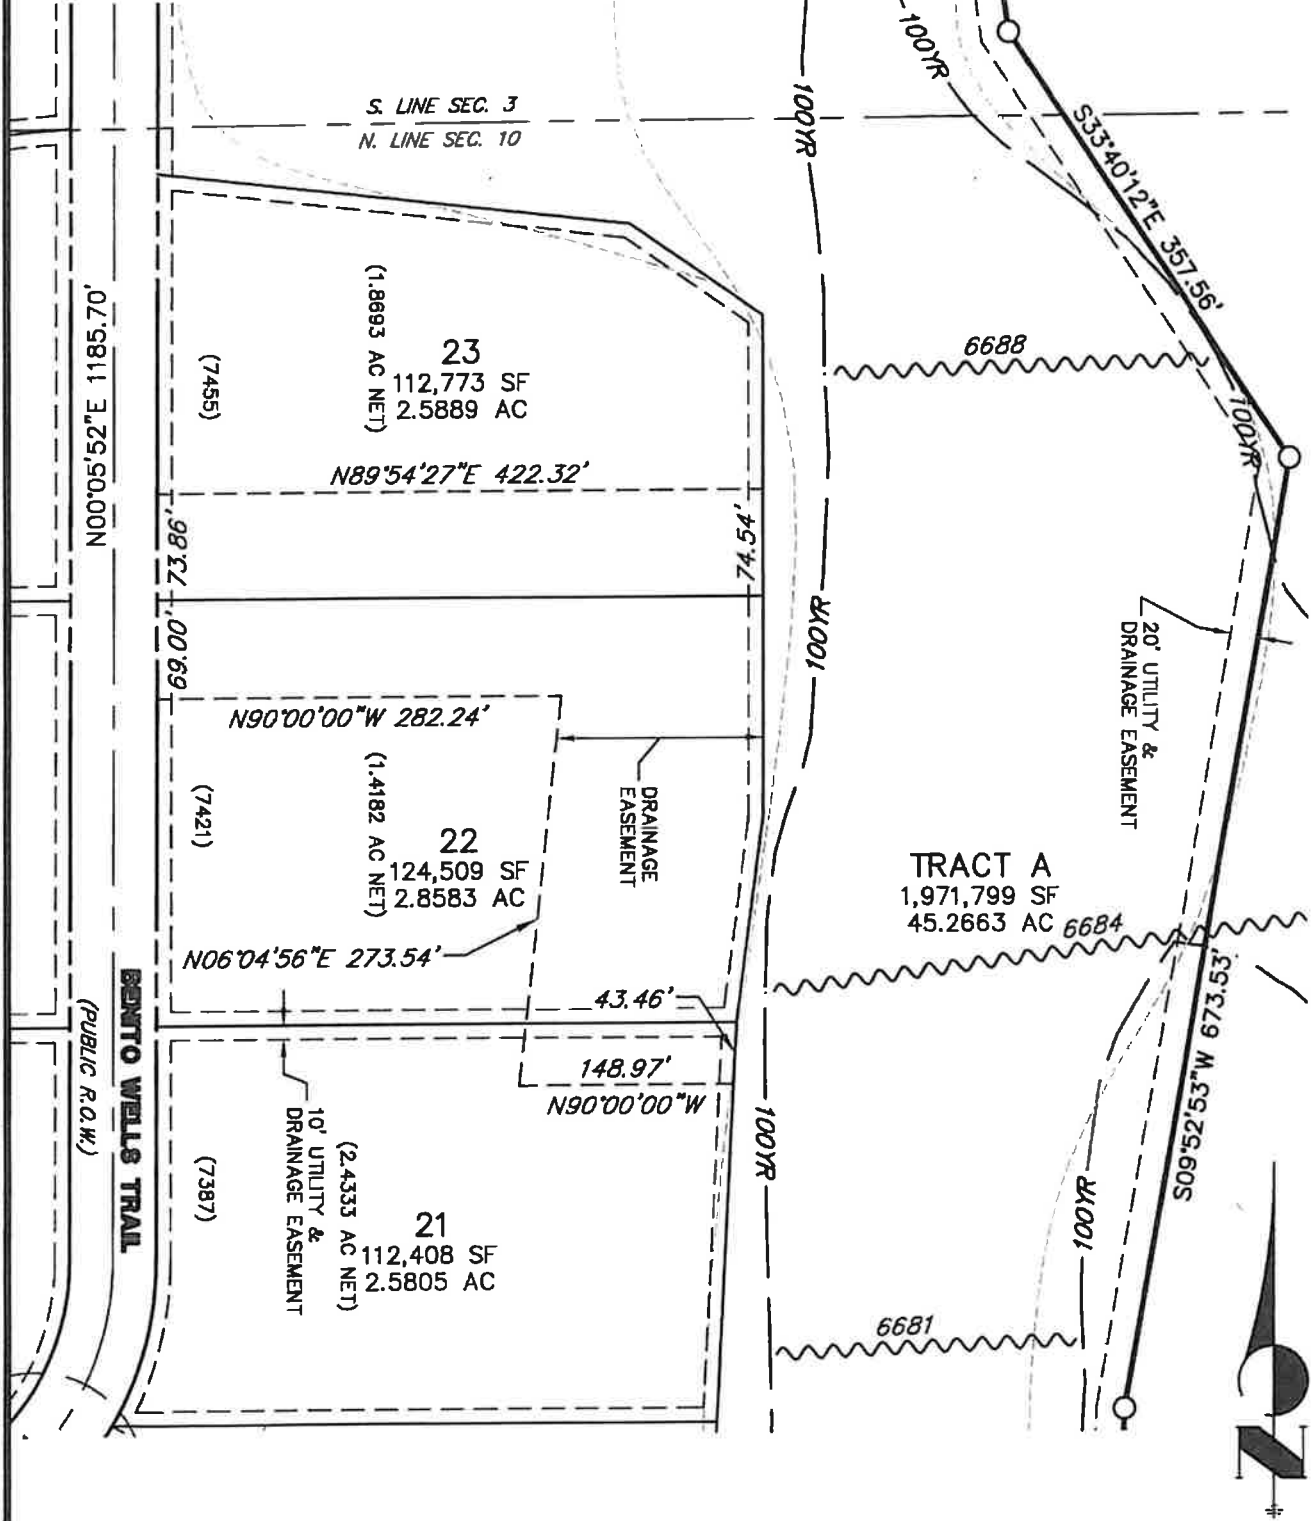
**EXHIBIT B**  
**Stormwater Facilities Areas**  
 Tract A, and the portions of Lots 21, 22, and 23 shown as drainage easements as indicated on the Saddlehorn Ranch Filing No. 2 Plat.

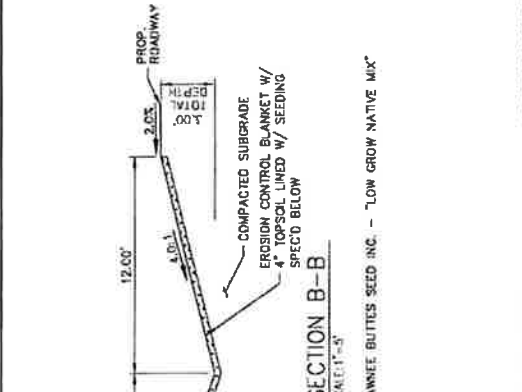
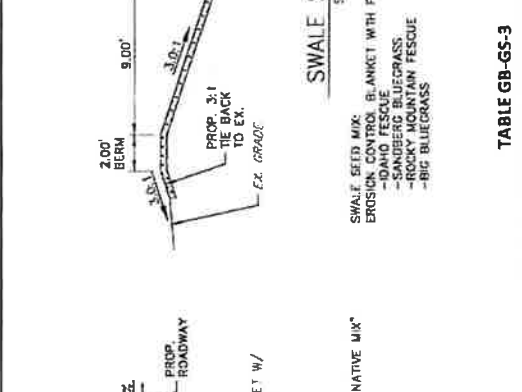
**ROADSIDE SWALE NOTES**  
 1. SWALE SHALL BE 3.00' DEEP WITH 3:1 SLOPE TO 12.00' TOTAL WIDTH. TOPSOIL SHALL BE 4\"/>

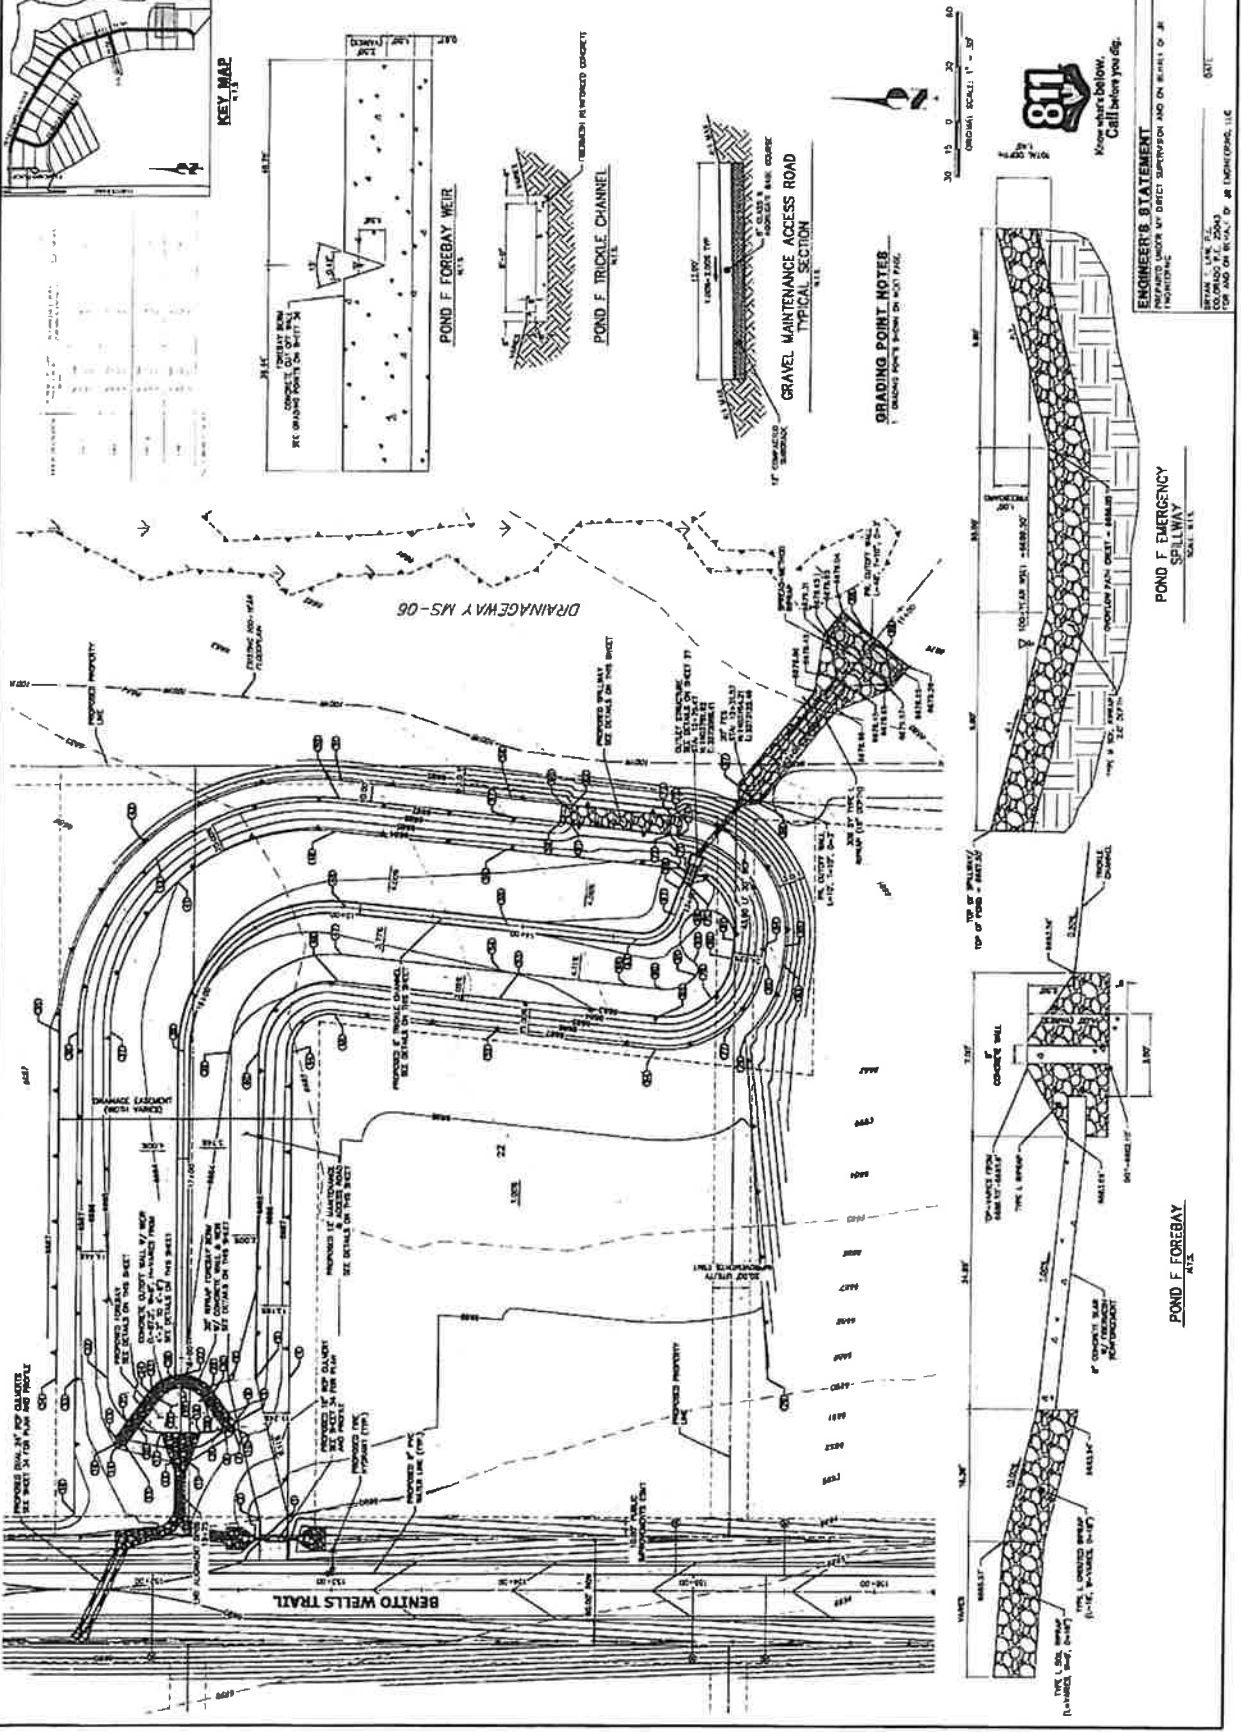
OWNER: RPI PROPERTY GROUP, LLC  
 PROJECT: SADDLEHORN RANCH - POND F GRADING PLAN - FILING 2  
 DATE: 01/11/21  
 SHEET NO. 23142.04 OF 40

POND F EMERGENCY SPILLWAY  
 SCALE: 1" = 20'

POND F FOREBAY  
 SCALE: 1" = 20'
