Stormwater Management Facility Operation and Maintenance (O&M) Plan Template

Saddlehorn Ranch - Filing 2

**Stormwater Management Facility
Inspection and Maintenance (I&M) Plan**

SADDLEHORN RANCH
FILING 2
GRASS SWALE AND
FACILITIES PLAN

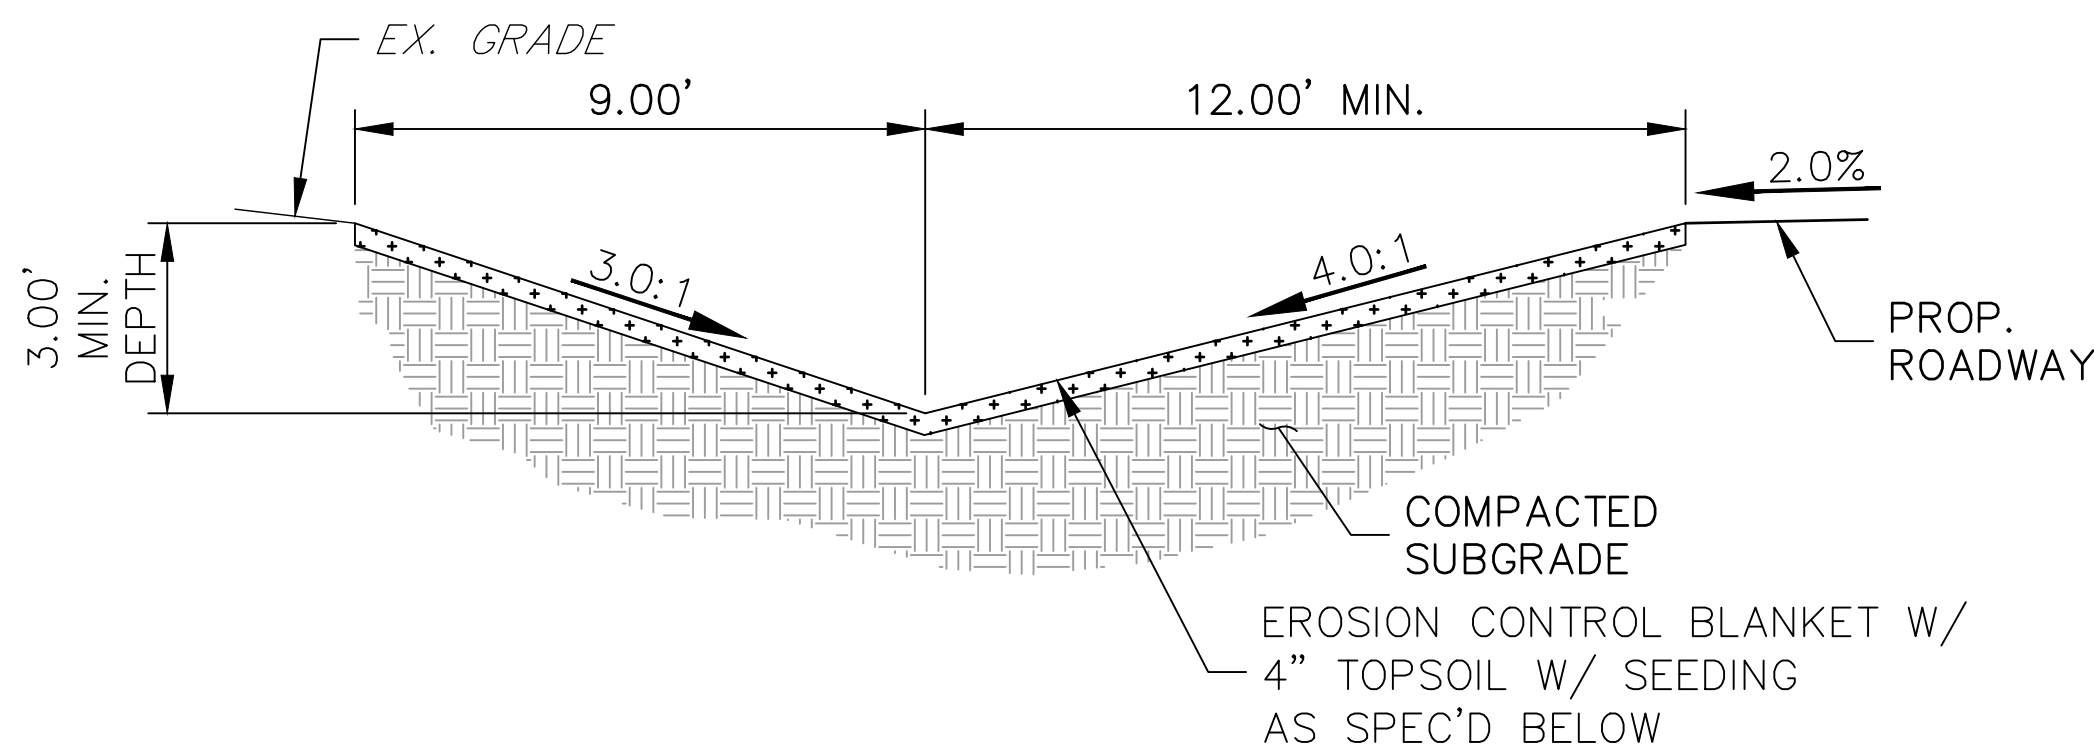
SWALE SECTION A-A

SCALE: 1"=5'

SWALE SEED MIX:
EROSION CONTROL BLANKET WITH PAWNEE BUTTES SEED INC. – "LOW GROW NATIVE MIX"
–IDAHO FESCUE
–SANDBERG BLUEGRASS
–ROCKY MOUNTAIN FESCUE
–BIG BLUEGRASS

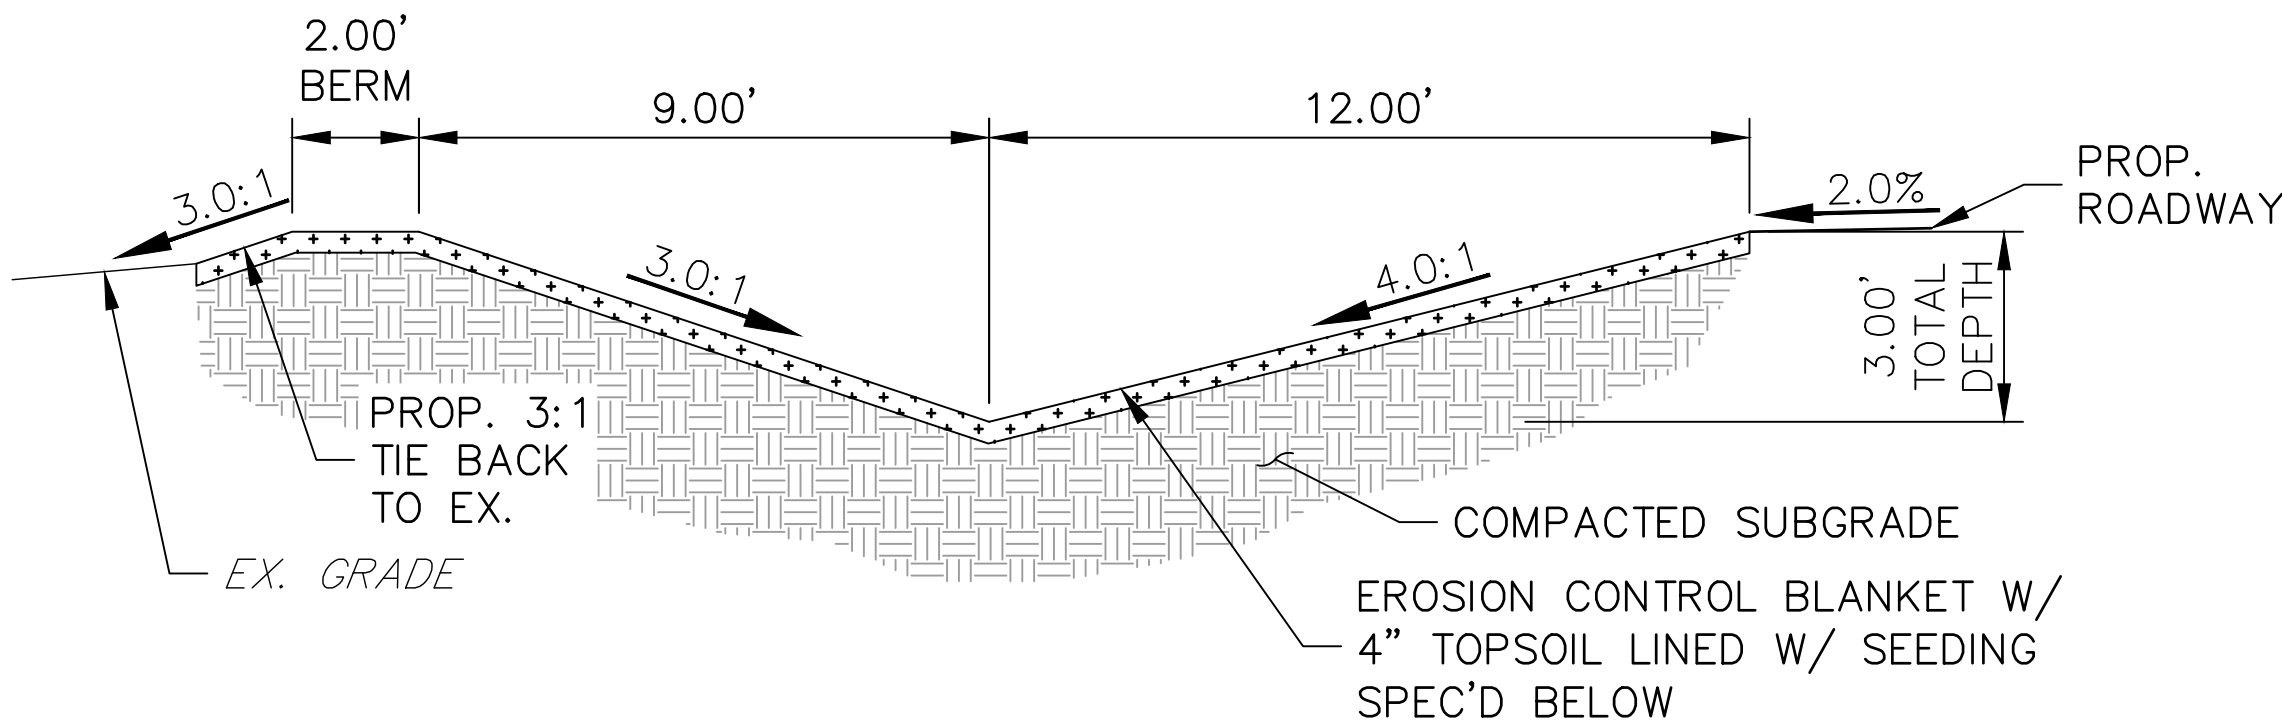
SWALE SECTION B-B

SCALE: 1"=5'
