ENTECH
ENGINEERING, INC.

**SOIL, GEOLOGY, AND GEOLOGIC HAZARD STUDY
THE RETREAT AT TIMBER RIDGE
VOLLMER ROAD AND ARROYA LANE
EL PASO COUNTY, COLORADO**

April 12, 2017

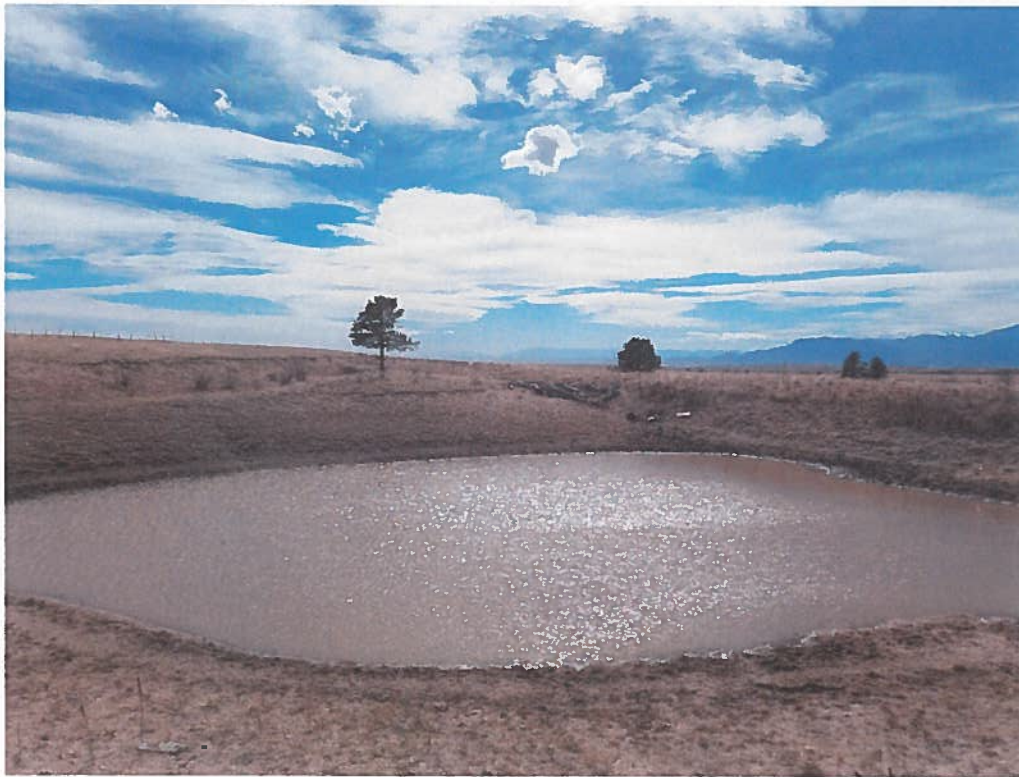
Looking southwest from the eastern portion of the site at the existing pond.

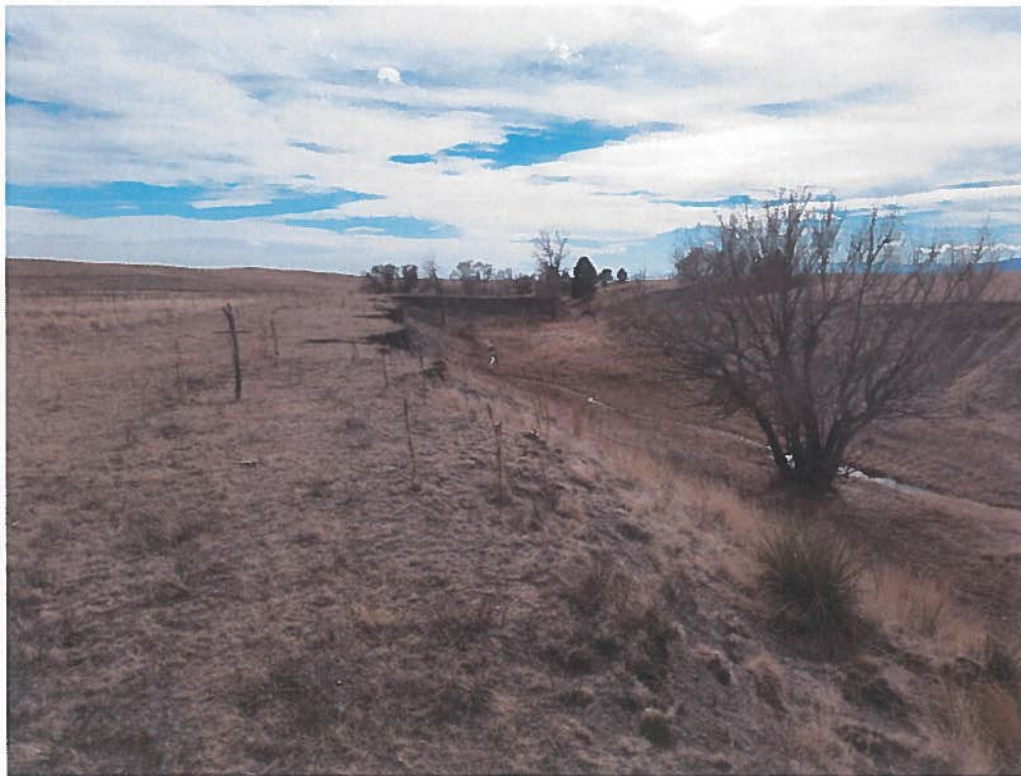
**Looking south along
Sand Creek from the
central portion of the
site.**

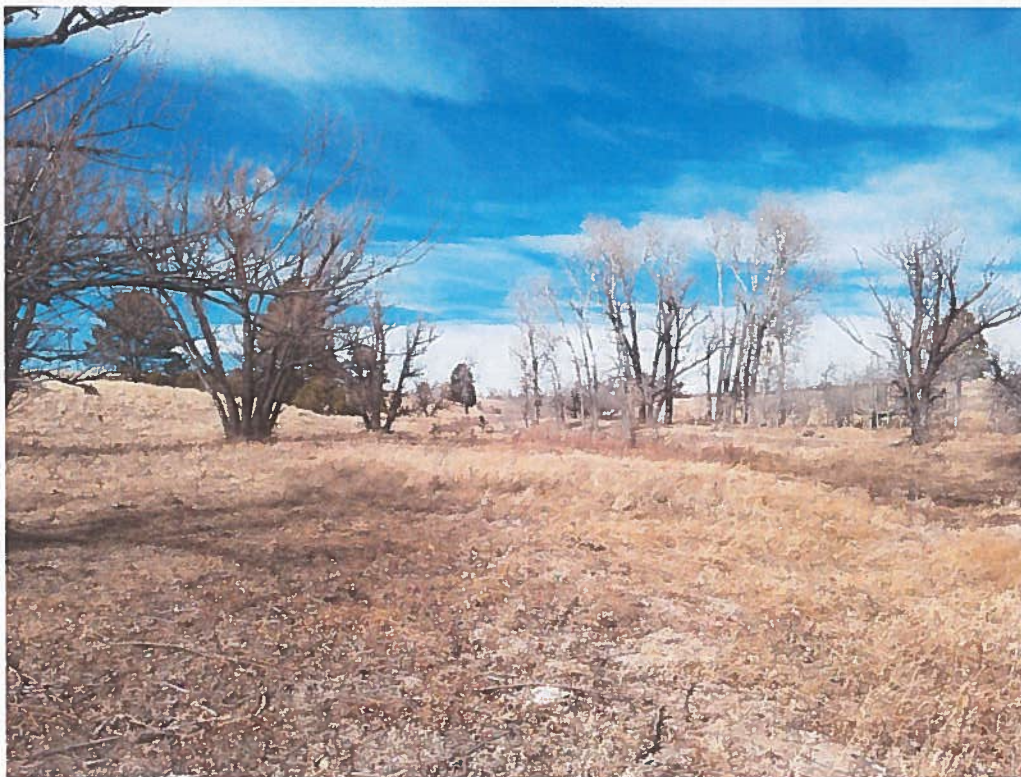
**Looking north from the
southern portion of the
site along Sand Creek.**

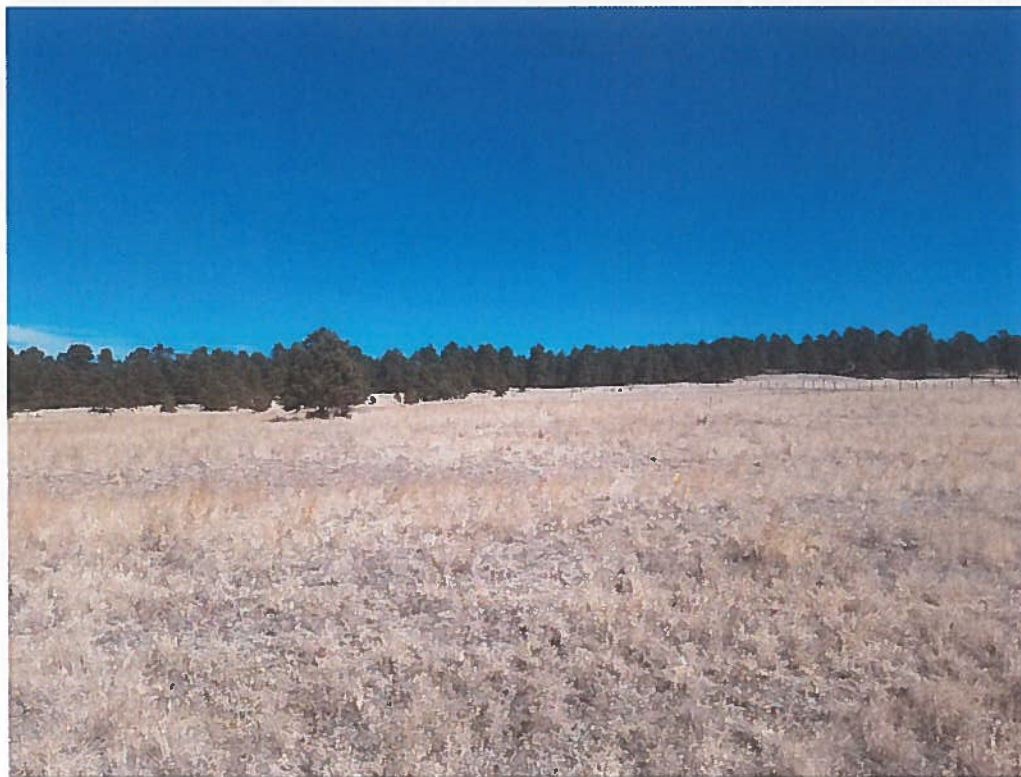
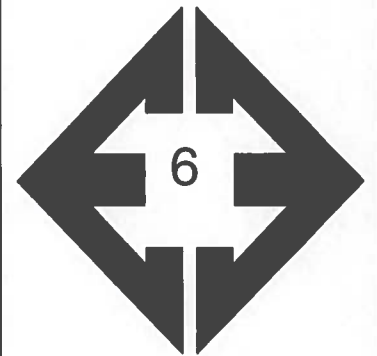
**Looking east from the
area of Profile Hole No.
2.**

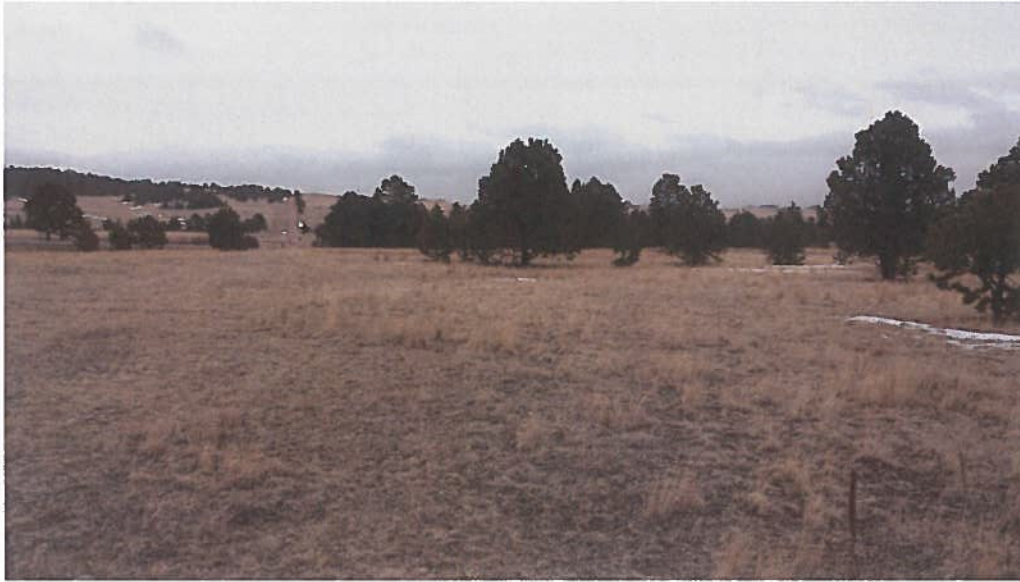
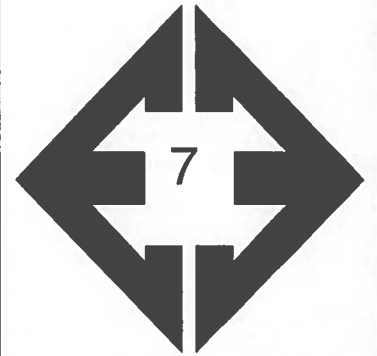
**Looking north from the
southeast portion of
the site.**

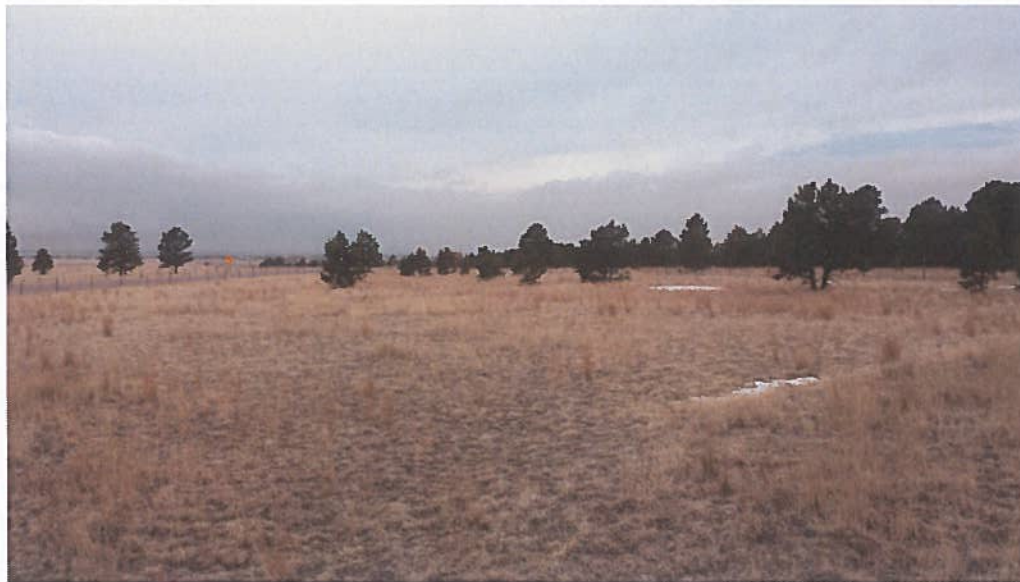
**Looking east from the
northwestern portion
of the western lots
towards Arroya Lane.**
