ENTECH
ENGINEERING, INC.

**SOILS AND GEOLOGY STUDY
OVERLOOK AT HOMESTEAD – FILING NO. 1
ELBERT ROAD
EL PASO COUNTY, COLORADO**

June 7, 2024

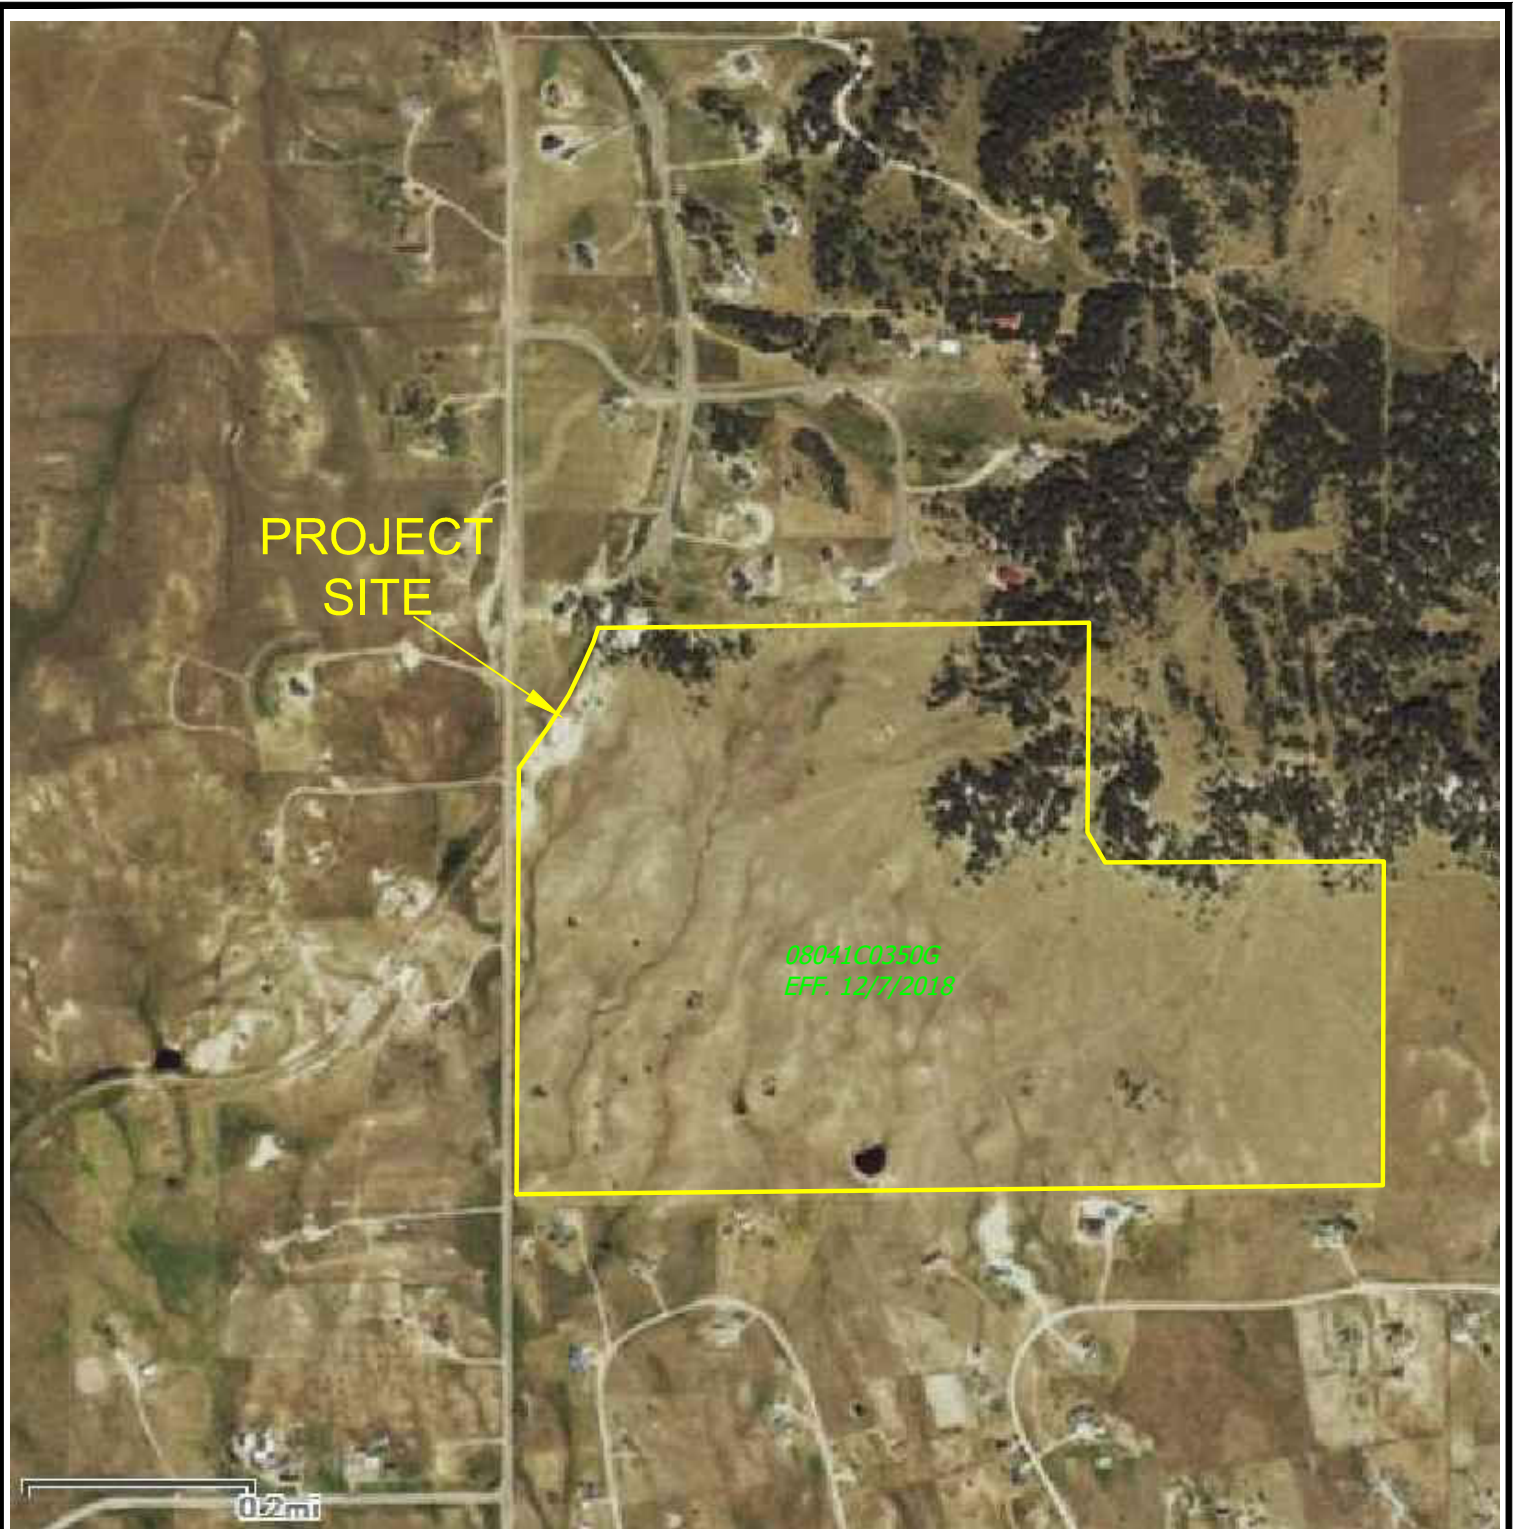
FEMA FLOODPLAIN MAP
OVERLOOK AT HOMESTEAD, FILING NO. 1
PT OVERLOOK, LLC

Areas of seasonal shallow and potential seasonally shallow groundwater were observed on site. These areas will likely be avoided due to the proposed lot sizes. Drains may be necessary for structures adjacent to these areas to help prevent the intrusion of water into areas below grade. Basements should be feasible across the majority of the site, however, lot specific subsurface soil investigations will be required. Typical drain details are presented in Figures 10 through 12. The site does not lie within any floodplain zones according to the FEMA Map No. 08041CO350G, dated December 7, 2018 (Figure 8, Reference 9). **Exact locations of floodplain and specific drainage studies are beyond the scope of this report.**

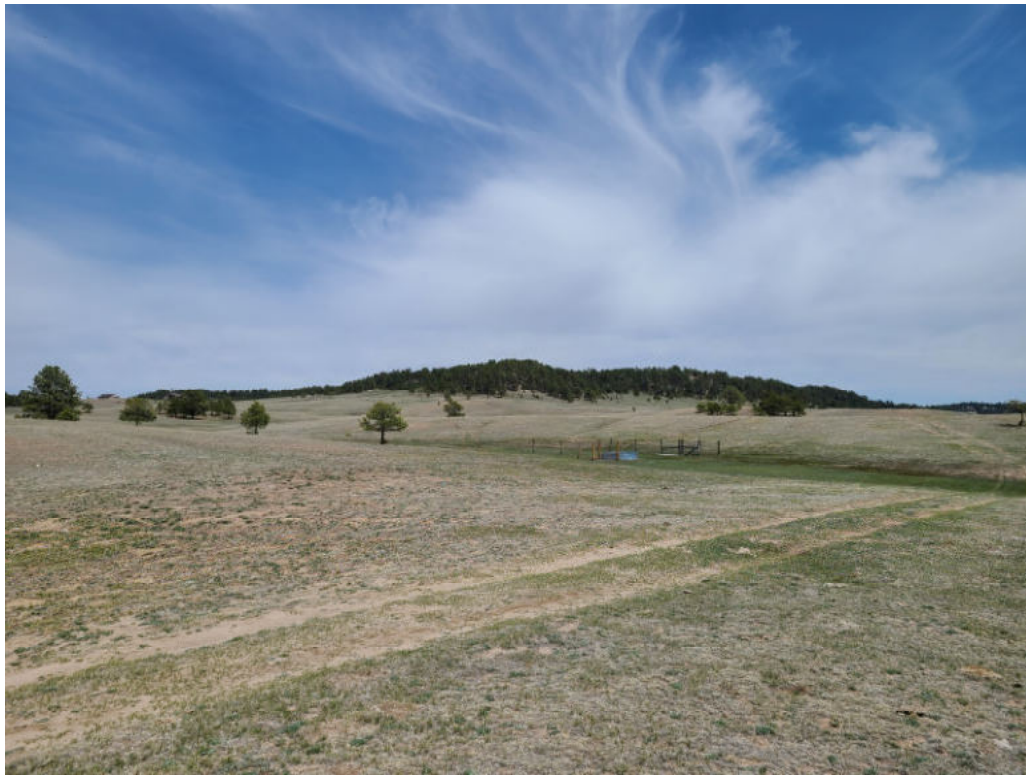
**Looking northeast
from the southwestern
side of the site.**

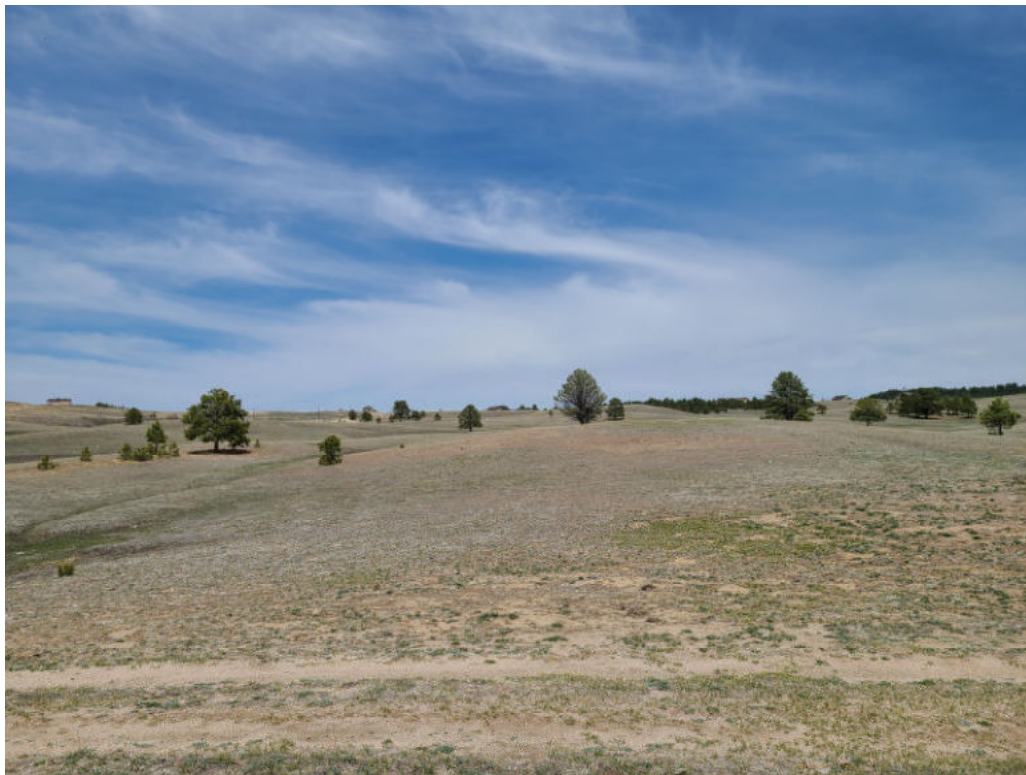
**Looking north from the
southwestern side of
the site.**

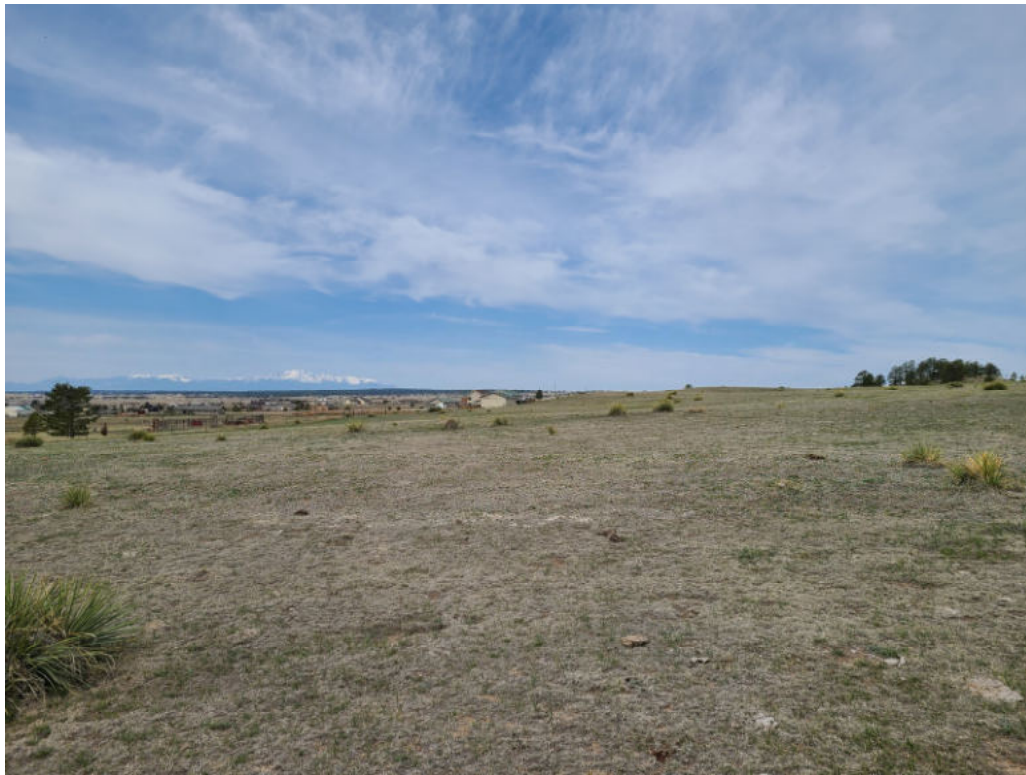
**Looking west from the
southeast corner of
the site.**

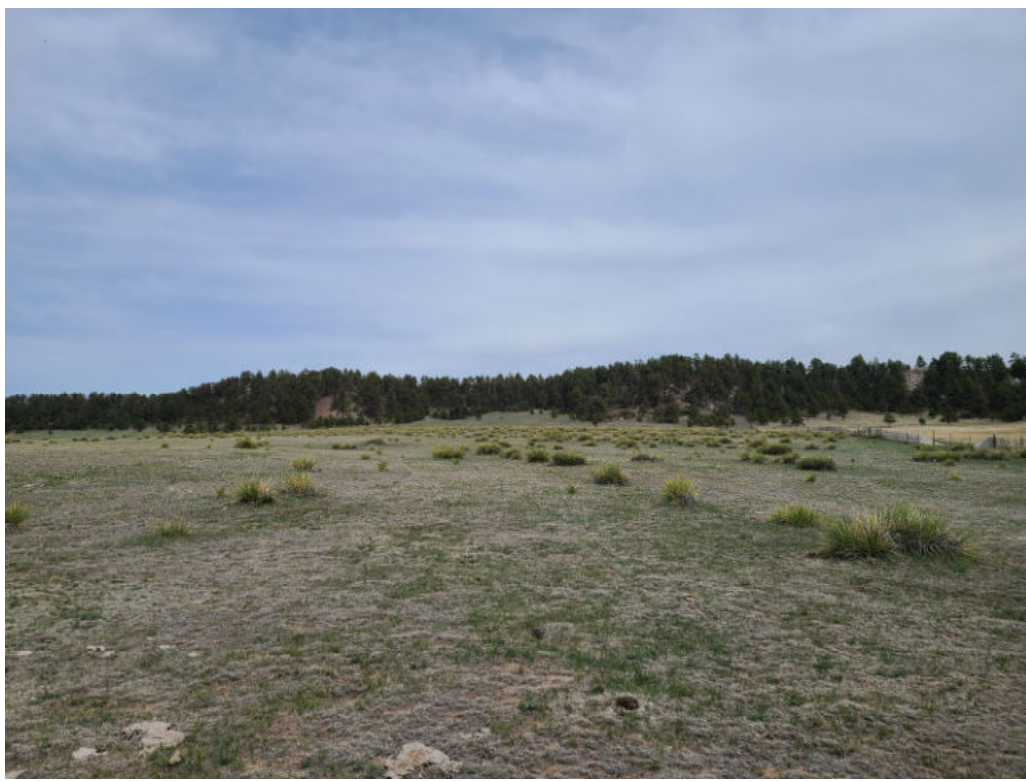
**Looking north from the
southeastern corner of
the site.**

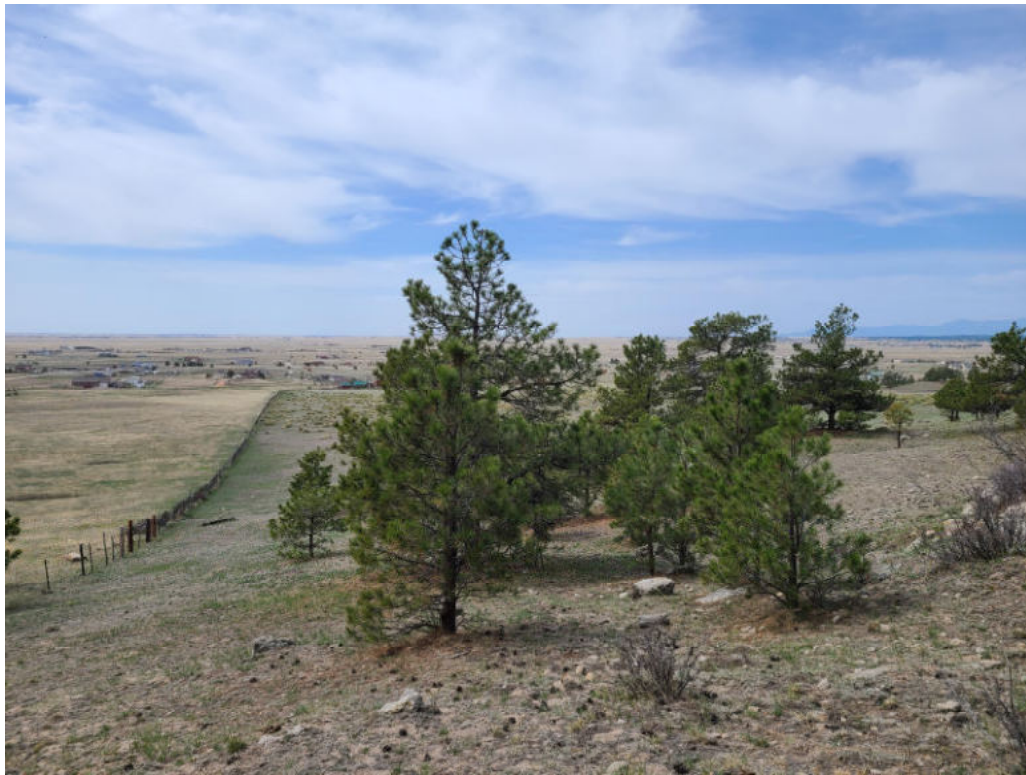
**Looking south from
the eastern side of the
site.**

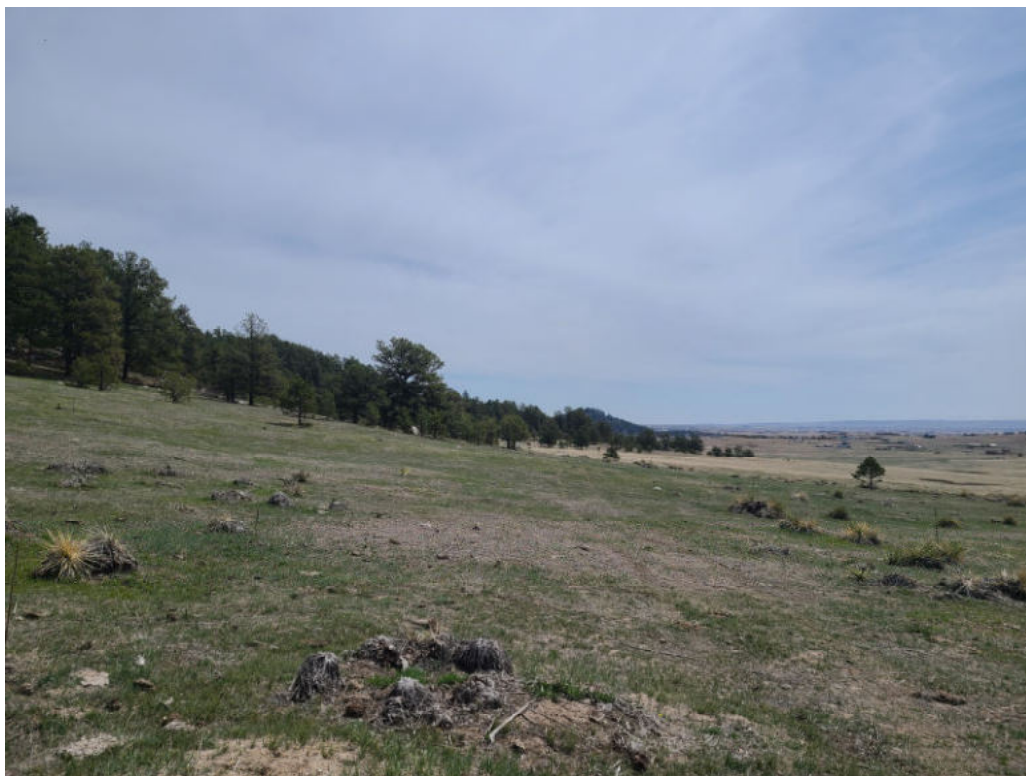
**Looking east from the
southeastern portion
of the site.**

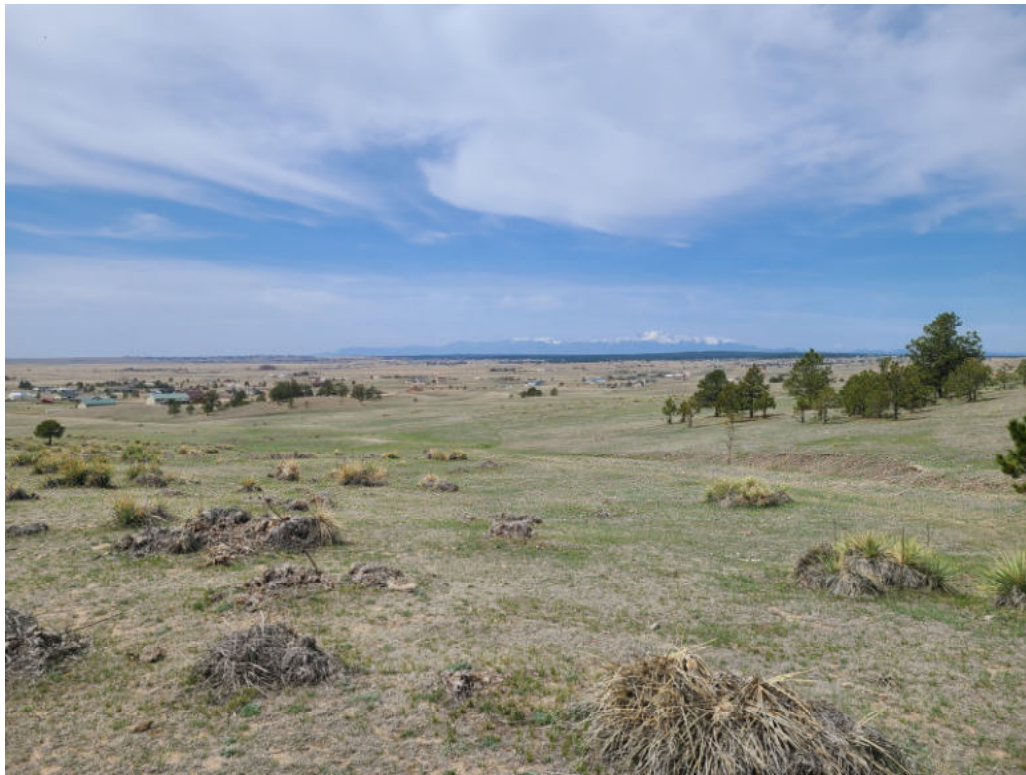
Looking west from the southeastern side of the site.

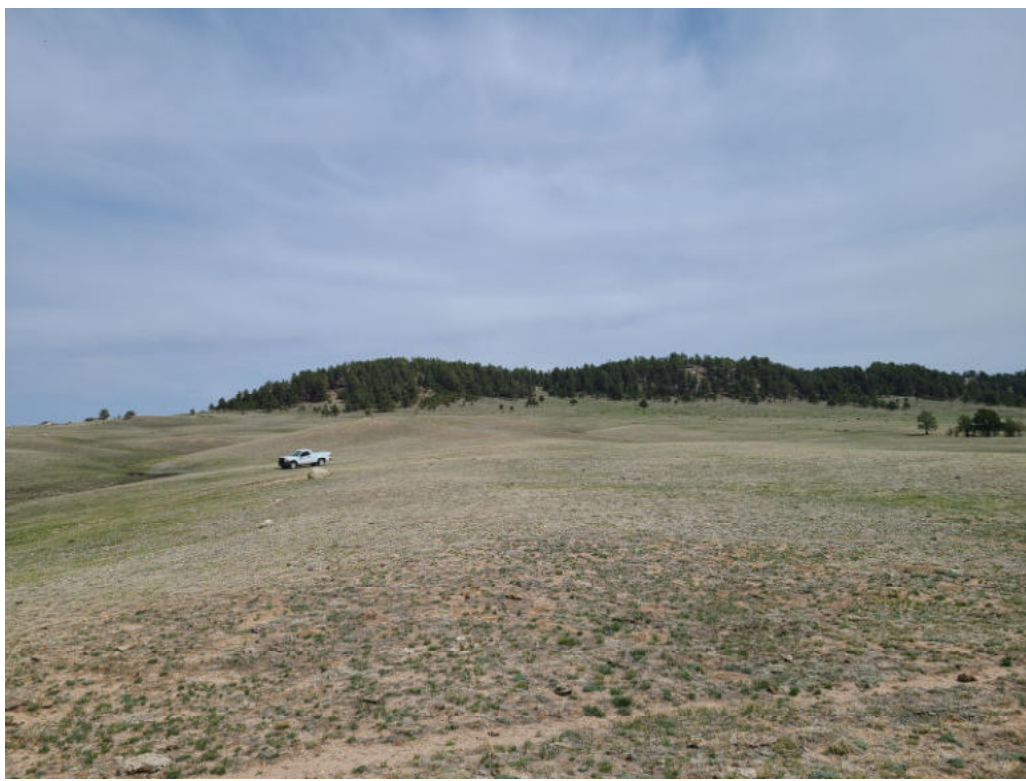
Looking north from the southern side of the site.

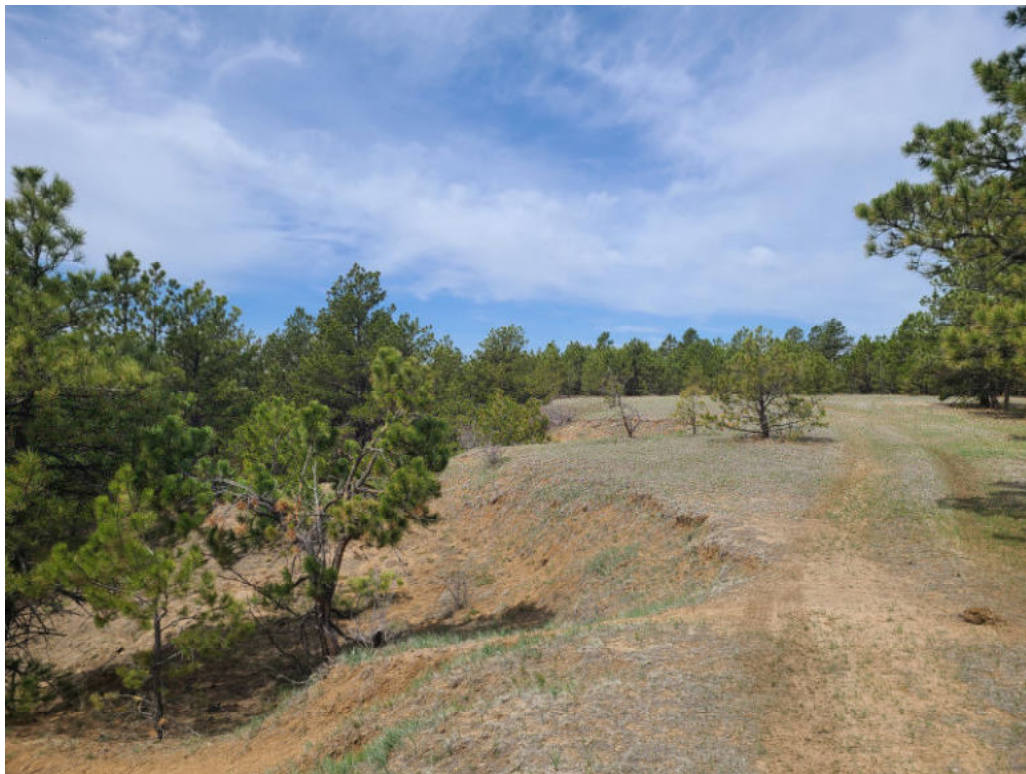
**Looking north from the
eastern side of the site
on Lot 17.**

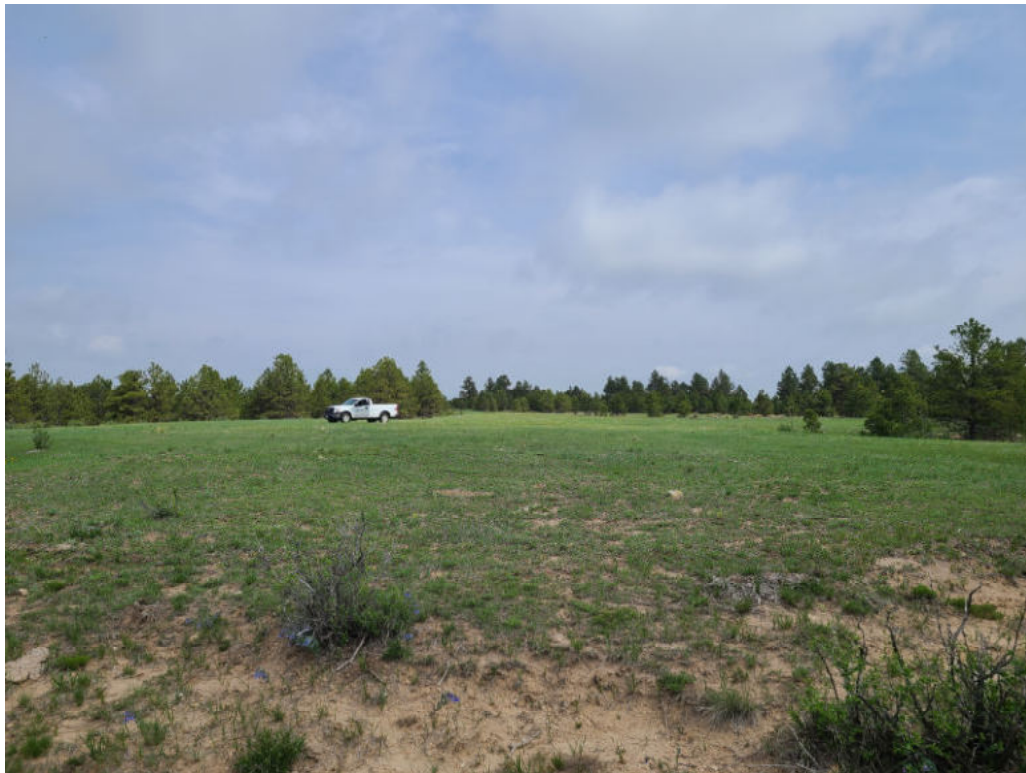
Looking north from the western side of Filing No. 3.

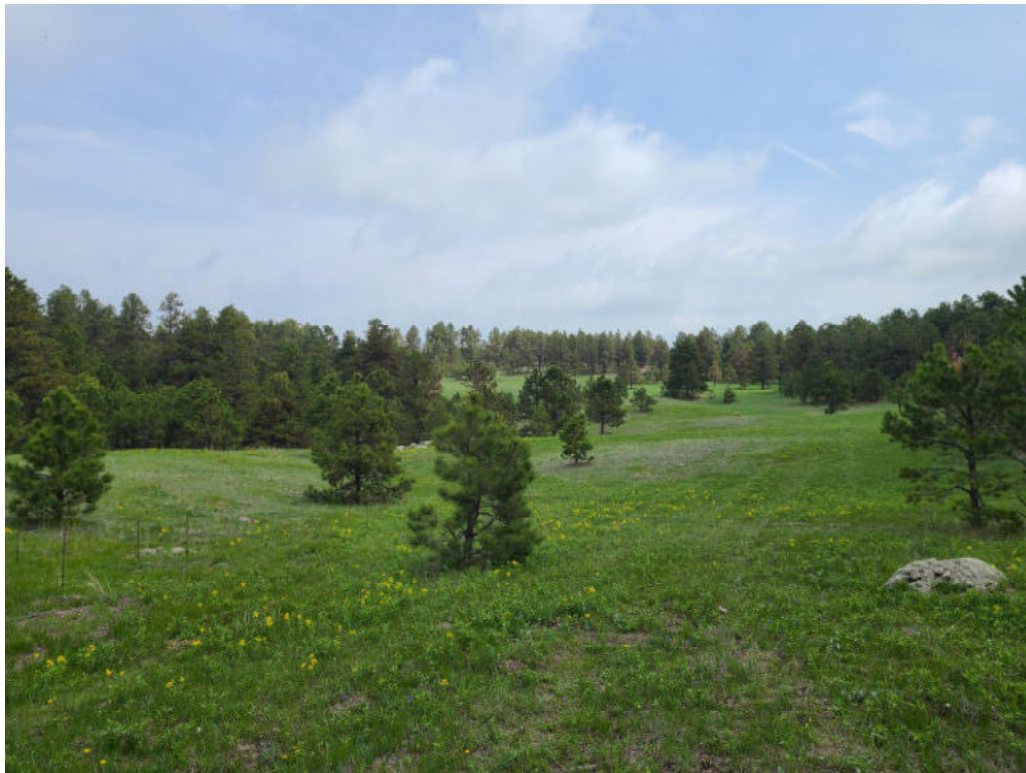
**Looking northeast the
north central portion of
the site.**

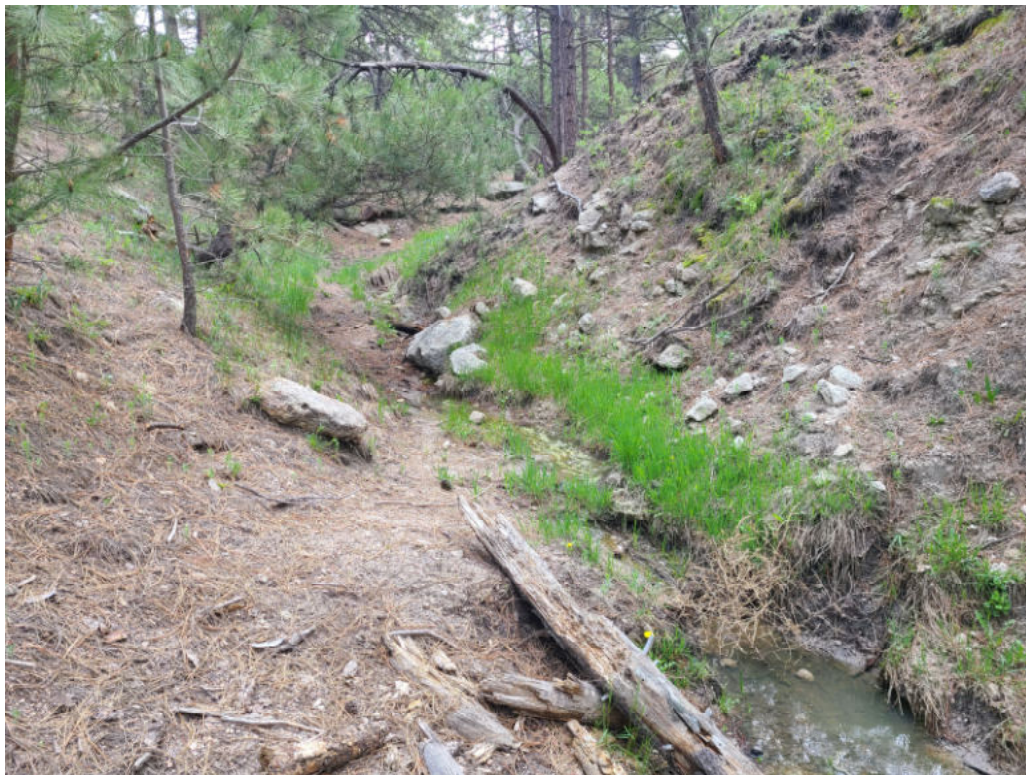
**Looking east along
drainage on Lot 59.**

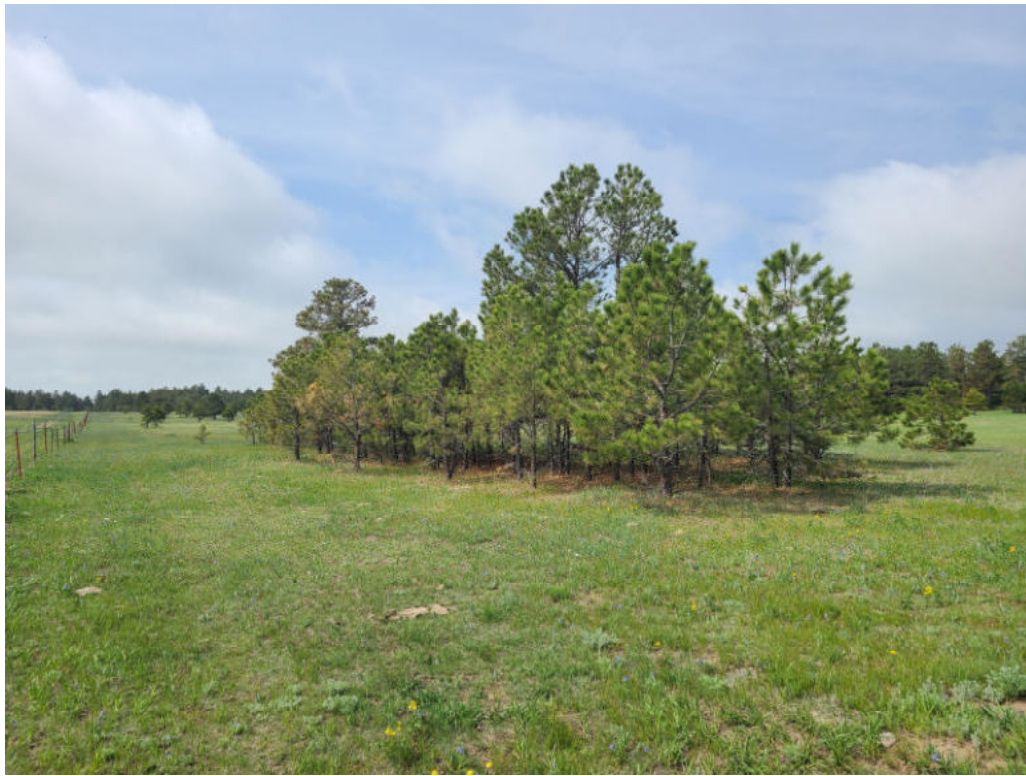
**Looking south from
the northeastern side
of the site.**

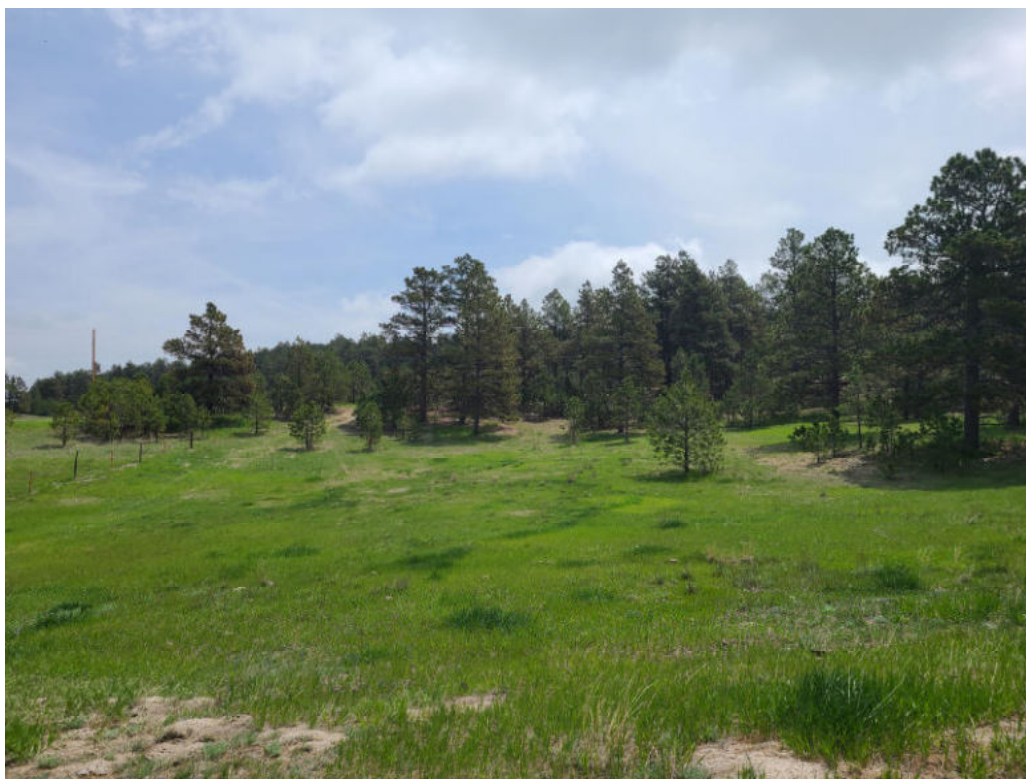
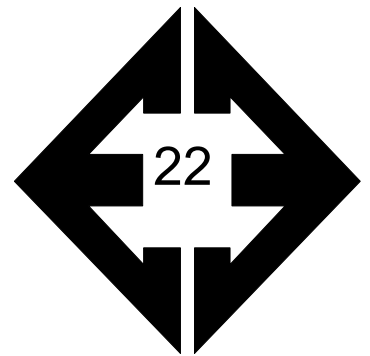
**Looking east
northwestern side of
the site.**
