**SOILS AND GEOLOGY STUDY  
OVERLOOK AT HOMESTEAD – FILING NO. 1  
ELBERT ROAD  
EL PASO COUNTY, COLORADO**

**PT Overlook, LLC**  
1864 Woodmoor Drive, Suite 100  
Monument, Colorado 80132

June 7, 2024  
Revised November 13, 2024

**PCD No. SF2425**

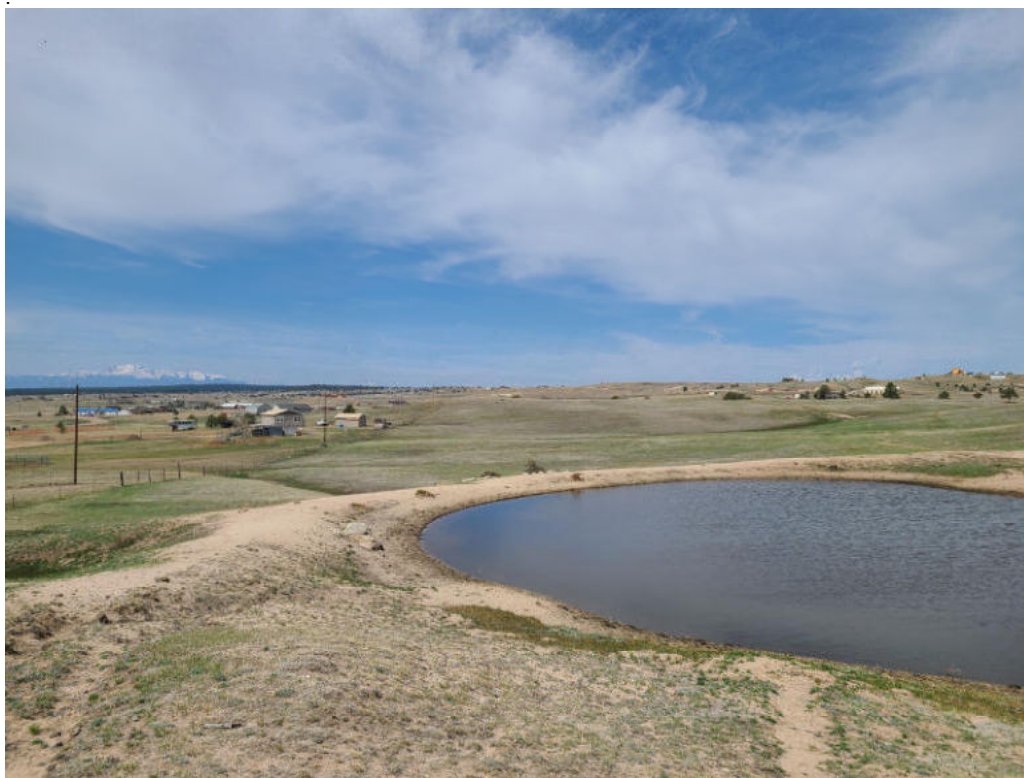
**Looking west towards  
pond in the southern  
side of the site.**

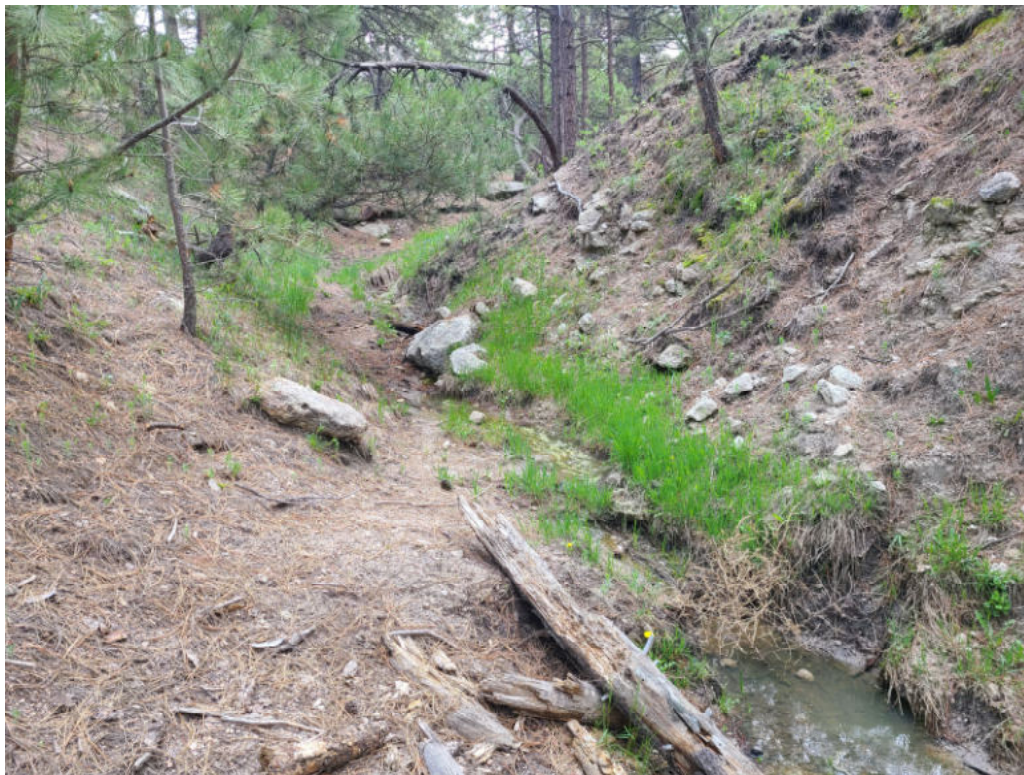
**Looking east along  
drainage on Lot 59.**
