**SOILS AND GEOLOGY STUDY
OVERLOOK AT HOMESTEAD – FILING NO. 1
ELBERT ROAD
EL PASO COUNTY, COLORADO**

June 7, 2024
Revised December 5, 2024

PCD No. SF2425

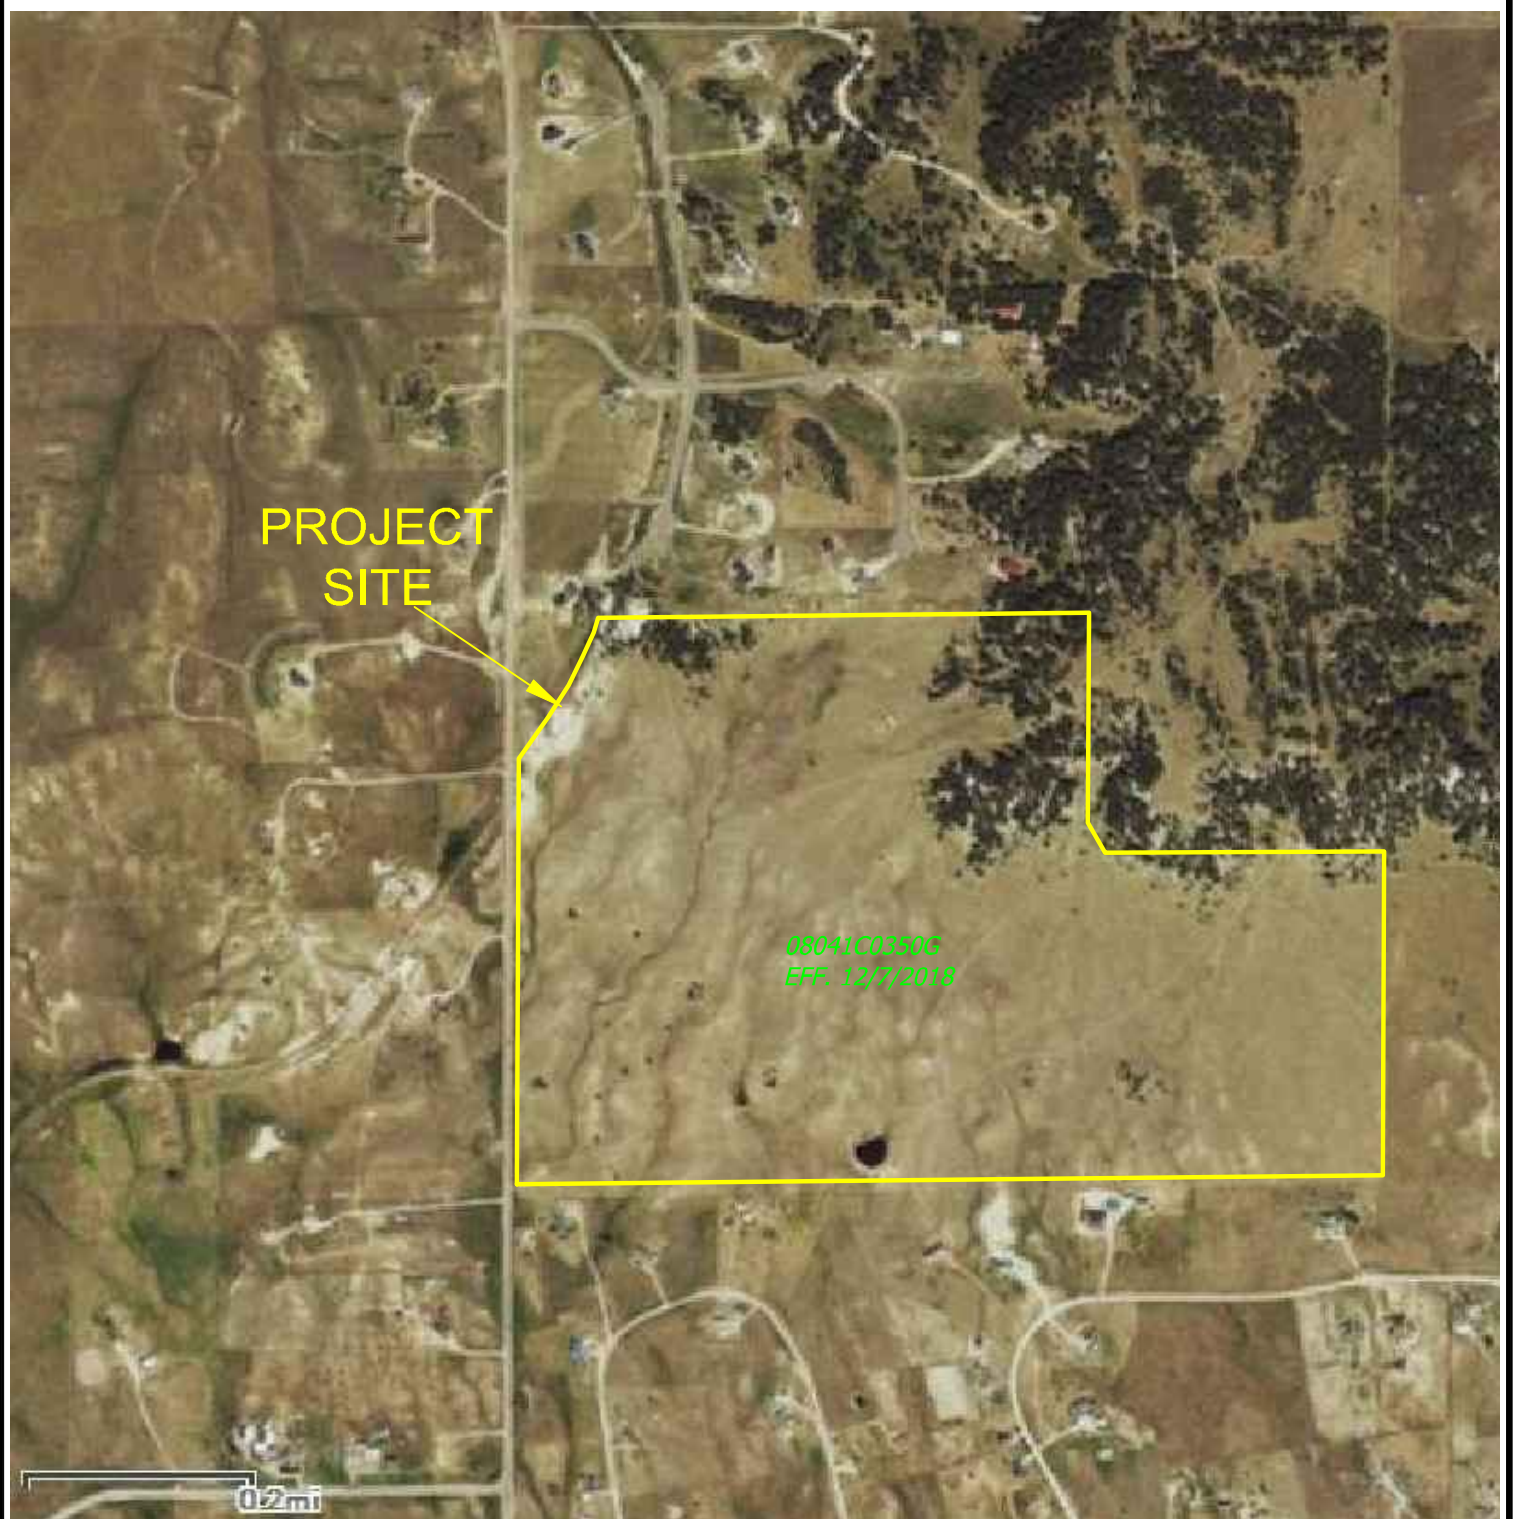
FEMA FLOODPLAIN MAP
OVERLOOK AT HOMESTEAD, FILING NO. 1
PT OVERLOOK, LLC

The main drainage is located in the southwestern portion of the site. Several minor drainages are located across the site that generally flow in southerly directions. None of the drainages on the site have been mapped within floodplain zones according to the FEMA Map No. 08041CO350G, (Figure 8, Reference 12). Areas where potentially seasonal shallow, seasonal shallow, ponded water, and springs have been indicated on the site geology/engineering geology map, Figure 7. Lots adjacent to the drainages may experience higher groundwater levels during peak flows. Subsurface perimeter drains are recommended for structures adjacent to the floodplains and drainages to help prevent the intrusion of water into areas below grade. Typical drain details are presented in Figure 9. Finished floor levels must be a minimum of one floor above the floodplain level. **Exact floodplain locations and drainage studies are beyond the scope of this report.**

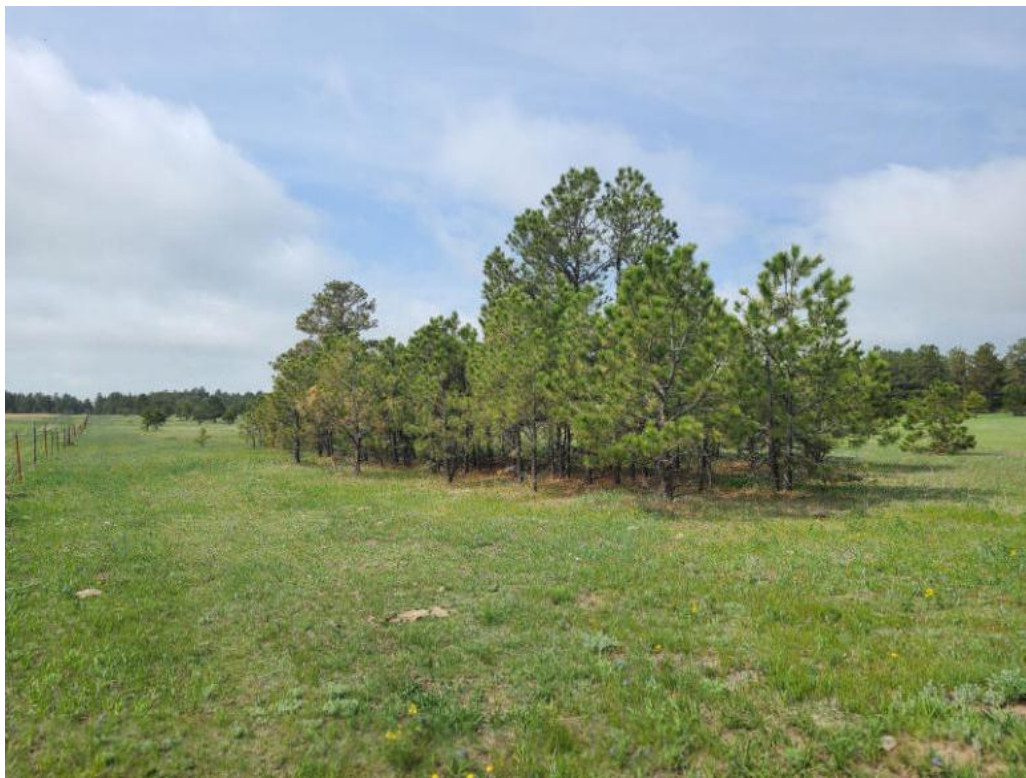
**Looking south from
the northeastern side
of the site.**

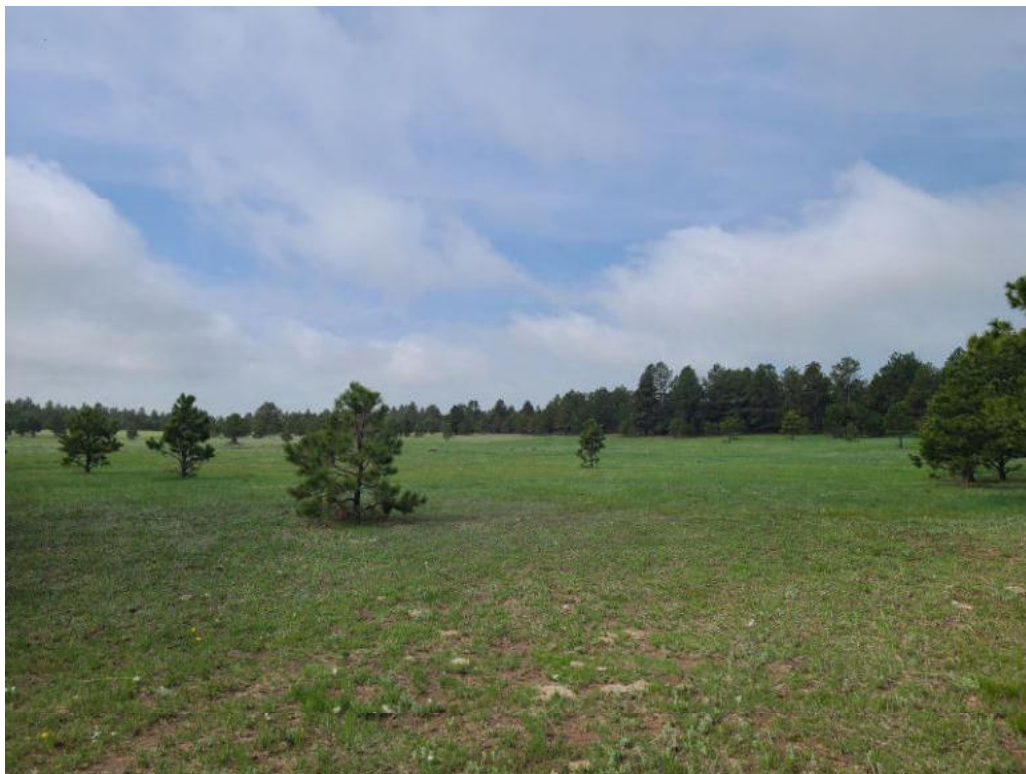
**Looking southwest
from northeastern side
of the site.**

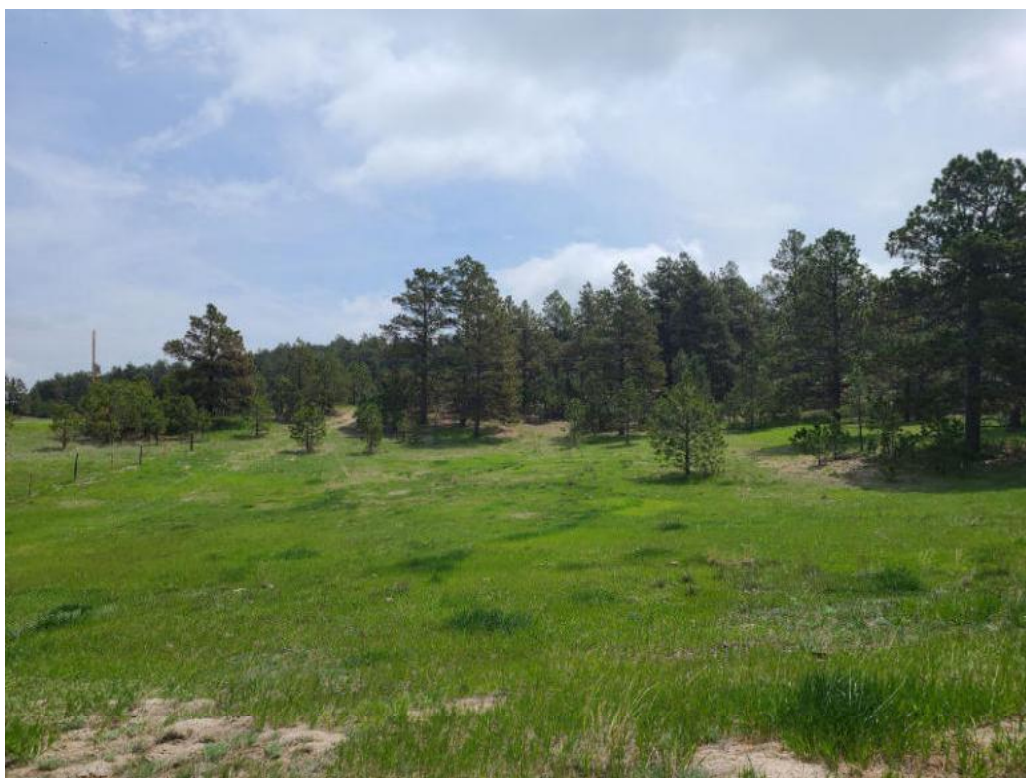
**Looking east
northwestern side of
the site.**

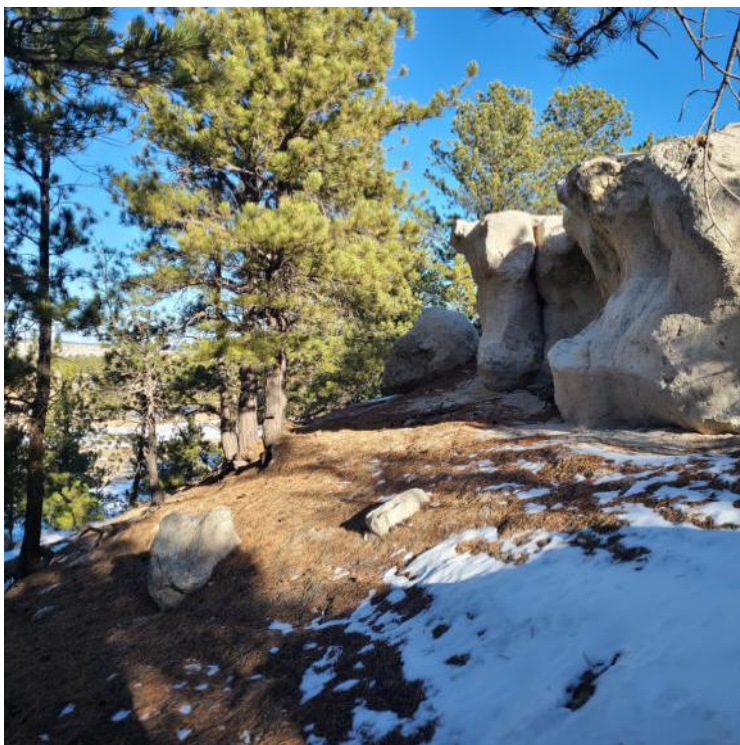
Rocks observed on the slope appeared to be relatively stable in their current state. Smaller sized rocks that do not reach the building area of the site were also noted. Erosion and frost wedging over time could destabilize the larger rocks and rocks along the slopes that could pose a threat at later dates. A portion of the outcrop located in the southern portion of Lot 25 has been identified as potentially unstable.

**Looking north towards
potentially unstable
sandstone slab on Lot
25.**

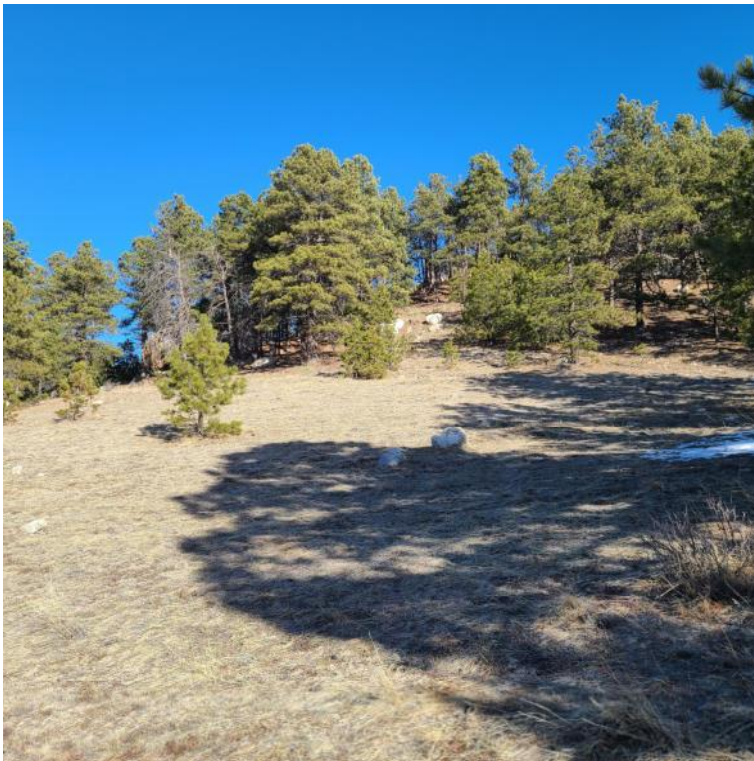
**Looking northeast
from southwestern
side of Lot 24.**
