**GEOLOGIC HAZARD / LAND USE STUDY
AND PRELIMINARY
SUBSURFACE SOIL INVESTIGATION
STERLING RANCH
EL PASO COUNTY, COLORADO**

Morley-Bentley Investments, LLC
15 N. Nevada Avenue
Colorado Springs, Colorado 80903

October 31, 2006

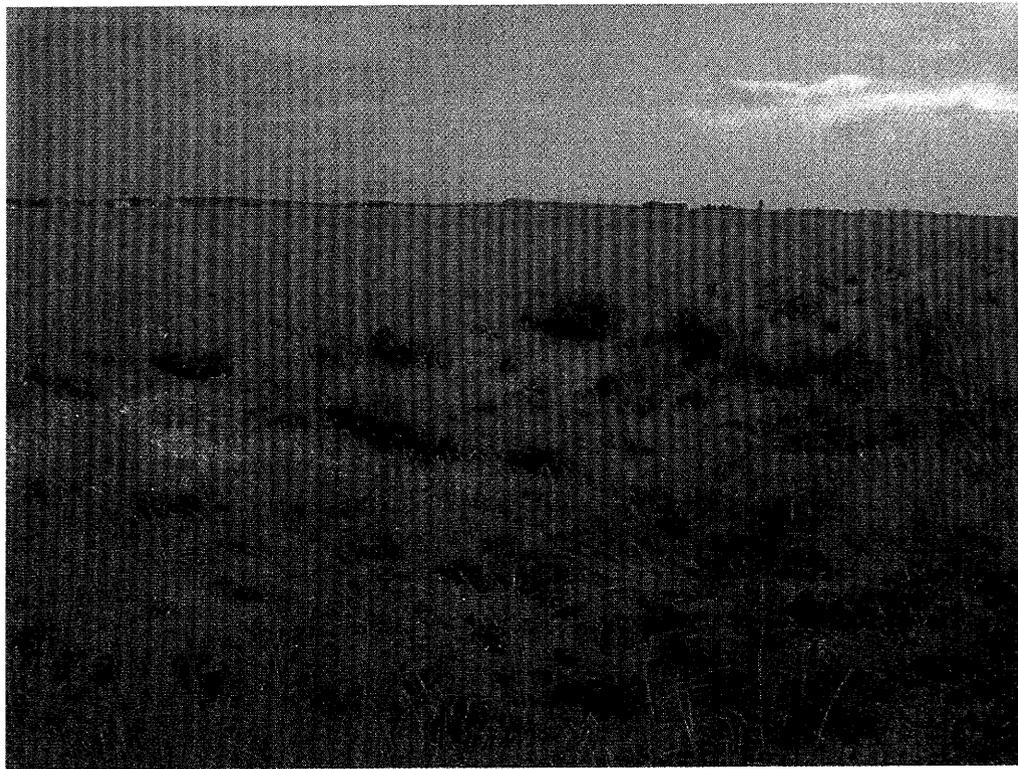
**Looking northeast
from southern portion
of the site.**

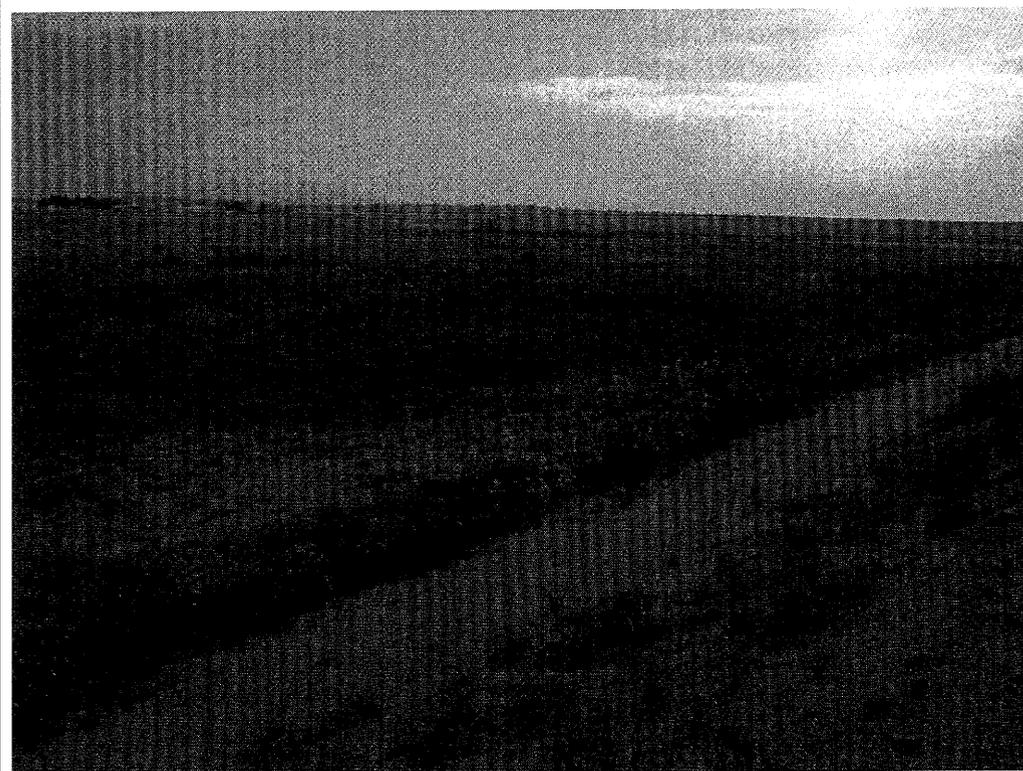
**Looking northeast
from southern portion
of site.**

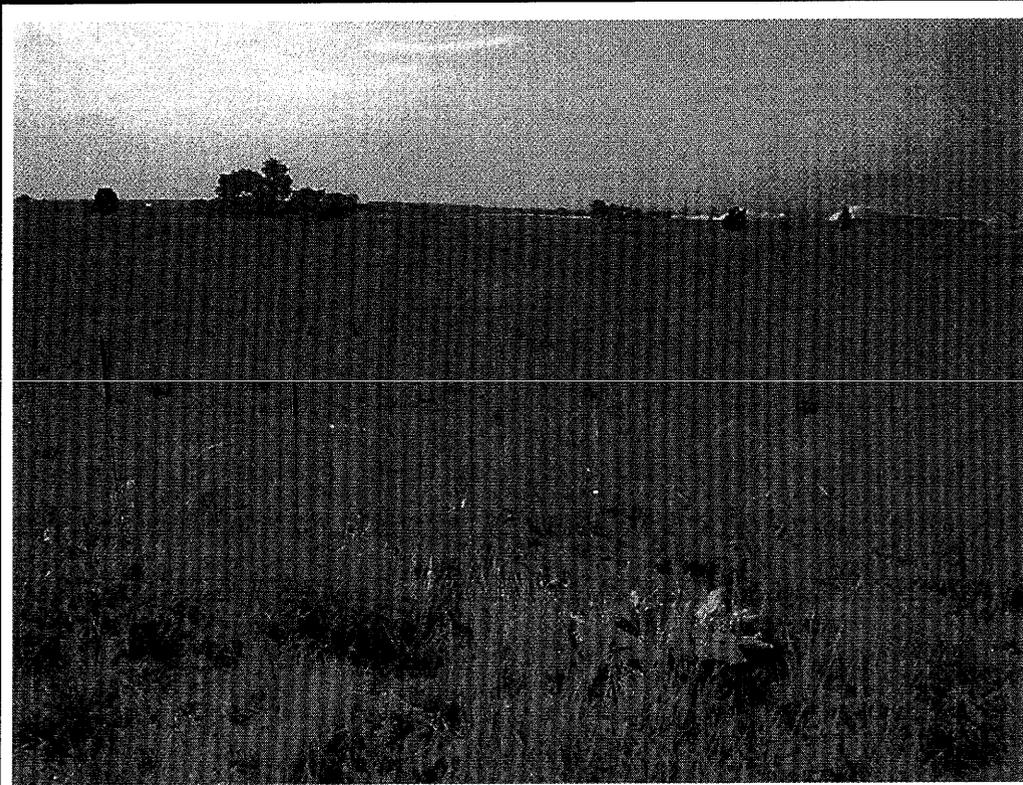
**Looking south from
southern portion of the
site.**

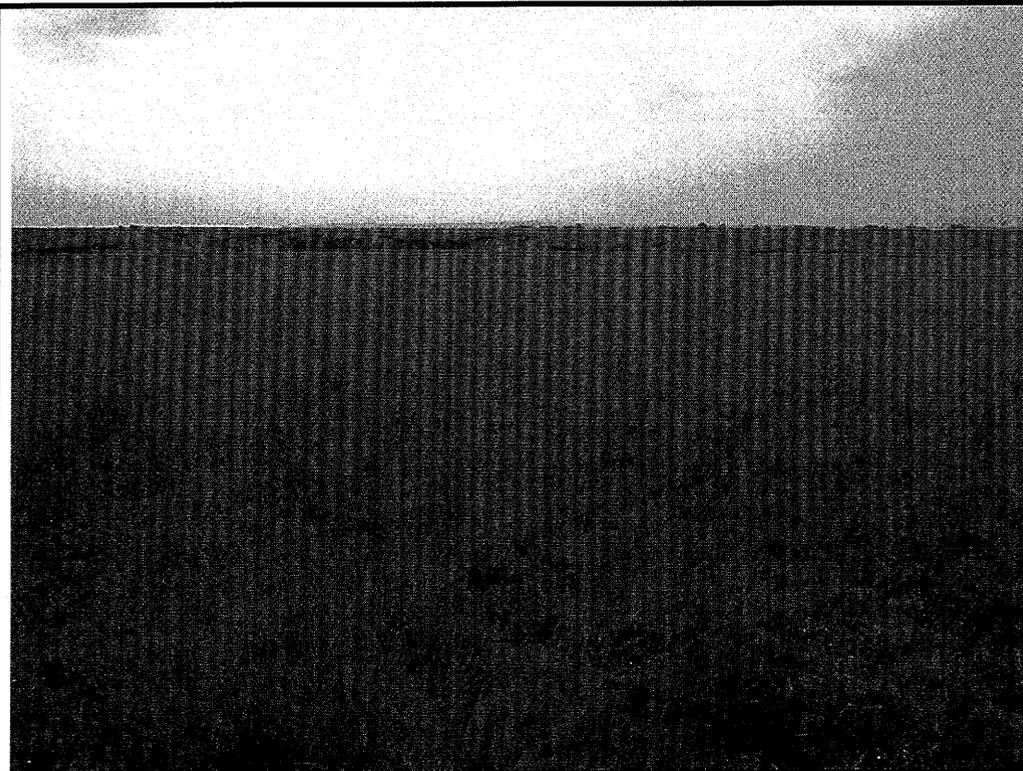
**Looking east from
southern portion of the
site**

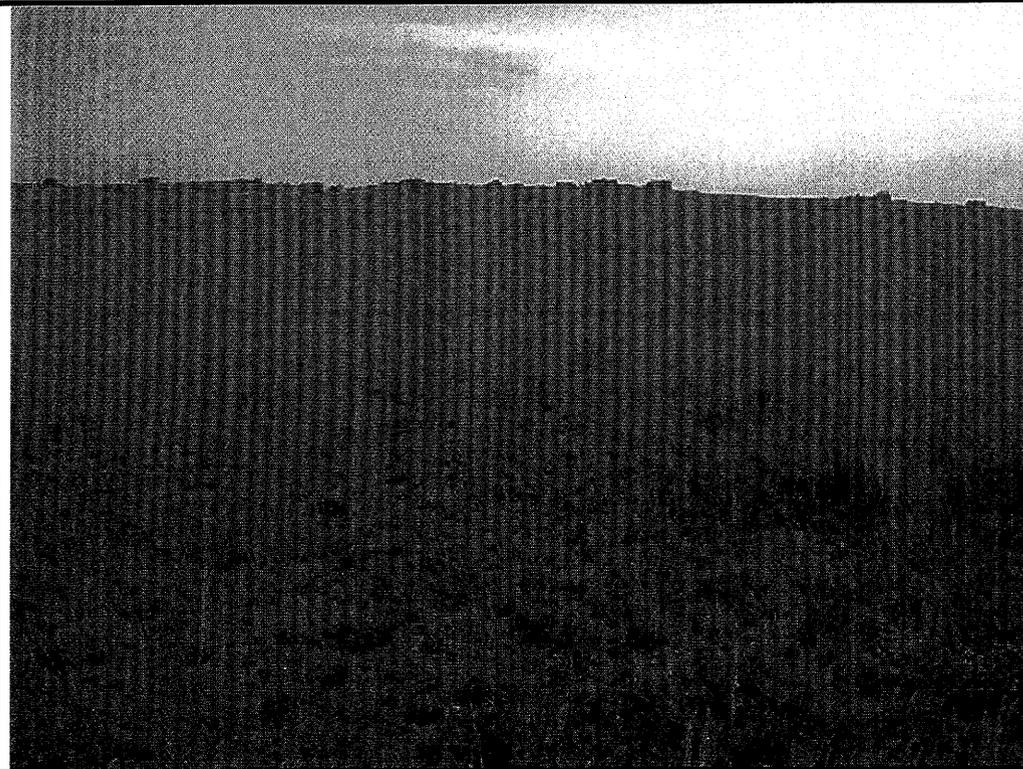
**Looking north from north
central portion of the
site.**
